**NYC Department of Education
Building Condition Assessment Survey 2023-2024**

Architectural Inspection

X815

Asset: REGION 1 ROC B - BRONX, 1 FORDHAM PLAZA, BRONX, NY, 10458

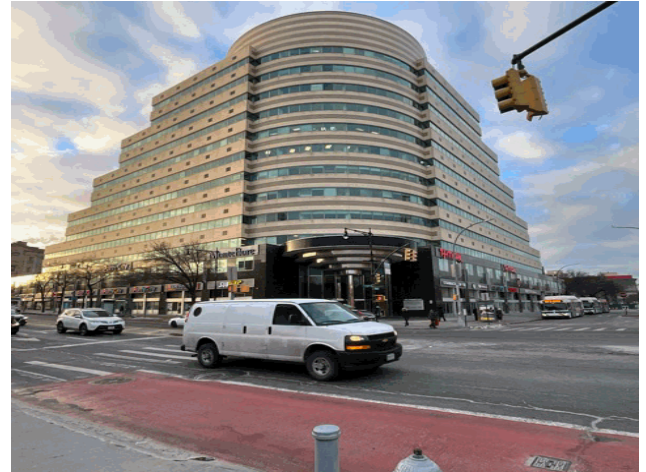
| Question | Answer |
|--|---|
| Facade Photo | |

Corner of Fordham Road and 3rd Avenue - Southeast Views

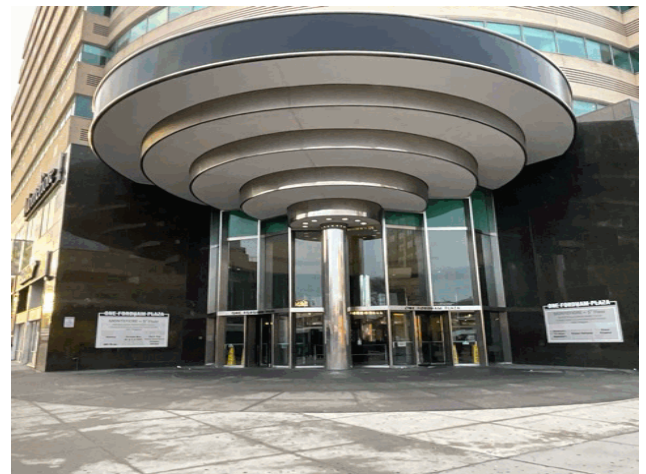
Main Entrance Photo

Facade A - Fordham Room
