**NYC Department of Education
Building Condition Assessment Survey 2023-2024**

Architectural Inspection

X848

Asset: P.S. 48 AX (HNTS PNT ECC1)-BRONX, 659 COSTER STREET, BRONX, NY, 10474

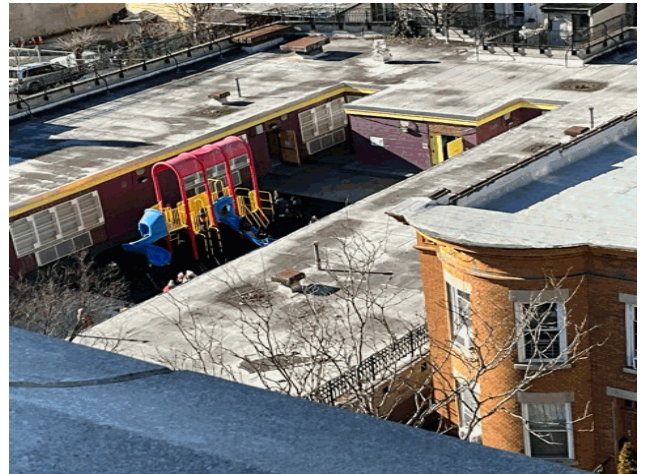
Roof 1 - Southwest View from Main Asset X048

Roof Photo

Question	Response
EXTERIOR	
ROOF	
ROOFING	Inspected
Replacement Quantity	10,000
Replacement Uom	S.F.
Instance on Modified Bitumen:Roof 1	Inspected
Instance Roof Photo	 
	Roof 1
Instance Condition	2- Between Good and Fair
Instance Quantity	10,000
Instance Quantity Uom	S.F.
Does the roof have major mechanical equipment sitting on Dunnage Steel less than 18" above the Roofing?	No
Does this Roof Instance have a Sustainable Roof System?	Yes
Sustainable Roof System Type	White Roof
Sustainable Roof System Location (Roof Number)	Roof 1
Do solar panels exist on these roofs?	No
Is/Are the roof(s) suitable for Solar Panel installation?	No
Installation Year	2015
Source of Installation Year	Documented
Deficiency	No deficiencies recorded
ROOFING DRAINS	Inspected
Condition	2- Between Good and Fair
Deficiency	No deficiencies recorded
SPECIALTIES	Inspected
BULKHEAD/PENTHOUSE	Does not exist
CUPOLA/ SPIRES/ TOWERS	Does not exist
DORMER	Does not exist
