**NYC Department of Education
Building Condition Assessment Survey 2023-2024**

Architectural Inspection

X980

Asset: P.S. 204 ANNEX - BRONX, 1732 DAVIDSON AVENUE, BRONX, NY, 10453

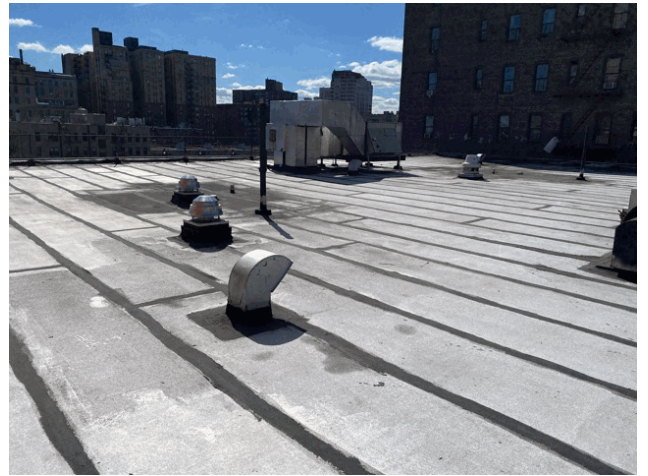
Roof 1 - Southeast View

Roof 1
Instance Condition	4- Between Fair and Poor
Instance Quantity	7,000

Question	Response
EXTERIOR	
ROOF	
ROOFING	
ROOFING	
Does the roof have major mechanical equipment sitting on Dunnage Steel less than 18" above the Roofing?	No
Does this Roof Instance have a Sustainable Roof System?	No
Do solar panels exist on these roofs?	No
Is/Are the roof(s) suitable for Solar Panel installation?	No
Installation Year	2008
Source of Installation Year	Documented
Deficiency	MODIFIED BITUMEN:ROOFING:DELAMINATION
Deficiency Location/Instance

Deficiency Quantity	150
Quantity Uom	S.F.
Potential Action	REPLACE ROOFING WITH MAJOR EQUIPMENT REMOVAL
Urgency of Action	PRIORITY 4
Purpose of Action	LEVEL 2
Deficiency Photo 1
