# **Educational Facilities and Risk Management**

**Natural disasters**

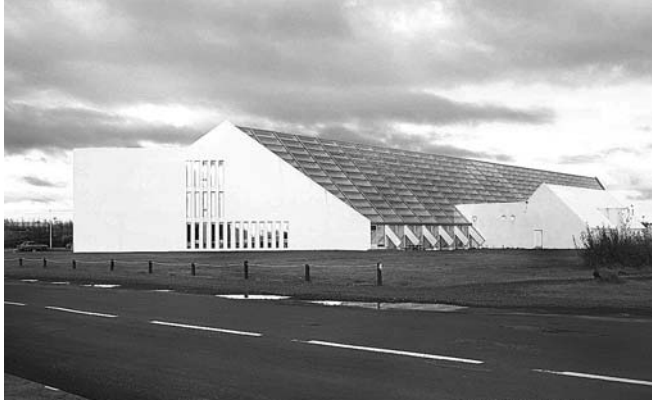
Figure 2. **Modern school building at Selfoss in South Iceland**

*Note:* The building withstood peak ground acceleration equal to approximately 18% g on 21 June 2000. The strength demand is assessed to roughly 50% g. Distance from the building to the causative fault was about 14 km. No significant damage to the building was reported.

The older school buildings in Iceland are commonly low-rise simple structures, built either of timber or concrete. Such buildings have proven to be seismically robust due to their high specific strength. Modern school buildings are characterised by elegance and functionality obtained through new materials and new building forms, leading to increasing complexity compared with the older buildings (see Figure 2).

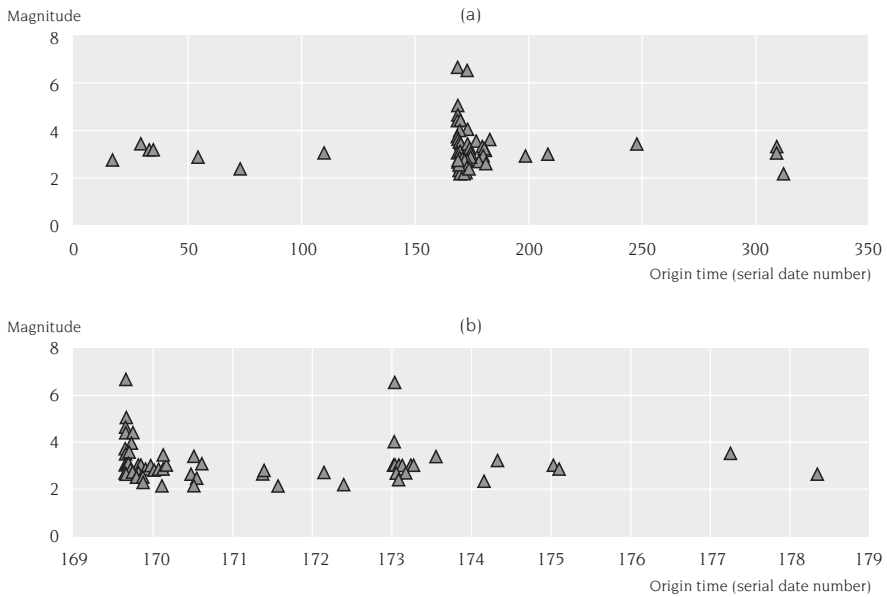
Figure 3. **Timeline of earthquake activity in Iceland in the year 2000 showing the South Iceland earthquake sequence starting on 17 June**

Note: The magnitude of events is given as a function of origin time represented as a serial date number. (a) Earthquake activity in Iceland in the year 2000. (b) Ten days with the most intense earthquake activity starting with day 169, that is 17 June 2000. Day 173 is 21 June 2000.

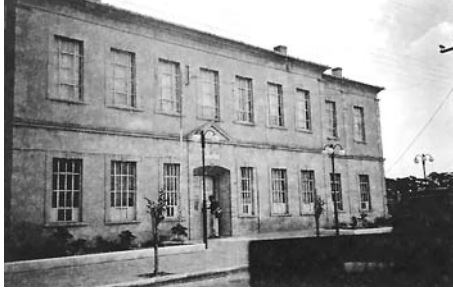
Figure 1. **Trambazion Elementary School, Siatista, West Macedonia**

- Two- or three-storey masonry buildings with timber decks and trussed roofs [Trambazion Elementary School at Siatista (Figure 1), Valtathonio High School in Kozani (Figure 2), former Elementary School at Vlatsi, etc.].
- Two- or three-storey masonry buildings with reinforced concrete decks and roofs. These decks, actually rigid diaphragms, replaced the old timber decks and roofs in the early 1960s [Tsofli High School, the 5<sup>th</sup> (Figure 3) and 15<sup>th</sup> Elementary Schools in Kozani, etc.].
- Two- or three-storey masonry buildings with semi-rigid diaphragmatic decks and roofs consisting of steel girders and masses with brick infills [the old building of the University of Thessaloniki, the National Library of Greece (Figure 4), etc.].

- In buildings with timber roofs and decks, where the diaphragmatic action is very poor, the structural walls respond, to a degree, independently one from the other, and as a result they present the following types of damage:
  - inclined cracks at the edges of the buildings, typical damage of independent out-of-plane behaviour of the walls;
