## APPENDIX C. 2017 HYDRAULIC CALIBRATION LOCATIONS

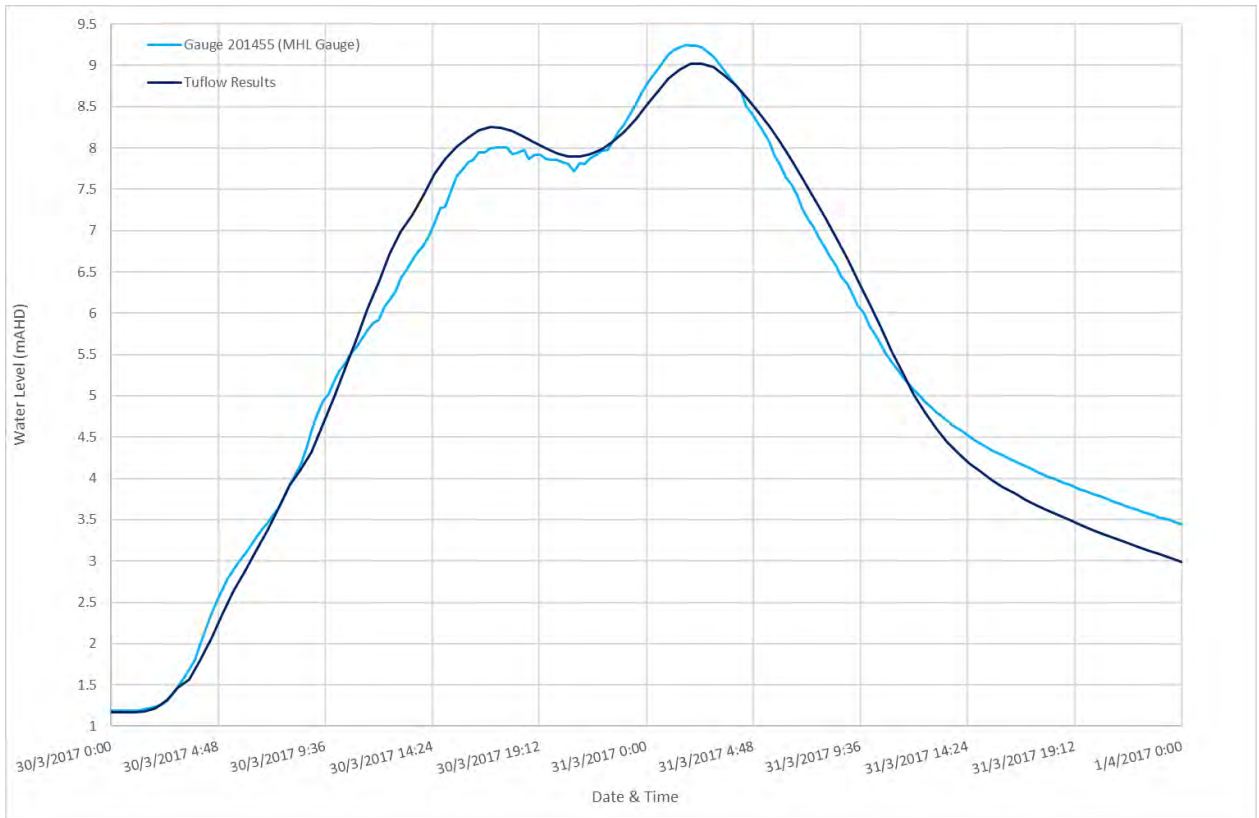
Diagram 69: 2017 Comparison of Water Level at Bray Park

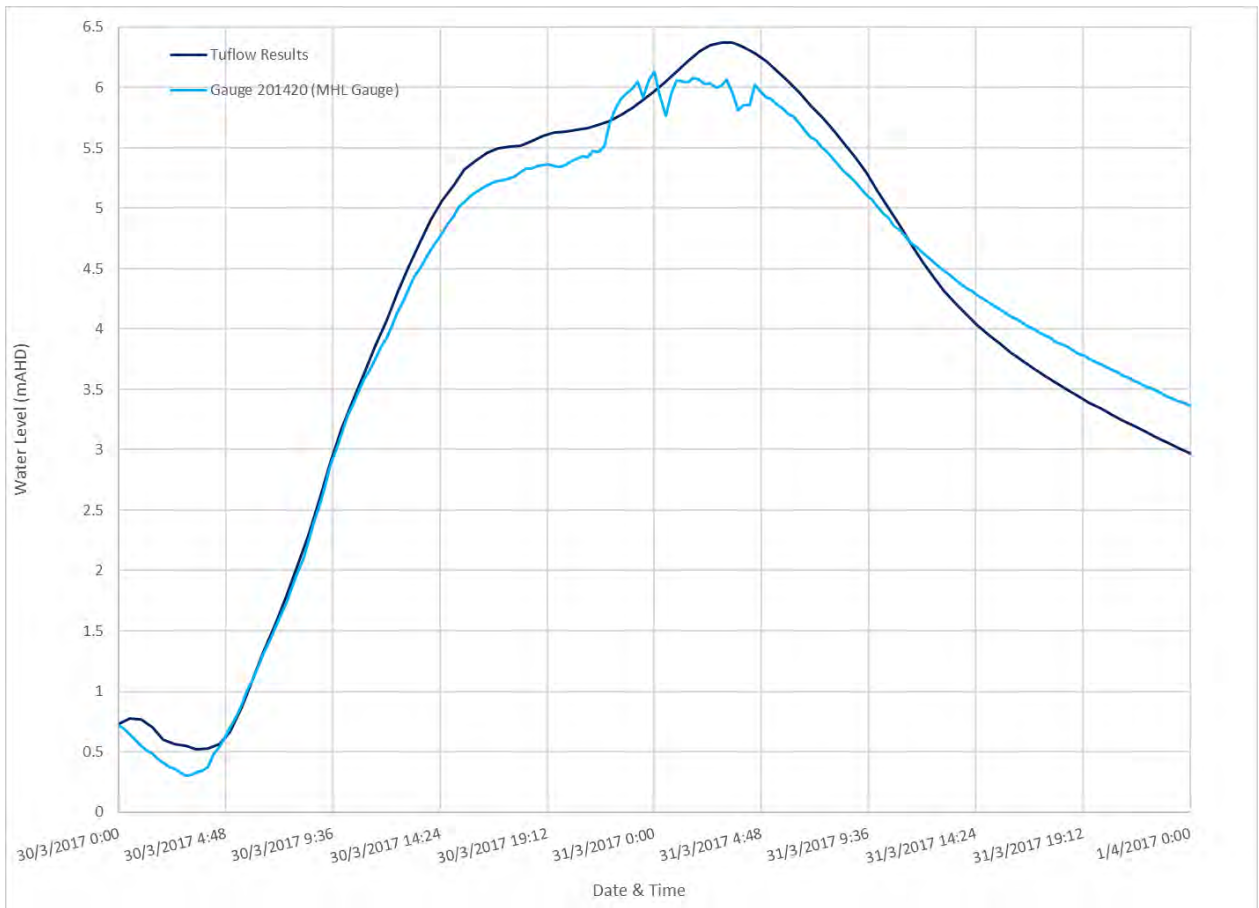
Diagram 70: 2017 Comparison of Water Level at North Murwillumbah

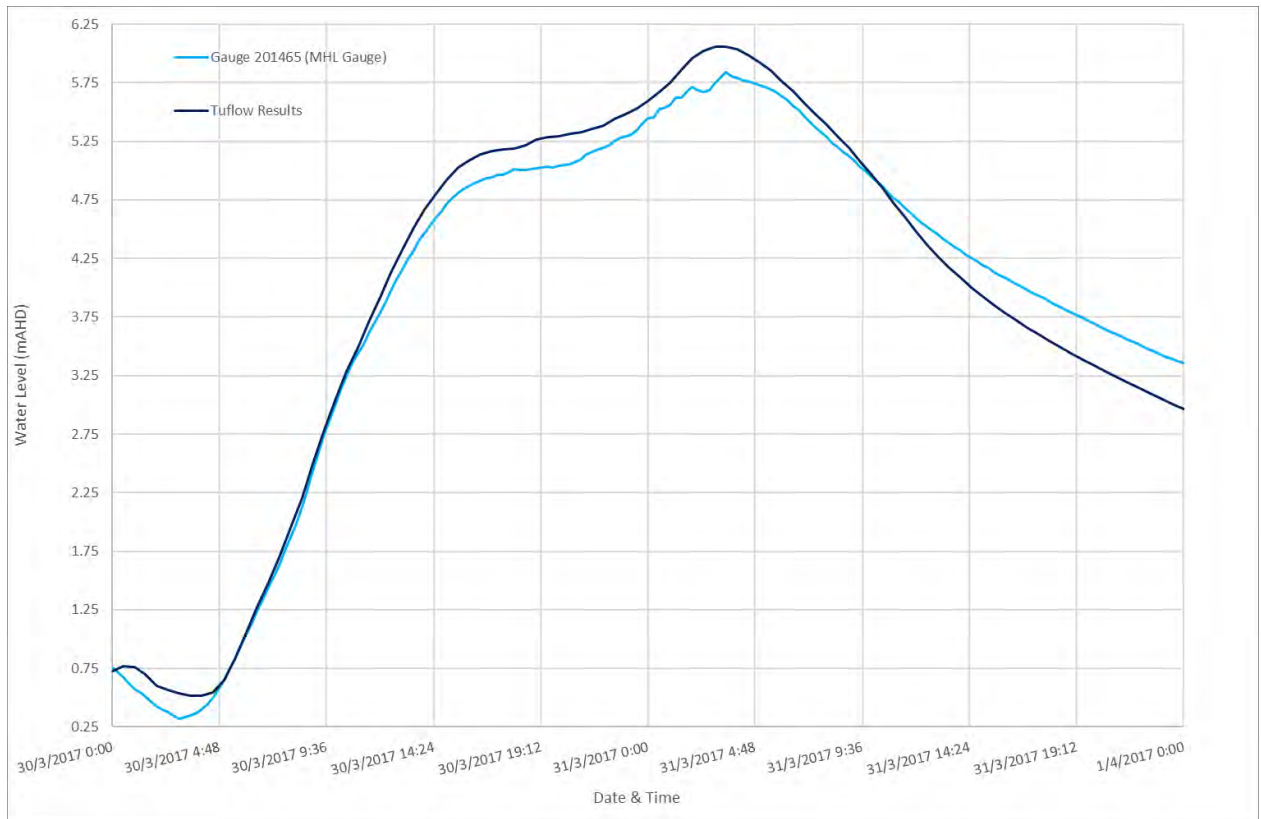
Diagram 71: 2017 Comparison of Water Level at Murwillumbah Bridge

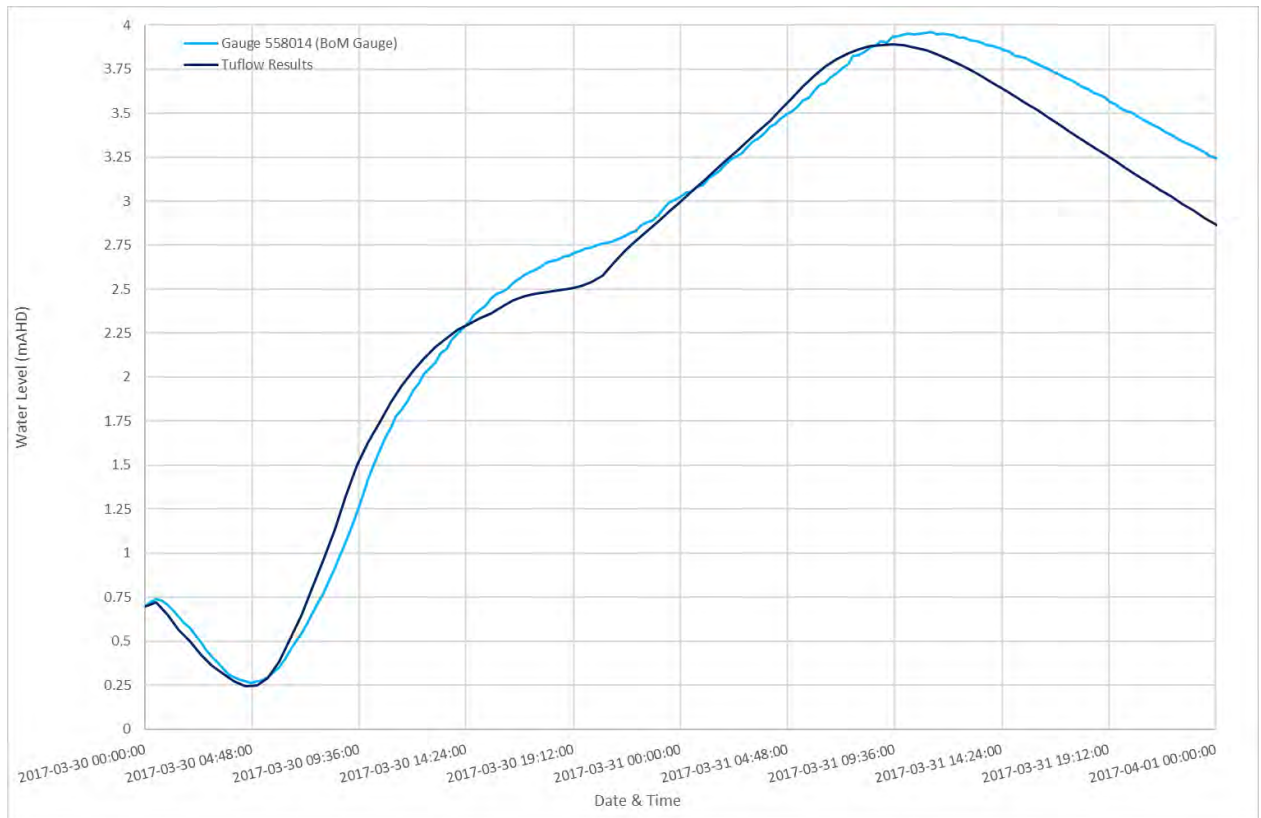
Diagram 72: 2017 Comparison of Water Level at Tumbulgum

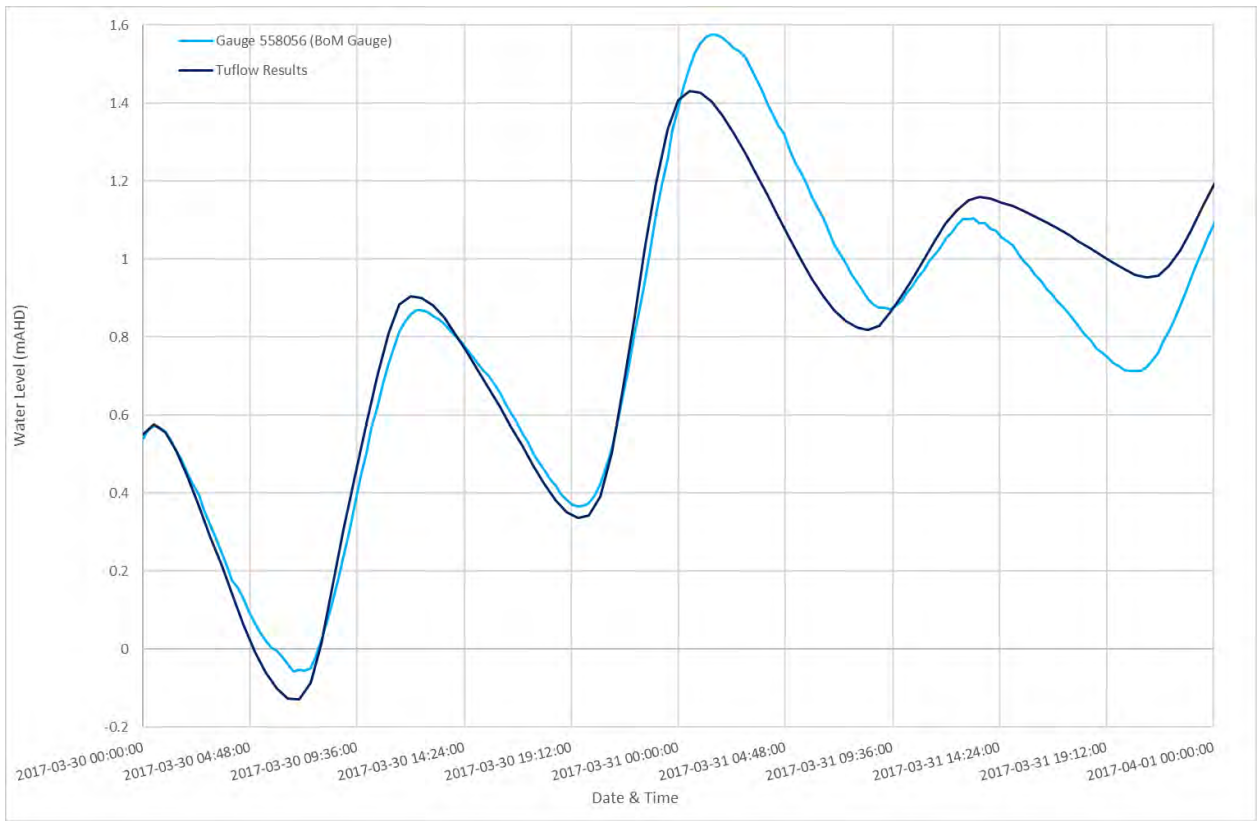
Diagram 73: 2017 Comparison of Water Level at Terranora

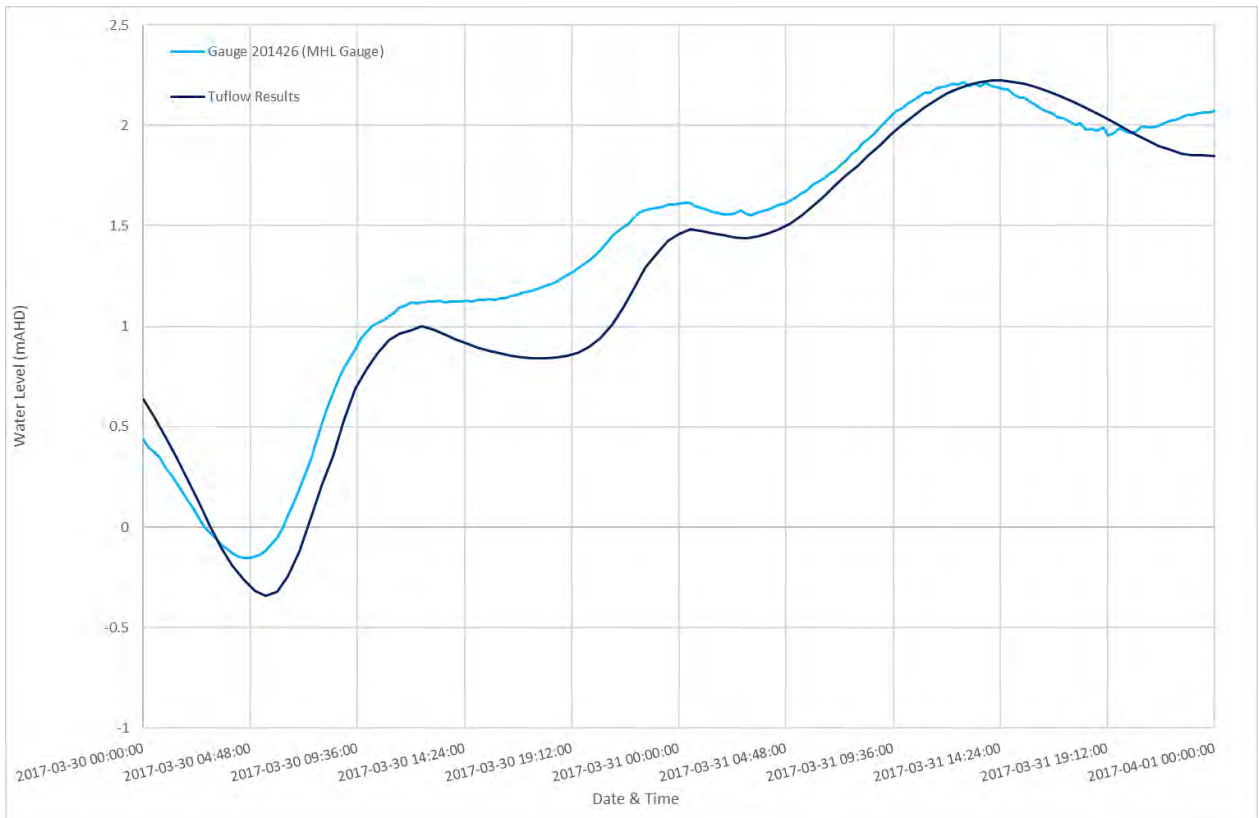
Diagram 74: 2017 Comparison of Water Level at Barney's Point

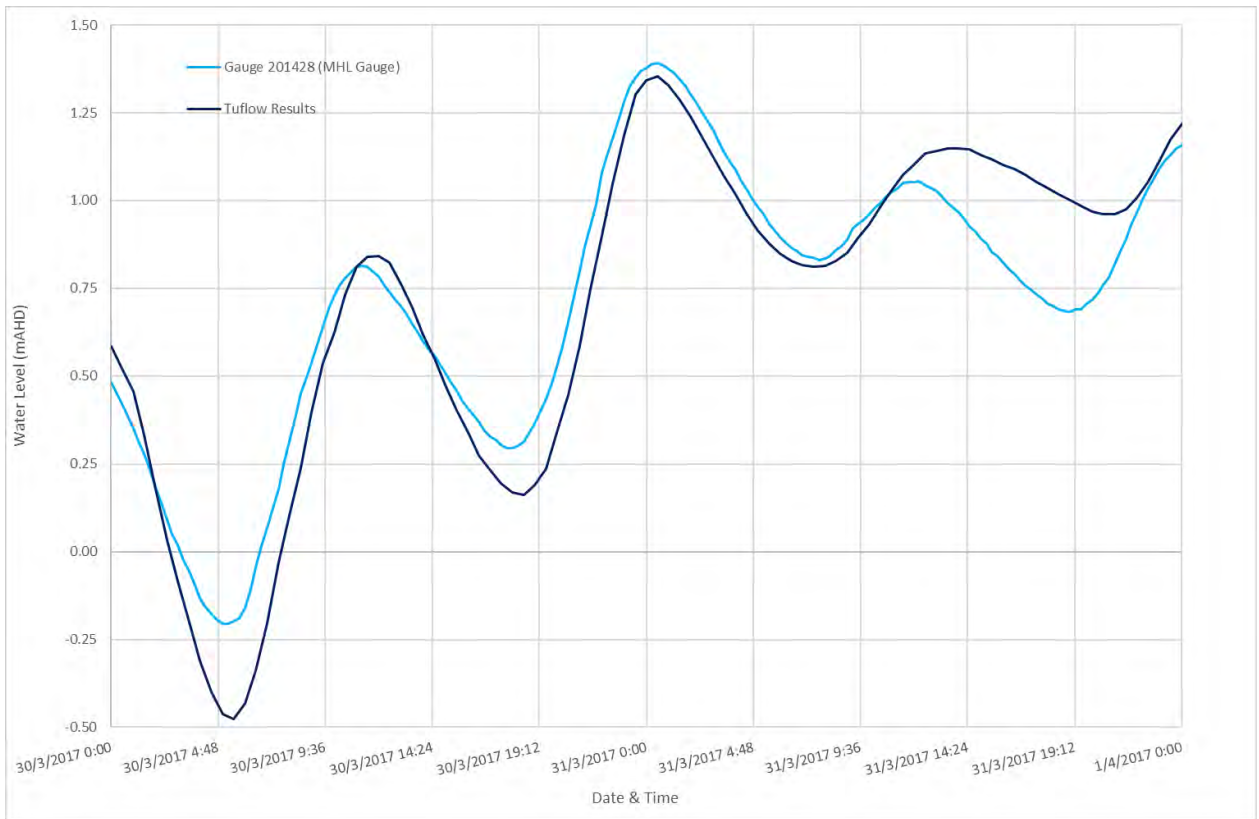
Diagram 75: 2017 Comparison of Water Level at Dry Dock
