TWEED
SHIRE COUNCIL

Murwillumbah CBD Levee & Drainage Study

Final Report

▶▶ Revision 2
June 2018

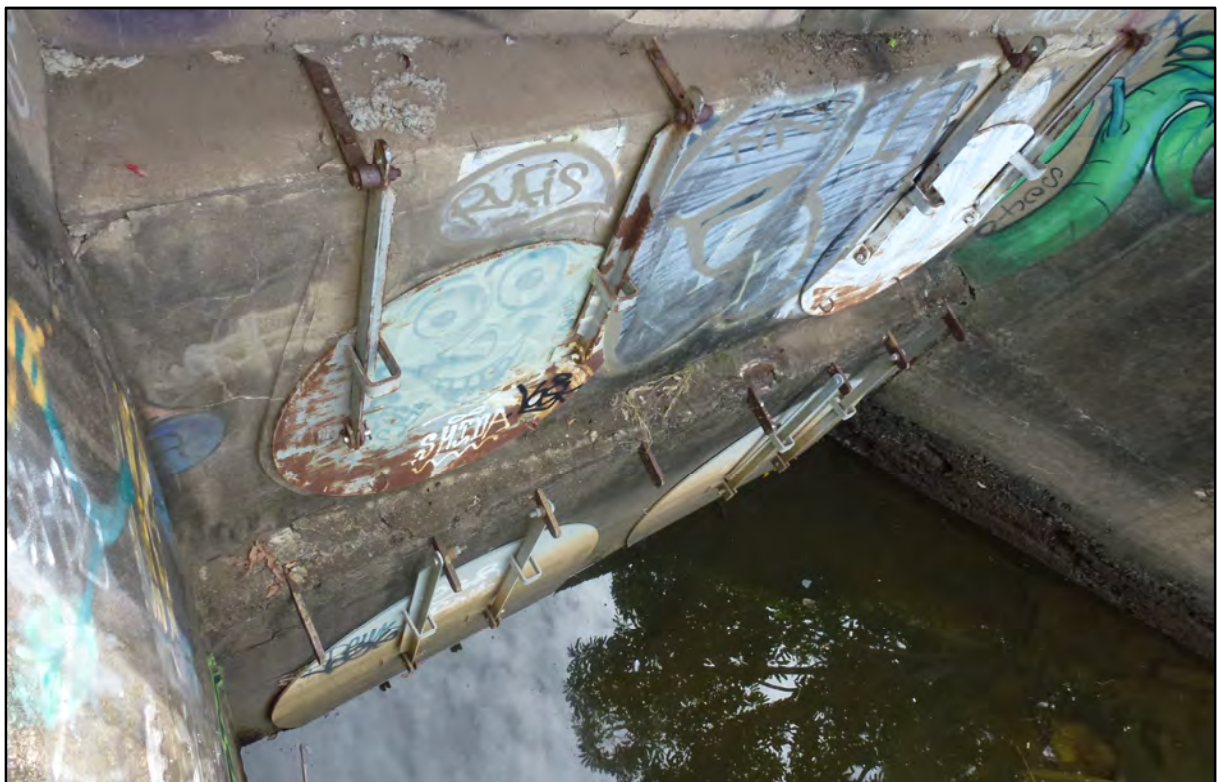
Plate 4 View showing flood gates on Tweed River side of Commercial Road culverts. The gates prevent water from the Tweed River “backing up” the culverts and inundating areas behind the levee

Council typically has sufficient warning time during Tweed River floods to check all flood gates to ensure they are operating as intended (e.g., removing any debris that may cause the gates to remain “open”).

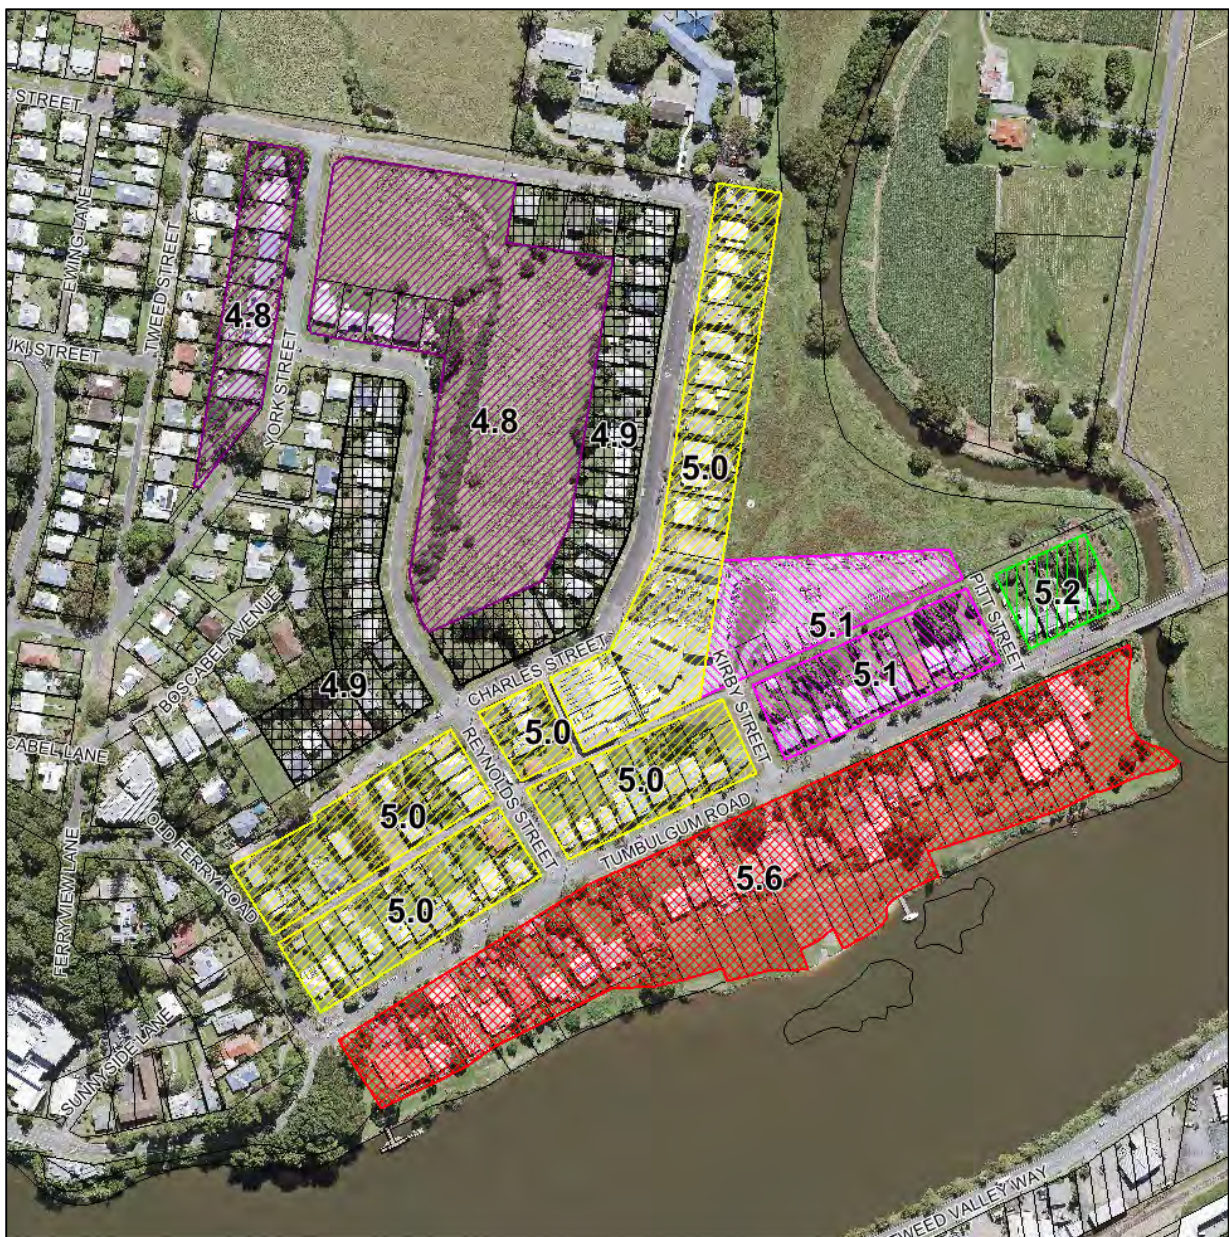
Plate 47 Suggested Design Flood Levels for East Murwillumbah

The design flood level map included in DCP-A3 provides a reasonable representation of the flood level gradient across East Murwillumbah. However, it is noted that the design flood level for a part section of East Murwillumbah (typically to the north of Charles Street) falls below 4.8 mAHD. Therefore, it is considered that the flood planning level map be reviewed and updated to ensure a design flood level of no lower than 4.8 mAHD is employed across East Murwillumbah. However, higher design flood levels should be retained adjacent to the Tweed River / Tumbulgum Road (minimum suggested design flood level for this area = 5.6 mAHD). **Plate 47** provides a summary of suggested design flood levels for East Murwillumbah that reflects the flood level gradient and key hydraulic controls in the area.

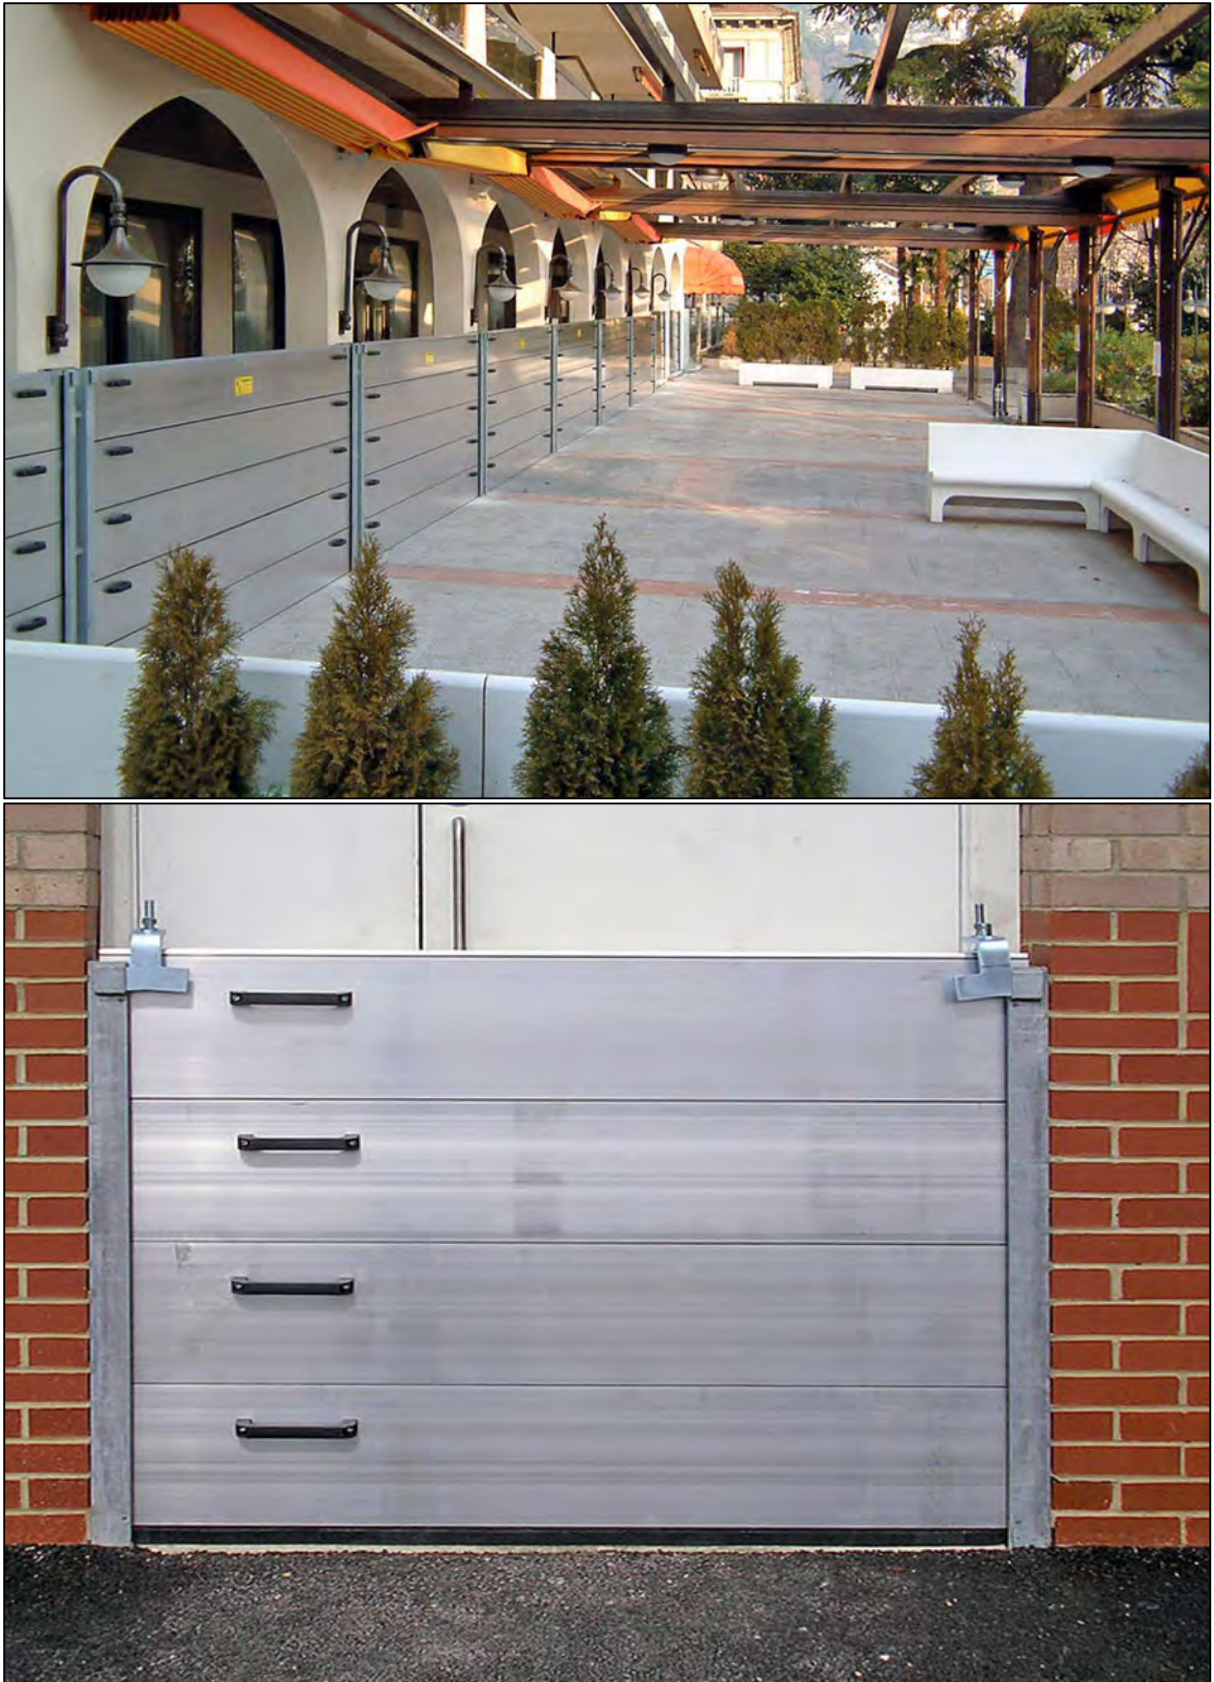
Plate 48 Examples of temporary flood barriers (provided courtesy of Flood Control International)

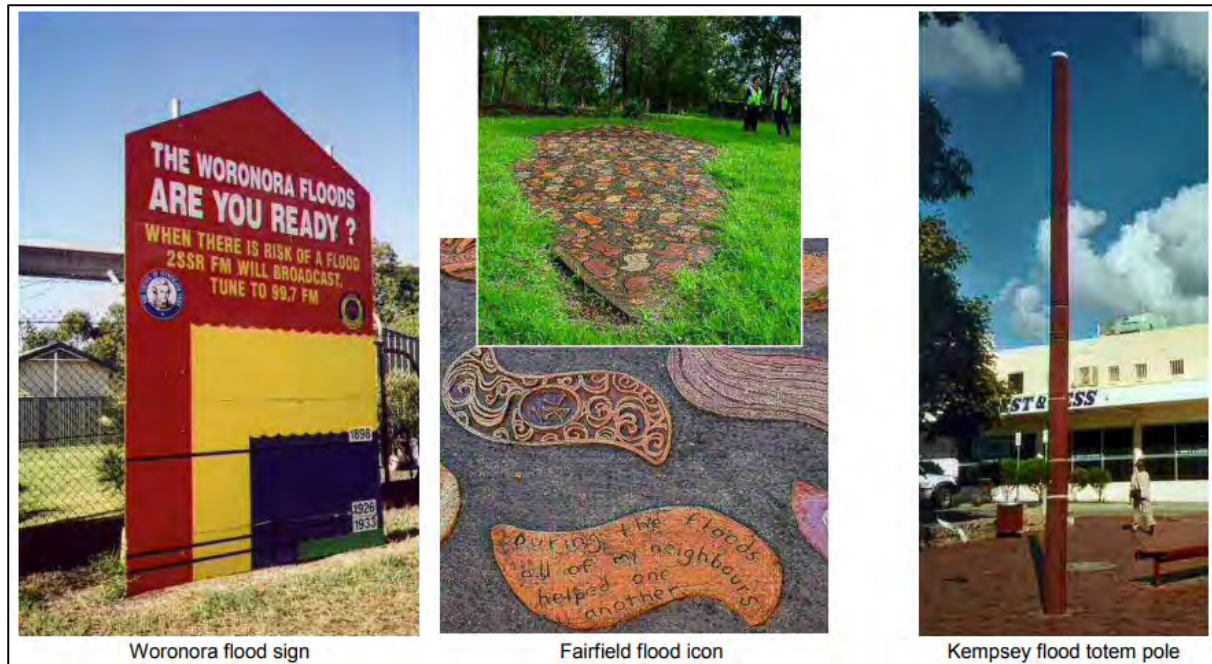
Plate 52 Examples of flood markers (Bewsher Consulting, 2012)

The effectiveness of a flood marker is highly dependent of the location. The markers should be located in a highly trafficked area to maximise exposure. Therefore, areas in and around the commercial area of Murwillumbah would likely be preferable. It is suggested that Wharf Street (near the intersection with Commercial Road) would be a suitable location. Due to the space constraints within the commercial area, it is likely that a “totem pole” style may be the most appropriate style of marker.

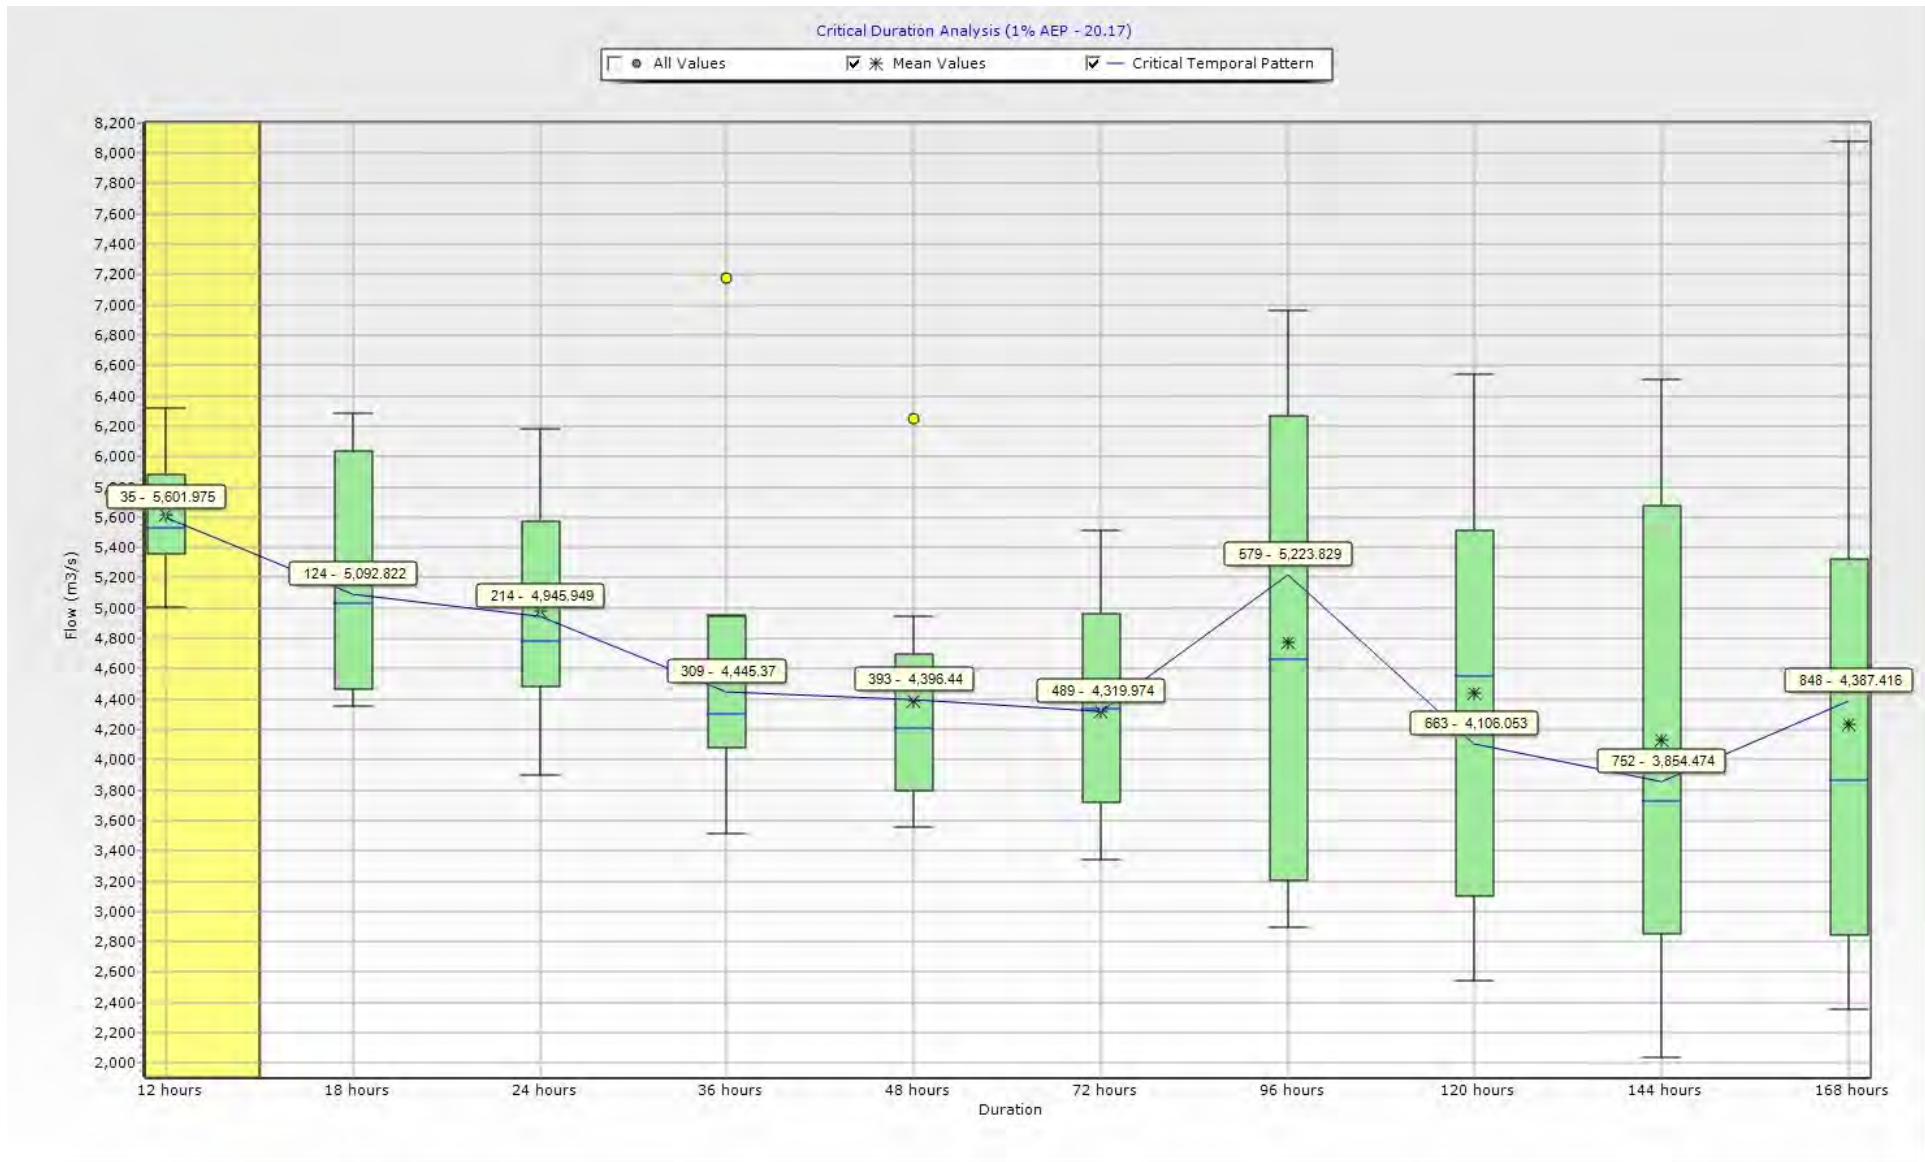
Plate 1 Box Plot for the Tweed River at Murwillumbah (subcatchment 20.17)

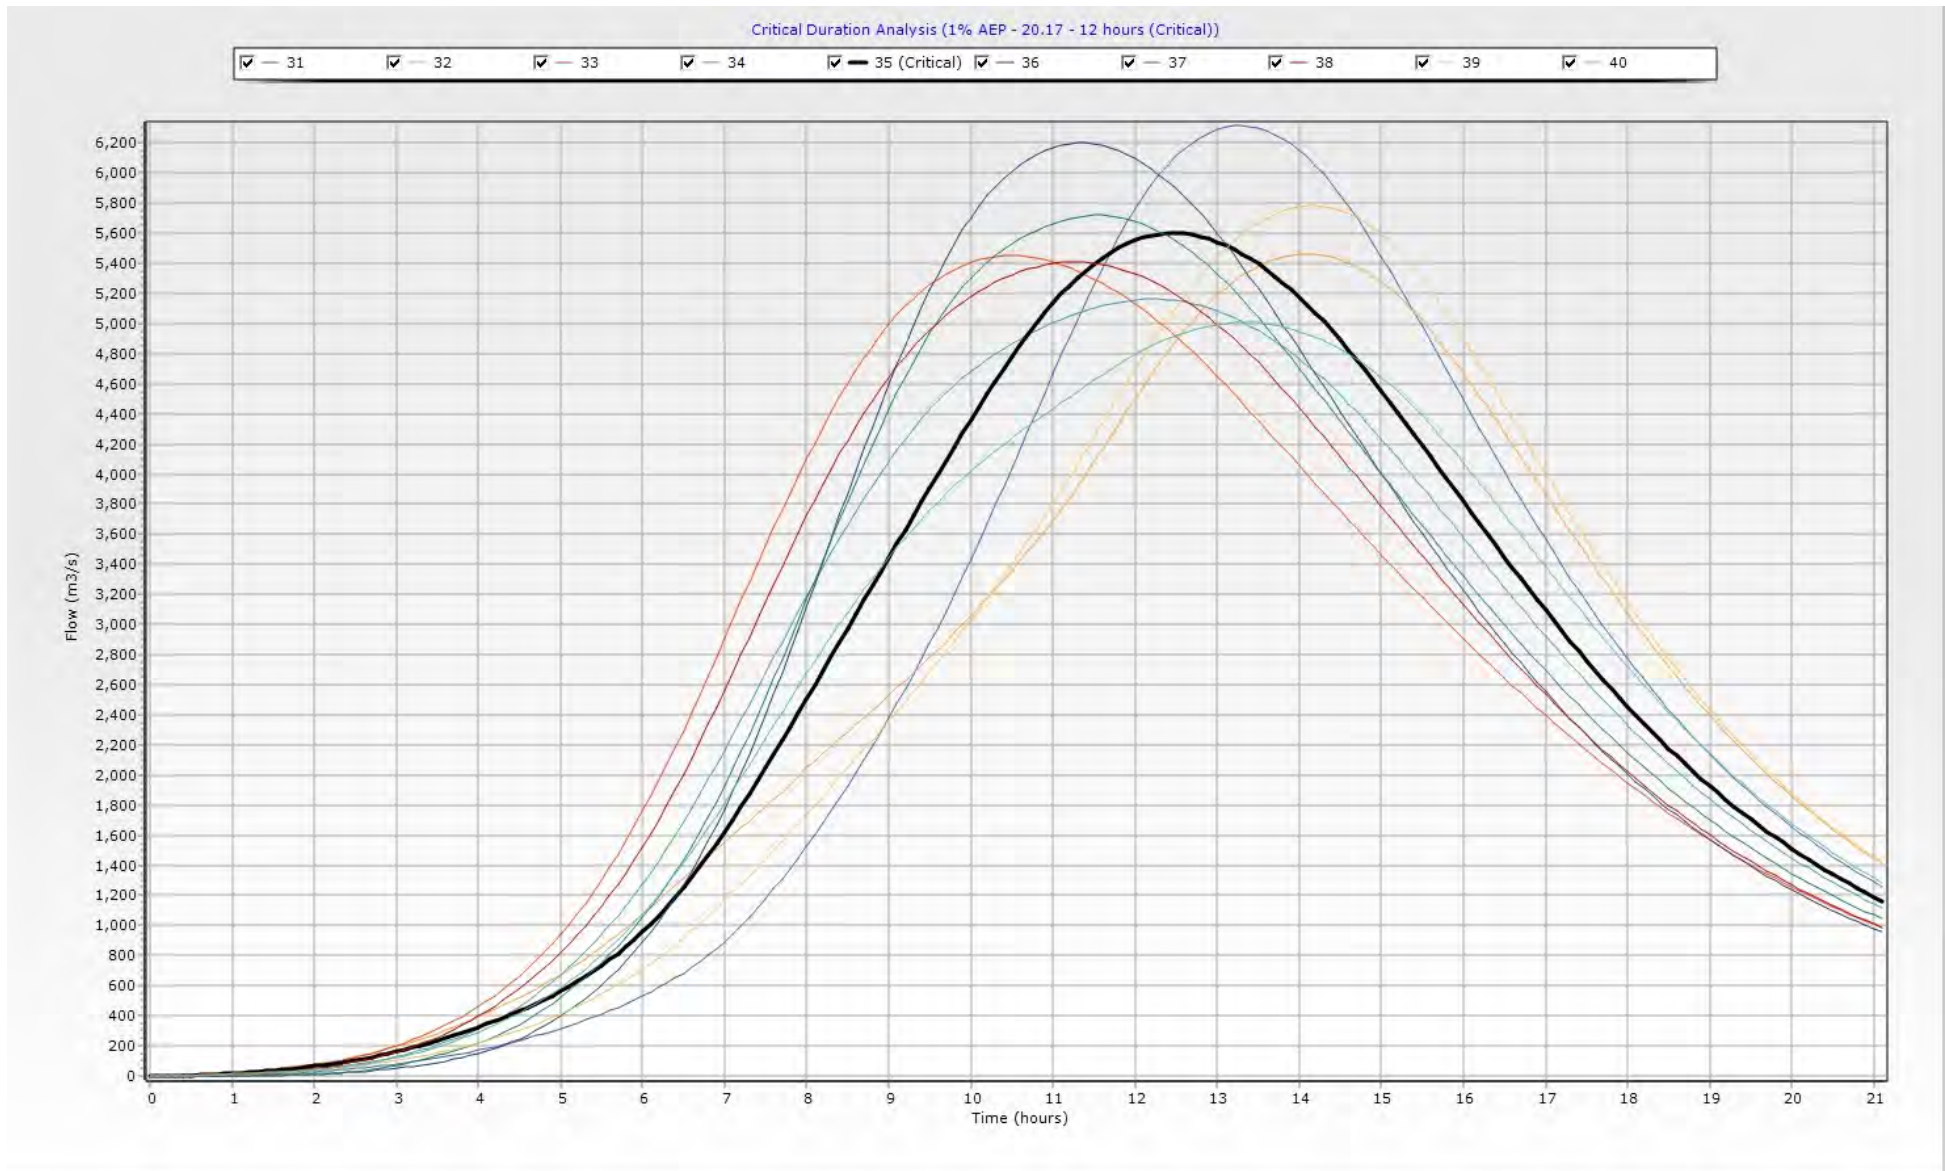
Plate 3 Design Flow Hydrographs for the Tweed River at Murwillumbah (subcatchment 20.17)
