OKLAHOMA, Western, Central and Southeast

National Weather Service Storm Data and Unusual Weather Phenomena

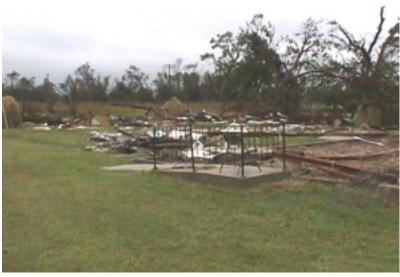
${\it Destroyed\ community\ center\ building\ at\ the\ Green\ Valley\ Church\ near\ Dacoma\ in\ Woods\ County}.}$ See summary at end of May 25/26th storm reports for more information.

Damage to the Green Valley Community Center 6 miles SSW of Dacoma is the basis for the F2 rating. As the accompanying photo (below listing of tornado at 2225 CST) shows, this building was completely destroyed with most of the debris found to the northwest of the foundation. Without considering structure design of the community center and damage to other nearby structures, an F3/F4 rating is warranted, however several factors have been used to lower this damage to an F2 rating. With regard to the community center, just 2 anchor bolts were used, and all walls were made of wood. Little or no concrete or brick was used. The building had only 3 rooms, 2 which comprised most of the surface area. This likely resulted in fewer attachments to the roof, which would occur in typical home design. Furthermore, neither the adjacent parsonage (just north of the community center) and other structures in the vicinity showed any damage consistent with an F3/F4 rating, that the community center damage might infer. A small silo, standing about 150 feet northeast of the community center, did not show any apparent damage, and should have been directly in the path of the tornado.
