ASDWA PFAS Water Utility Treatment Case Study

Town of Blades, Delaware

December 3, 2018

Water Treatment Installation

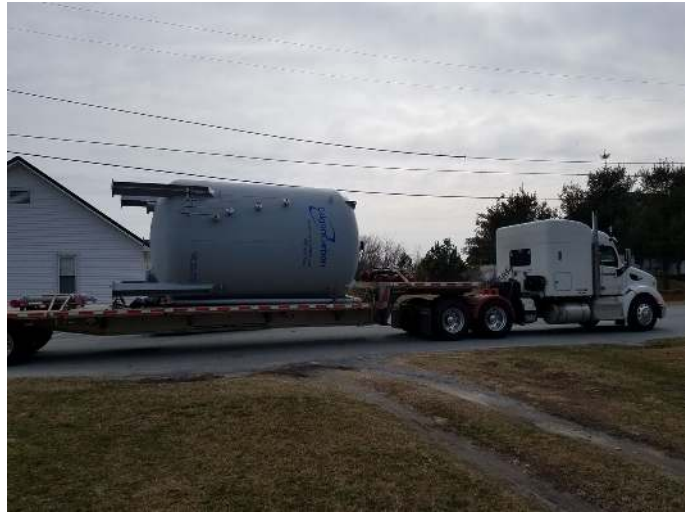
After the town decided that they wanted to install GAC treatment, they contacted the Calgon Carbon company in Pennsylvania who agreed to work overtime to get the 20,000-pound GAC filtration system in place. Within three days, Calgon had loaded the new filter on a flatbed tractor trailer on its way to the Town of Blades from Pennsylvania. It was installed within 24 hours and after connecting and testing the system, it was online within a week. The time it took from the issuance of the public notice about the drinking water contamination to the filter being installed and ready to go live was less than two weeks. See the following links to press releases and articles written about the town's journey.

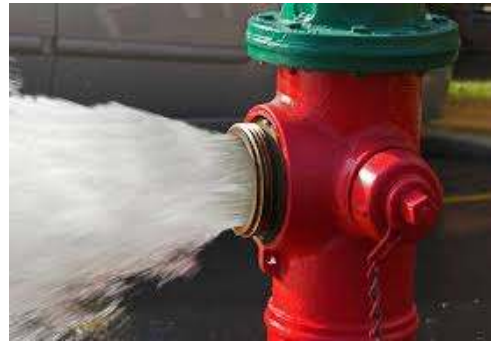
The carbon filtration system was paid for with assistance from the Division of Waste & Hazardous Substances through the Hazardous Substance Cleanup Act (HSCA) Program. The cost to purchase the 20,000-pound filter, 20,000 pounds of granular activated carbon, delivery, installation, and engineering was approximately \$240,000.00 dollars. Part of this cost covered the engineering plan for flushing out the water system. The town had to flush its tower and all existing water in the distribution system before giving the okay for citizens to use the water for drinking and cooking.
