NYC Department of Education
Building Condition Assessment Survey 2023 - 2024

Architectural Inspection

Asset: P.S. 16 - BROOKLYN, 157 WILSON STREET, New York, 11211

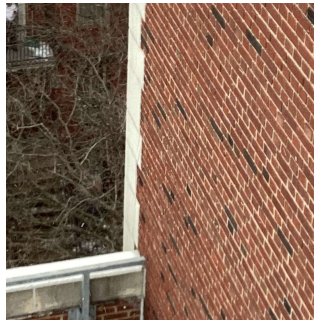
Facade G

Deficiency

TERRA COTTA: CHIPPED/SPALLED/BROKEN PIECES - MAJOR

Deficiency Quantity

70

REPLACE

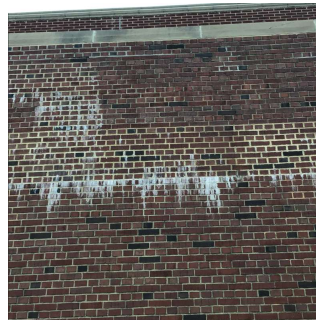
Facade G

Deficiency

BRICK: DETERIORATED JOINTS

Deficiency Quantity

500

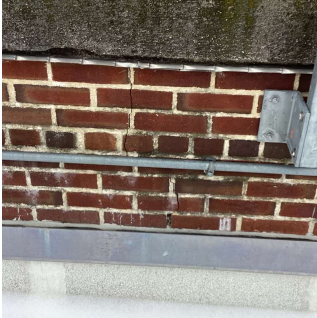
Violations	Facade A No violations recorded.
Deficiency	BRICK: MAJOR DETERIORATION/CRACKS
Roof Plan reference

Deficiency Quantity	120
Quantity Uom	S.F.
Potential Action	REMOVE AND REBUILD
Urgency of Action	PRIORITY 4
Purpose of Action	LEVEL 2
Deficiency Photo1

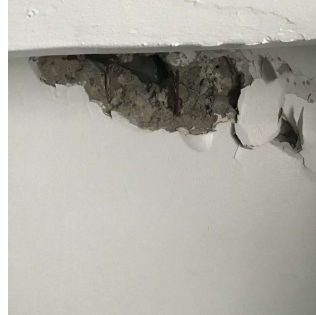
BH2

Deficiency	BULKHEAD/PENTHOUSE ROOF: DETERIORATED
------------	---------------------------------------

Deficiency Quantity	10
Quantity Uom	S.F.
Potential Action	REPLACE
Urgency of Action	PRIORITY 4

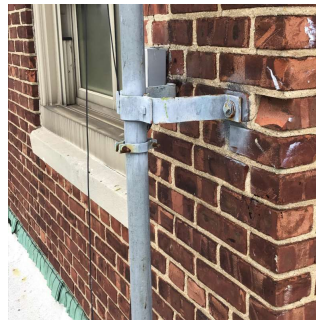
BH1

**BULKHEAD/PENTHOUSE WALLS/EXTERIOR:
CRACKS/SPALLING - MAJOR**

Deficiency Quantity

20

REPLACE

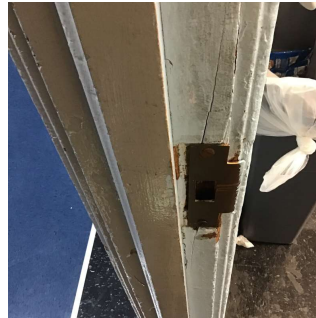
Room 520

WOOD: DETERIORATED DOOR AND FRAME

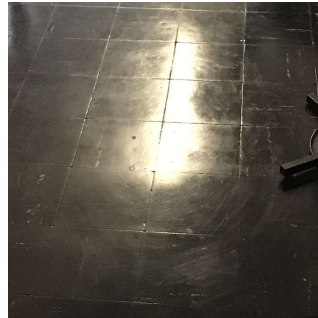
Room 533

VINYL TILES: BROKEN/DETERIORATED/MISSING TILES

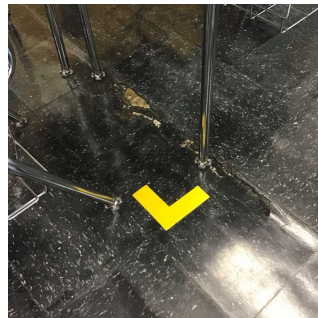
Room 518

VINYL TILES: DETERIORATED SUBSTRATE

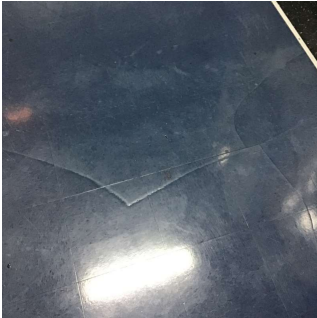
Question	Response
INTERIOR	
CLASSROOMS/CORRIDORS/ADMIN SPACES	
Floor Finish	
Deficiency	VINYL TILES: DETERIORATED SUBSTRATE
Deficiency Location/Instance	Corridor near Rooms 319, 428, 518, 526, Room 229, and others
Deficiency Quantity	450
Quantity Uom	S.F.
Potential Action	REPLACE
Urgency of Action	PRIORITY 3
Purpose of Action	LEVEL 2
Deficiency Photo1

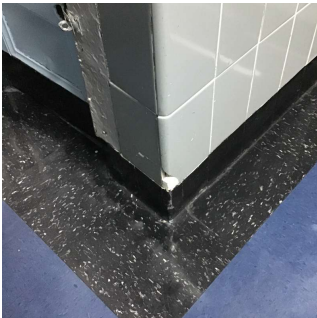
Corridor near Room 518
Violations	No violations recorded.
Walls	
Condition	Inspected
Deficiency	2 - Between Good and Fair
Deficiency	CERAMIC TILE: BROKEN/ MISSING
Deficiency Location/Instance	Corridor near Rooms 329, 515
Deficiency Quantity	20
Quantity Uom	S.F.
Potential Action	REPLACE
Urgency of Action	PRIORITY 3
Purpose of Action	LEVEL 2
Deficiency Photo1

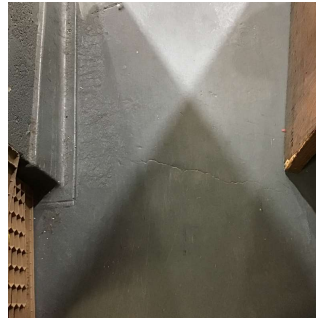
Storage Closet

CONCRETE: CRACKS

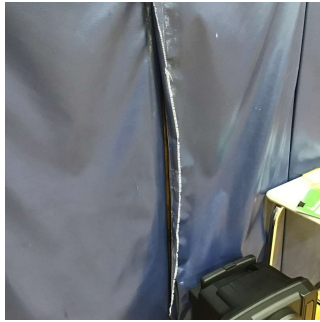
Violations	Near Drinking Fountain No violations recorded.
Sliding-folding Partition	
Instance on 3rd Floor	Does not Exist
Stage	
Instance on 3rd Floor	Does not Exist
Walls	
Instance on 3rd Floor	Inspected
Condition	2 - Between Good and Fair
Deficiency	WALL PADDING: DETERIORATED
Deficiency Location/Instance	Left Side, Near Locker Rooms
Deficiency Quantity	60
Quantity Uom	S.F.
Potential Action	REPLACE
Urgency of Action	PRIORITY 3
Purpose of Action	LEVEL 2
Deficiency Photo1

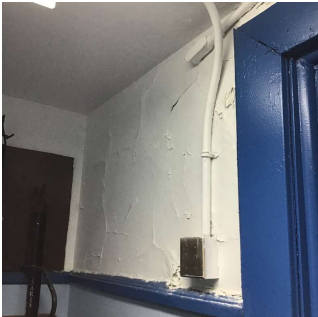
Stair C/1 Vestibule
Violations	No violations recorded.
Walls	Inspected
Condition	2 - Between Good and Fair
Deficiency	PLASTER: CRACKS/SPALLING
Deficiency Location/Instance	Stairs A/1, C/1 Vestibule,4, D/1 Vestibule, E/5, and others
Deficiency Quantity	100
Quantity Uom	S.F.
Potential Action	REPLACE
Urgency of Action	PRIORITY 3
Purpose of Action	LEVEL 2
Deficiency Photo1

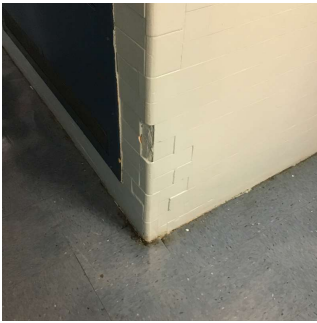
Stair D/1 Vestibule
Violations	No violations recorded.
Deficiency	CERAMIC TILE: BROKEN/ MISSING
Deficiency Location/Instance	Stairs C/1,4,5, D/1,2,5
Deficiency Quantity	60
Quantity Uom	S.F.
Potential Action	REPLACE
Urgency of Action	PRIORITY 3

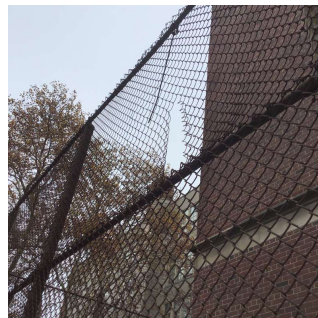
CHAIN LINK: DAMAGED/DETERIORATED
Near Walkway
100
S.F.
REPLACE
PRIORITY 3
LEVEL 2
