NYC Department of Education
Building Condition Assessment Survey 2023 - 2024

Architectural Inspection

Asset: P.S. 46 - BROOKLYN, 100 CLERMONT AVENUE, New York, 11205

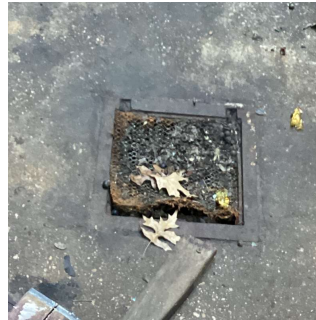
AW1

| Question | Response |
|---|---|
| Deficiency | AREAWAY DRAINS: DETERIORATED |

| Question | Response |
|---|---|
| Potential Action | REPLACE |

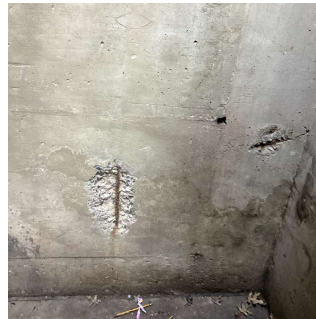
AW1

AREAWAY WALLS: CRACKS AND SPALLING

REPLACE

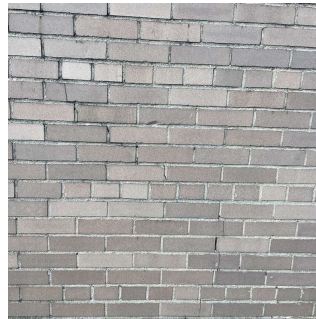
CH

BRICK: MINOR CRACKS AND SPALLING

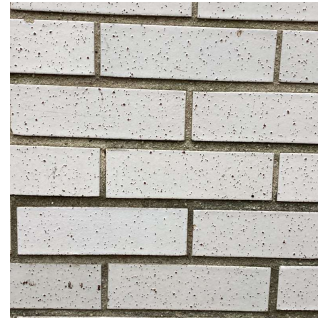
Facade K

BRICK: DETERIORATED JOINTS

PRIORITY 3
LEVEL 2

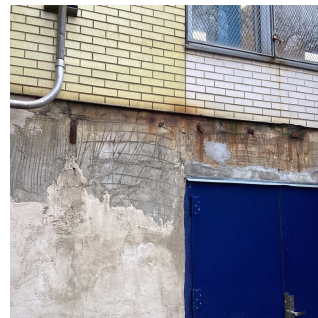
Facade K

STUCCO CEMENT SURFACE: CRACKS, SPALLING

REPLACE

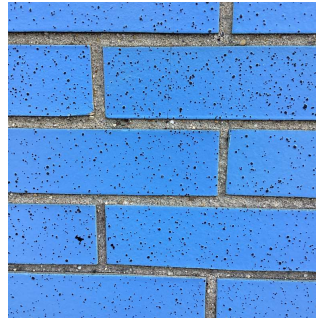
BH3

| Question | Response |
|---|--|
| Deficiency | BULKHEAD/PENTHOUSE WALLS/INTERIOR: CMU CRACKS/SPALLING |

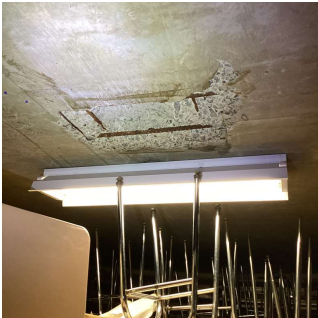
| Question | Response |
|---|--|
| | Basement - Crawlspace by Room B5 |

| Question | Response |
|---|--|
| Deficiency | CONCRETE: CRACKS/SPALLED/REINFORCEMENT EXPOSED |
| Deficiency Location/Instance | Basement - Crawlspace by Room B5 |

| Question | Response |
|---|--|
| Potential Action | REPAIR |

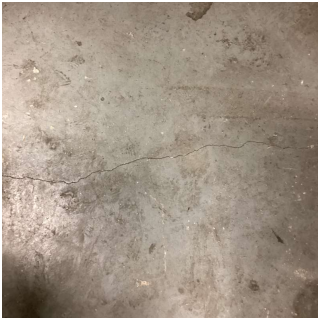
| Question | Response |
|---|--|
| | Basement - MER Room B3 |

| Question | Response |
|---|--|
| Deficiency | CONCRETE SLAB ON GRADE: THRU CRACKS |
| Deficiency Location/Instance | Basement - MER Room B3, B11 |

| Question | Response |
|---|--|
| Potential Action | REPAIR |

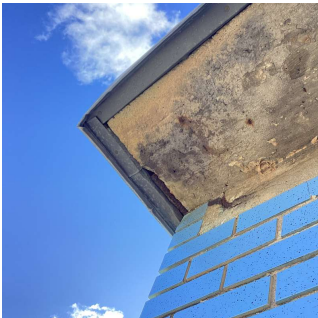
| Question | Response |
|---|--|
| | Roof 1 - BH2 |

| Question | Response |
|---|--|
| Deficiency | CONCRETE: CRACKED/SPALLED/REINFORCEMENT EXPOSED |
| Deficiency Location/Instance | Roof 1 - BH2 |

| Question | Response |
|---|--|
| Potential Action | REPAIR |

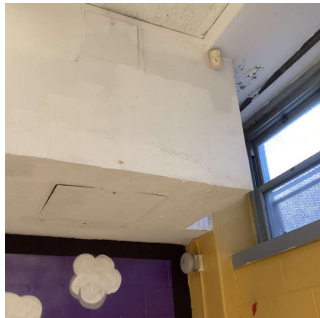
| Question | Response |
|---|--|
| Deficiency | PLASTER: CRACKS/SPALLING |
| Deficiency Location/Instance | Rear |

| Question | Response |
|---|--|
| Potential Action | REPLACE |

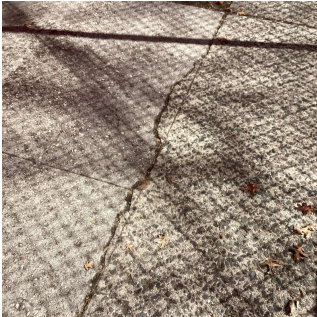
| Question | Response |
|---|--|
| Deficiency | DAMAGED/DETERIORATED/MISSING SECTIONS |

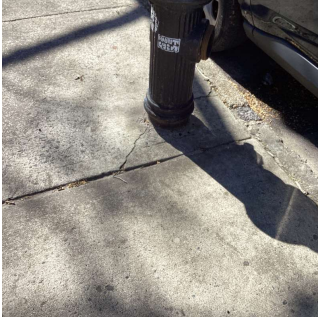
| Question | Response |
|---|--|
| Condition | 3 - Fair |
| Deficiency | DAMAGED/DETERIORATED/MISSING SECTIONS |
| Deficiency Location/Instance | Adelphi Street, Clermont Avenue |
| Deficiency Quantity | 225 |

| Question | Response |
|---|--|
| Potential Action | REPLACE |

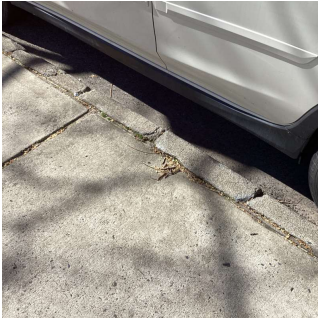
| Question | Response |
|---|--|
| Deficiency | DAMAGED CURBS |
| Deficiency Location/Instance | Adelphi Street, Clermont Avenue |
| Deficiency Quantity | 130 |

| Question | Response |
|---|--|
| Potential Action | REPLACE |
| Urgency of Action | PRIORITY 3 |

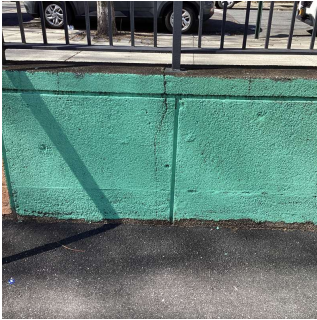
| Question | Response |
|---|--|
| Condition | 3 - Fair |
| Deficiency | CAST IN PLACE CONCRETE: CRACKS/SPALLING - MAJOR |
| Deficiency Location/Instance | Schoolyard, Adelphi Street, Clermont Avenue |
| Deficiency Quantity | 40 |

| Question | Response |
|---|--|
| Potential Action | REPLACE |

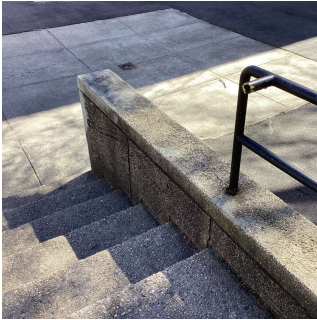
| Question | Response |
|---|--|
| Condition | 4 - Between Fair and Poor |
| Deficiency | MISSING |
| Deficiency Location/Instance | Adelphi Street Schoolyard |
| Deficiency Quantity | 16 |

| Question | Response |
|---|--|
| Potential Action | REPLACE |
| Urgency of Action | PRIORITY 5 |
