NYC Department of Education
Building Condition Assessment Survey 2023 - 2024

Architectural Inspection

Asset: P.S. 99 - BROOKLYN, 1120 EAST 10 STREET, New York, 11230

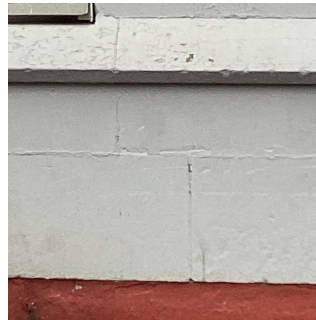
Facade H

STONE: DETERIORATED JOINTS

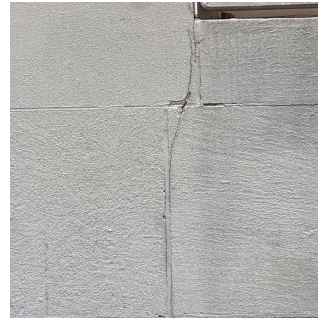
Facade G

STONE: CHIPPED/SPALLED/BROKEN PIECES - MINOR

PRIORITY 3
LEVEL 2

REPAIR

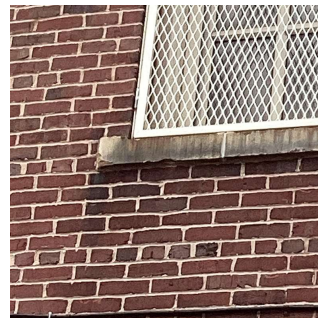
Facade F

BRICK: DETERIORATED MASONRY SILLS - MINOR

REPAIR

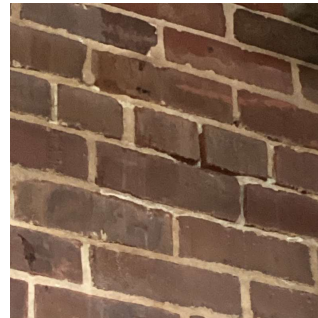
Facade E

BRICK: DETERIORATED JOINTS

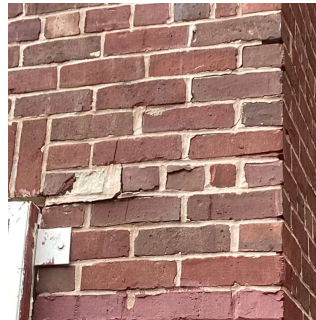
Facade F

BRICK: MAJOR / THRU CRACKS

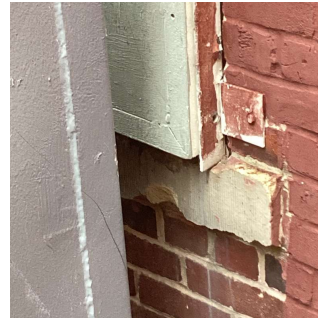
Facade F

BRICK: DETERIORATED MASONRY SILLS - MAJOR

REMOVE AND REPLACE

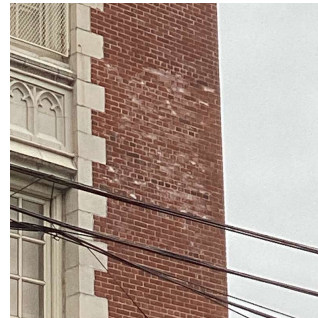
Facade A

BRICK: EFFLORESCENCE

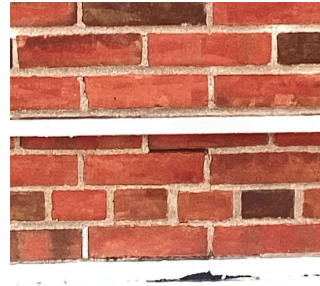
Roof 1

BRICK: DETERIORATED JOINTS

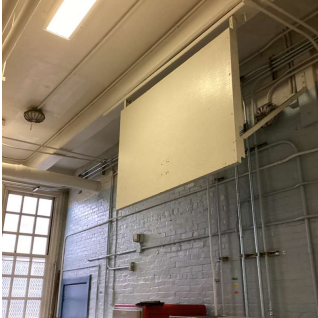
Question	Response
INTERIOR	
CAFETERIA	
Fixed Equipment	
Condition	3 - Fair
Deficiency	DAMAGED/MISSING
Deficiency Location/Instance	Front, Rear
Deficiency Quantity	2
Quantity Uom	EACH
Potential Action	MAINTENANCE
Urgency of Action	PRIORITY 3
Purpose of Action	LEVEL 2
Deficiency Photo1

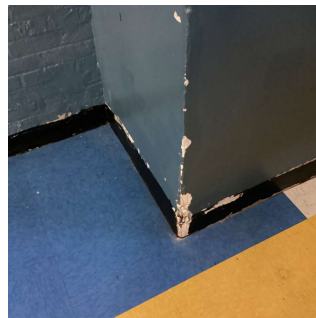
GYP SUM BOARD: DETERIORATED

REPLACE

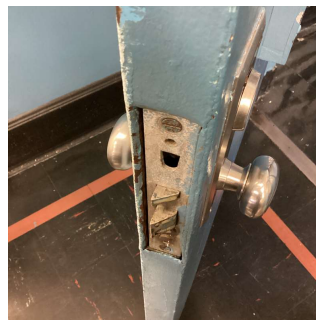
Room 303

Deficiency	METAL CLAD WOOD: DETERIORATED DOOR
Deficiency Location/Instance	Room 303, 305, 223, 225, 103 and others
Deficiency Quantity	6
Quantity Uom	EACH
Potential Action	MAINTENANCE
Urgency of Action	PRIORITY 3
Purpose of Action	LEVEL 2

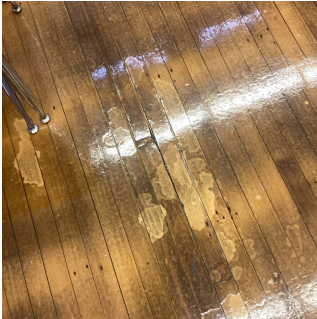
Question	Response
INTERIOR	
CLASSROOMS/CORRIDORS/ADMIN SPACES	
Door(s)	Inspected
Violations	No violations recorded.
Floor Finish	Inspected
Condition	5 - Poor
Deficiency	WOOD: DAMAGED/DETERIORATED
Deficiency Location/Instance	Rooms 217, 319
Deficiency Quantity	40
Quantity Uom	S.F.
Potential Action	REPLACE
Urgency of Action	PRIORITY 3
Purpose of Action	LEVEL 2
Deficiency Photo1

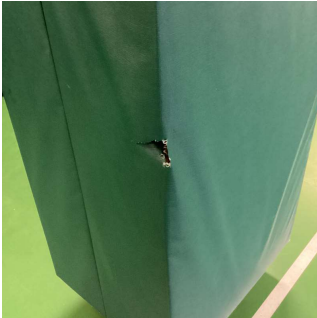
Column	
Violations	No violations recorded.
Instance on Basement- East	Inspected
Condition	3 - Fair
Deficiency	WALL PADDING: DETERIORATED
Deficiency Location/Instance	Column, Perimeter
Deficiency Quantity	140
Quantity Uom	S.F.
Potential Action	REPLACE
Urgency of Action	PRIORITY 3
Purpose of Action	LEVEL 2
Deficiency Photo1

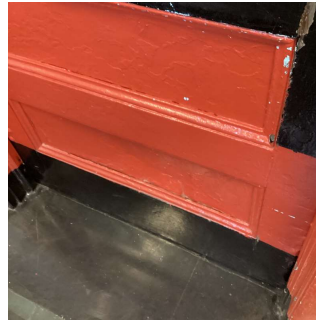
Violations	No violations recorded.
SCIENCE PREP ROOM	Does not Exist
SHOWER ROOM	Does not Exist
STAIRS/RAMPS: INTERIOR	Inspected
Do Letter Stair Signs Exist?	Yes
Ceiling	
Condition	2 - Between Good and Fair
Deficiency	No deficiencies recorded
Door(s)	
Condition	2 - Between Good and Fair
Deficiency	METAL CLAD WOOD: DETERIORATED DOOR
Deficiency Location/Instance	Stair E/F 3

Deficiency Quantity	1
Quantity Uom	EACH
Potential Action	MAINTENANCE
Urgency of Action	PRIORITY 3
Purpose of Action	LEVEL 2

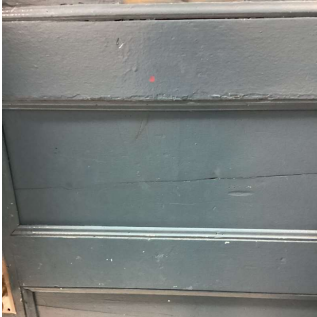
Violations	Room 208A No violations recorded.
Stalls	Does not Exist
Walls	Inspected
Condition	2 - Between Good and Fair
Deficiency	No deficiencies recorded
TOILET ROOMS - STUDENTS	
Ceiling	Inspected
Condition	2 - Between Good and Fair
Deficiency	No deficiencies recorded
Door(s)	Inspected
Condition	5 - Poor
Deficiency	WOOD: DETERIORATED DOOR
Deficiency Location/Instance	3rd Floor Girls, 2nd Floor Boys
Deficiency Quantity	2
Quantity Uom	EACH
Potential Action	MAINTENANCE
Urgency of Action	PRIORITY 3
Purpose of Action	LEVEL 2
Deficiency Photo1

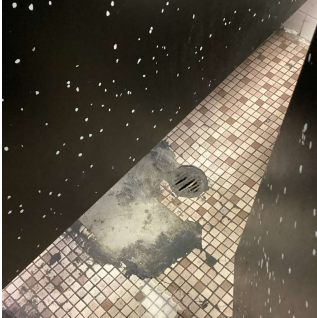
Violations	3rd Floor Girls No violations recorded.
Floor Finish	Inspected
Condition	4 - Between Fair and Poor
Deficiency	CERAMIC TILE: BROKEN/MISSING TILES

Question	Response
INTERIOR	
TOILET ROOMS - STUDENTS	
Floor Finish	
Deficiency Location/Instance	2nd Floor Boys
Deficiency Quantity	30
Quantity Uom	S.F.
Potential Action	REPLACE
Urgency of Action	PRIORITY 3
Purpose of Action	LEVEL 2
Deficiency Photo1

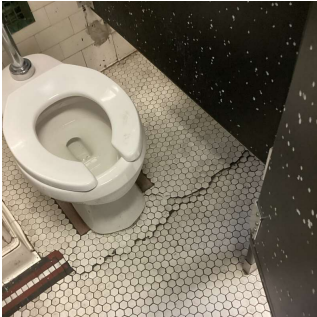
Violations	2nd Floor Boys No violations recorded.
Deficiency	CERAMIC TILE: DETERIORATED SUBSTRATE
Deficiency Location/Instance	3rd Floor Girls
Deficiency Quantity	80
Quantity Uom	S.F.
Potential Action	REPLACE
Urgency of Action	PRIORITY 3
Purpose of Action	LEVEL 2
Deficiency Photo1

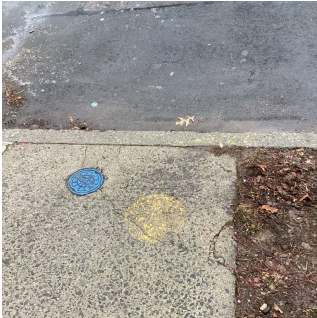
Question	Response
SITE	
PAVING	
Student Use	
Asphalt	
Quantity Uom	S.F.
Potential Action	REPLACE
Urgency of Action	PRIORITY 3
Purpose of Action	LEVEL 2
Deficiency Photo1	 
	Schoolyard
Violations	No violations recorded.
Concrete	Inspected
Condition	4 - Between Fair and Poor
Deficiency	CRACKS - MAJOR
Deficiency Location/Instance	Schoolyard
Deficiency Quantity	500
Quantity Uom	S.F.
Potential Action	REPLACE
Urgency of Action	PRIORITY 3
Purpose of Action	LEVEL 2
Deficiency Photo1	 
	Schoolyard
Violations	No violations recorded.
Pavers	Does not Exist
Site Sidewalks & Walkways	Inspected
Asphalt	Does not Exist
Concrete	Under Construction
Pavers	Does not Exist
DOT Sidewalk	Inspected
Asphalt	Does not Exist
Concrete	Inspected
Condition	3 - Fair
Deficiency	DAMAGED/DETERIORATED/MISSING SECTIONS

Question	Response
SITE	
PAVING	
DOT Sidewalk	
Concrete	
Deficiency Location/Instance	E. 10th Street, E. 10th Street,
Deficiency Quantity	150
Quantity Uom	S.F.
Potential Action	REPLACE
Urgency of Action	PRIORITY 3
Purpose of Action	LEVEL 2
Deficiency Photo1
