**NYC Department of Education**  
**Building Condition Assessment Survey 2023 - 2024**

Architectural Inspection

**Asset: P.S. 276 - BROOKLYN, 1070 EAST 83 STREET, New York, 11236**

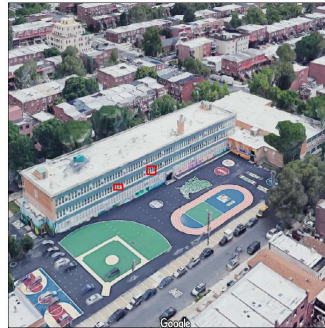
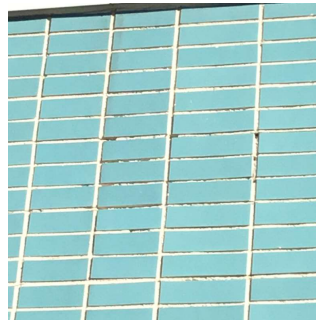
Facade E

BRICK: DETERIORATED JOINTS  
K276

25  
S.F.  
REPOINT  
PRIORITY 4  
LEVEL 2

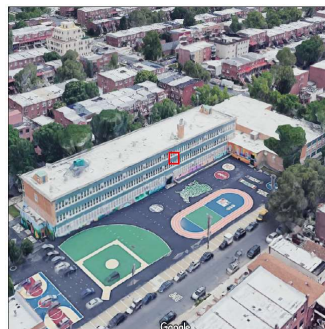
BRICK: MINOR CRACKS AND SPALLING

25  
S.F.  
RESTITCH

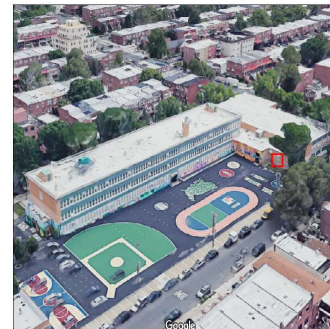
BRICK: DETERIORATED MASONRY SILLS - MINOR

15  
L.F.  
REPAIR  
PRIORITY 3  
LEVEL 2

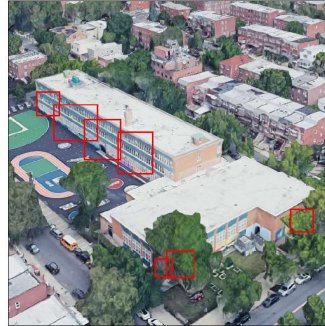
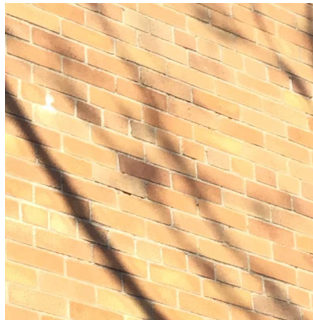
Facade B

BRICK: DETERIORATED JOINTS

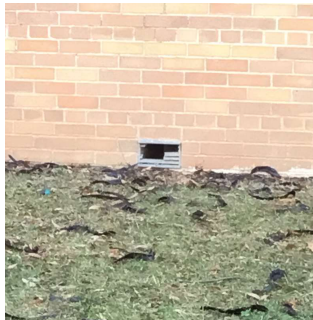
Facade A

BROKEN/ DENTED BLADES

REPLACE

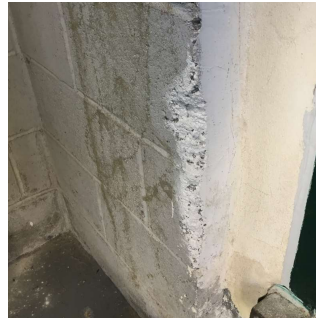
BH2

**BULKHEAD/PENTHOUSE WALLS/INTERIOR: CMU  
CRACKS/SPALLING**

20  
S.F.  
REPLACE  
PRIORITY 3  
LEVEL 2

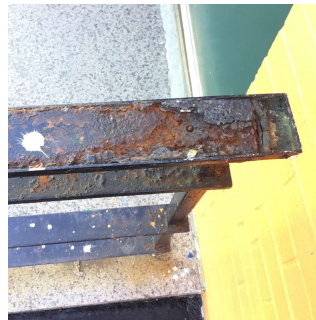
Facade D

**RUST - MAJOR**

REPLACE

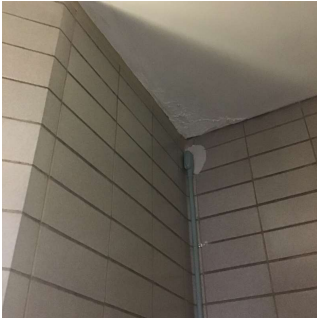
Violations	Exit 9 Vestibule No violations recorded.

Violations	Basement Corridor No violations recorded.
<b>ROOF STRUCTURE</b>	
Condition	Inspected
Deficiency	2 - Between Good and Fair
<b>VAULTS-BUNKERS</b>	
Condition	Inspected
Deficiency	No deficiencies recorded
<b>Slab Structure</b>	
Condition	Inspected
Deficiency	2 - Between Good and Fair
<b>Vault/Ash Hoist Doors and Framing</b>	
Condition	Inspected
Deficiency	No deficiencies recorded
<b>Vault/Ash Hoist Doors and Framing</b>	
Condition	Does not Exist
<b>AUDITORIUM</b>	
Instance on 1st Floor (418 Seats)	Inspected
<b>Ceiling</b>	
Instance on 1st Floor (418 Seats)	Inspected
Condition	2 - Between Good and Fair
Deficiency	PLASTER: CRACKS/SPALLING
Deficiency Location/Instance	Exit 9 Vestibule
Deficiency Quantity	10
Quantity Uom	S.F.
Potential Action	REPLACE
Urgency of Action	PRIORITY 3

Purpose of Action	LEVEL 2
Deficiency Photo1

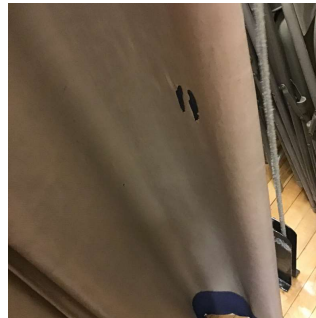
Right Side

WORN/DETERIORATED

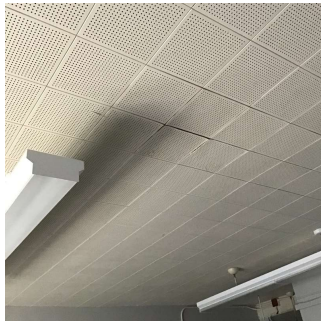
Question	Response
<b>INTERIOR</b>	
<b>CLASSROOMS/CORRIDORS/ADMIN SPACES</b>	
<b>Ceiling</b>	
Deficiency Photo1

Violations	Room 124 No violations recorded.
<b>Door(s)</b>	Inspected
Condition	5 - Poor
Deficiency	WOOD: DETERIORATED DOOR
Deficiency Location/Instance	Room 312, 313, 327, 328, 329 and others
Deficiency Quantity	20
Quantity Uom	EACH
Potential Action	MAINTENANCE
Urgency of Action	PRIORITY 3
Purpose of Action	LEVEL 2
Deficiency Photo1

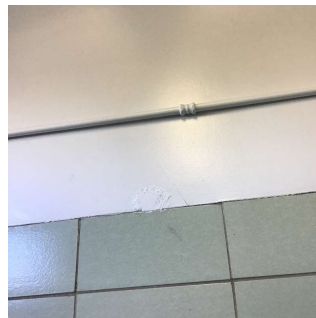
PLASTER: CRACKS/SPALLING

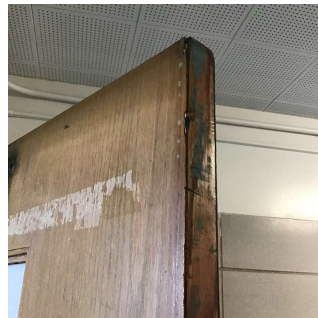
Entrance

WOOD: DETERIORATED DOOR

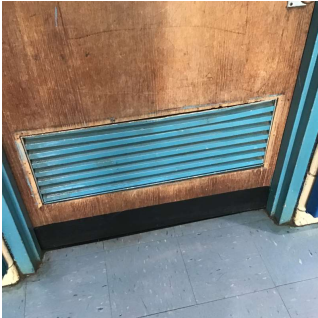
Question	Response
<b>INTERIOR</b>	
<b>GYMNASIUM</b>	
<b>Door(s)</b>	
Violations	No violations recorded.
Deficiency	WOOD: DAMAGED LOUVER
Deficiency Location/Instance	Office
Deficiency Quantity	1
Quantity Uom	EACH
Potential Action	MAINTENANCE
Urgency of Action	PRIORITY 3
Purpose of Action	LEVEL 2
Deficiency Photo1

Violations	Office No violations recorded.
<b>Fixed Equipment</b>	
Instance on 1st Floor	Inspected
Condition	2 - Between Good and Fair
Deficiency	No deficiencies recorded
<b>Floor Finish</b>	
Instance on 1st Floor	Inspected
Condition	2 - Between Good and Fair
Deficiency	No deficiencies recorded
<b>Seating</b>	
Instance on 1st Floor	Does not Exist
<b>Sliding-folding Partition</b>	
Instance on 1st Floor	Does not Exist
<b>Stage</b>	
Instance on 1st Floor	Does not Exist
<b>Walls</b>	
Instance on 1st Floor	Inspected
Condition	2 - Between Good and Fair
Deficiency	WALL PADDING: DETERIORATED
Deficiency Location/Instance	Right Side, Along Windows, Left Side

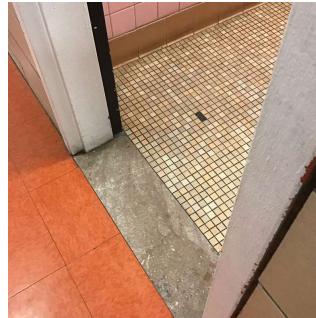
Room 222

CERAMIC TILE: BROKEN/MISSING TILES

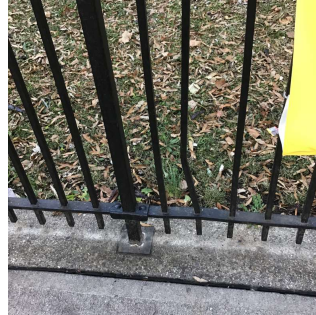
<b>Drainage System for Soil</b>	Inspected
<b>Catch Basins/Manhole - Surrounded by Soil</b>	Inspected
Condition	2 - Between Good and Fair
Deficiency	No deficiencies recorded
<b>Culverts - Soil Covering</b>	Does not Exist
<b>DRINKING FOUNTAINS</b>	Does not Exist
<b>FENCES</b>	Inspected
Condition	4 - Between Fair and Poor
Deficiency	WROUGHT IRON: MISSING SECTIONS
Deficiency Location/Instance	E.83rd Street , E.82nd Street, Avenue K
Deficiency Quantity	400
Quantity Uom	S.F.

REPLACE  
PRIORITY 3  
LEVEL 2

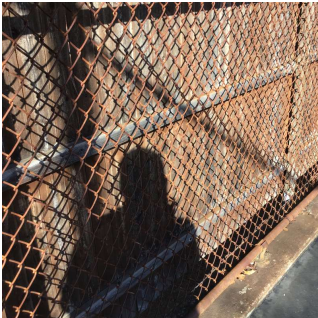
Question	Response
<b>SITE</b>	
<b>FENCES</b>	
Violations	Schoolyard Entrance No violations recorded.
Deficiency	CHAIN LINK: RUST - MAJOR
Deficiency Location/Instance	Schoolyard
Deficiency Quantity	2,300
Quantity Uom	S.F.
Potential Action	REPLACE
Urgency of Action	PRIORITY 3
Purpose of Action	LEVEL 2
Deficiency Photo1

Violations	Schoolyard No violations recorded.
<b>IRRIGATION SYSTEM</b>	Does not Exist
<b>PAVING</b>	Inspected
<b>Student Non-Use</b>	Inspected
Gravel Exists?	No
<b>Asphalt</b>	Does not Exist
<b>Concrete</b>	Inspected
Condition	2 - Between Good and Fair
Deficiency	No deficiencies recorded
<b>Pavers</b>	Inspected
Condition	2 - Between Good and Fair
Deficiency	No deficiencies recorded
<b>Student Use</b>	Inspected
Gravel Exists?	No
<b>Asphalt</b>	Inspected
Condition	4 - Between Fair and Poor
Deficiency	CRACKS - MAJOR
Deficiency Location/Instance	Schoolyard
Deficiency Quantity	3,000
Quantity Uom	S.F.
Potential Action	REPLACE

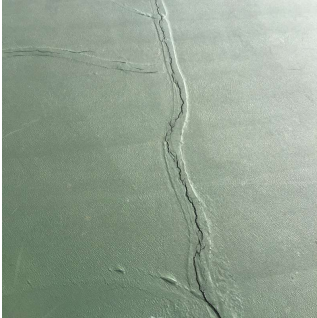
Urgency of Action	PRIORITY 3
Purpose of Action	LEVEL 2

Violations	Schoolyard No violations recorded.
<b>Concrete</b>	Inspected
Condition	2 - Between Good and Fair
Deficiency	No deficiencies recorded
<b>Pavers</b>	Does not Exist
<b>Site Sidewalks &amp; Walkways</b>	Inspected
<b>Asphalt</b>	Inspected
Condition	2 - Between Good and Fair
Deficiency	No deficiencies recorded
<b>Concrete</b>	Inspected
Condition	3 - Fair
Deficiency	CRACKS - MAJOR
Deficiency Location/Instance	Near Main Entrance, Exit 3
Deficiency Quantity	300
Quantity Uom	S.F.
Potential Action	REPLACE
Urgency of Action	PRIORITY 3
Purpose of Action	LEVEL 2
Deficiency Photo1

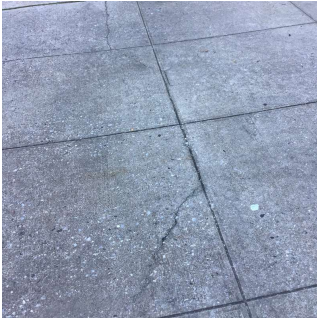
Violations	Near Main Entrance No violations recorded.
<b>Pavers</b>	Does not Exist
<b>DOT Sidewalk</b>	Inspected
<b>Asphalt</b>	Does not Exist
<b>Concrete</b>	Inspected
Condition	4 - Between Fair and Poor
Deficiency	HEAVING

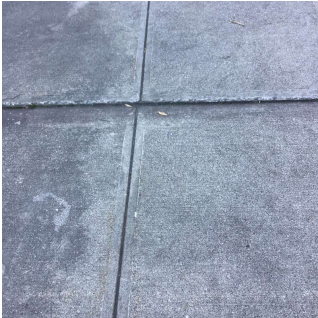
Question	Response
<b>SITE</b>	
<b>PAVING</b>	
<b>DOT Sidewalk</b>	
<b>Concrete</b>	
Deficiency Location/Instance	E.83rd Street , E.82nd Street, Avenue K
Deficiency Quantity	200
Quantity Uom	S.F.
Potential Action	REPLACE
Urgency of Action	PRIORITY 3
Purpose of Action	LEVEL 2
Deficiency Photo1

Violations	E.83rd Street No violations recorded.
Deficiency	HEAVING
Deficiency Location/Instance	E.83rd Street , E.82nd Street, Avenue K
Deficiency Quantity	350
Quantity Uom	S.F.
Potential Action	REPLACE
Urgency of Action	PRIORITY 5
Purpose of Action	LEVEL 6
Deficiency Photo1

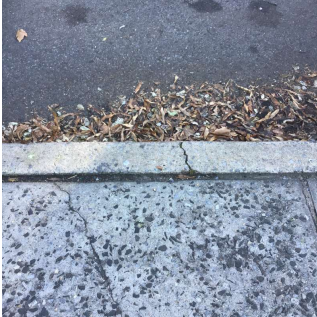
Violations	E.83rd Street No violations recorded.
Deficiency	DAMAGED CURBS
Deficiency Location/Instance	E.83rd Street , E.82nd Street, Avenue K
Deficiency Quantity	250
Quantity Uom	L.F.
Potential Action	REPLACE
Urgency of Action	PRIORITY 3
Purpose of Action	LEVEL 2

E.83rd Street
Violations	No violations recorded.
Deficiency	DAMAGED/DETERIORATED/MISSING SECTIONS
Deficiency Location/Instance	E.83rd Street , E.82nd Street, Avenue K
Deficiency Quantity	2,400
Quantity Uom	S.F.
Potential Action	REPLACE
Urgency of Action	PRIORITY 3
Purpose of Action	LEVEL 2
Deficiency Photo1
