NYC Department of Education
Building Condition Assessment Survey 2023 - 2024

Architectural Inspection

Asset: P.S. 277 - BROOKLYN, 2529 GERRITSEN AVENUE, New York, 11229

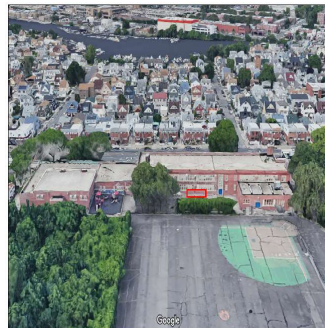
BRICK: MASONRY SILLS - DETERIORATED JOINTS

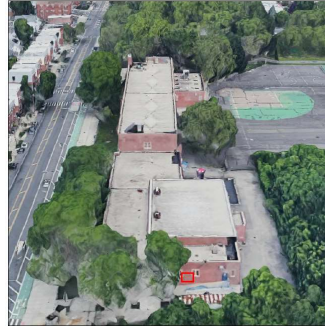
BRICK: DETERIORATED JOINTS
K277

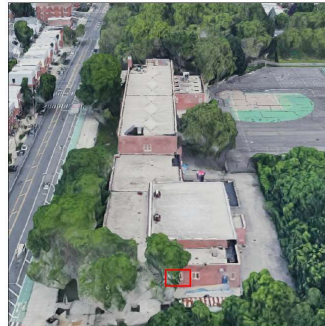
BRICK: MINOR CRACKS AND SPALLING

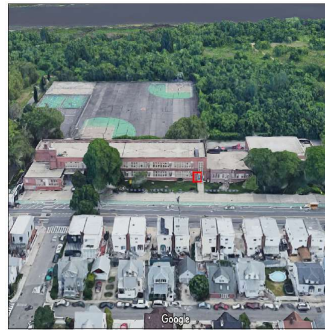
CAST IN PLACE / PRE-CAST CONCRETE: MINOR
CRACKS/SPALLING

REPAIR

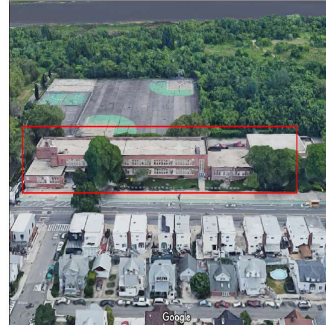
BRICK: DETERIORATED JOINTS

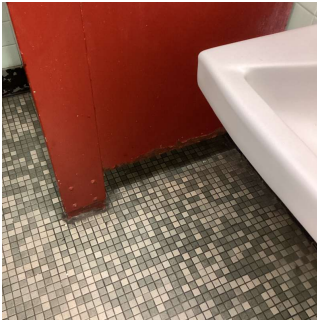
Question	Response
INTERIOR	
TOILET ROOMS - STUDENTS	
Floor Finish	
Deficiency Photo1	 
Violations	2nd Floor Boys No violations recorded.
Stalls	
Condition	Inspected 5 - Poor
Deficiency	RUST - MAJOR
Deficiency Location/Instance	1st Floor Unisex
Deficiency Quantity	4
Quantity Uom	EACH
Potential Action	REPLACE
Urgency of Action	PRIORITY 3
Purpose of Action	LEVEL 2
Deficiency Photo1

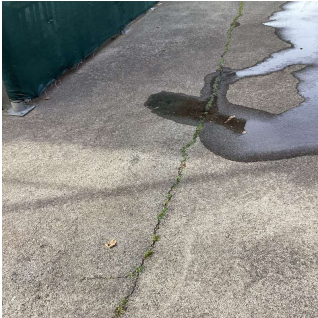
Question	Response
SITE	
IRRIGATION SYSTEM	Does not Exist
PAVING	Inspected
Student Non-Use	Inspected
Gravel Exists?	No
Asphalt	Does not Exist
Concrete	Inaccessible
Pavers	Does not Exist
Student Use	Inspected
Gravel Exists?	No
Asphalt	Inspected
Condition	4 - Between Fair and Poor
Deficiency	CRACKS - MAJOR
Deficiency Location/Instance	Schoolyard
Deficiency Quantity	1,200
Quantity Uom	S.F.
Potential Action	REPLACE
Urgency of Action	PRIORITY 3
Purpose of Action	LEVEL 2
Deficiency Photo1

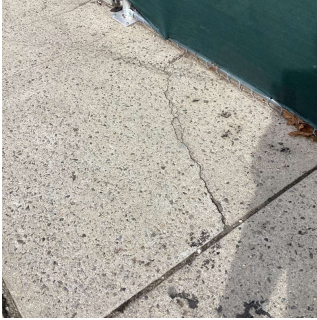
Gerritsen Avenue
Violations	No violations recorded.
Deficiency	DAMAGED/DETERIORATED/MISSING SECTIONS
Deficiency Location/Instance	Gerritsen Avenue
Deficiency Quantity	1,625
Quantity Uom	S.F.
Potential Action	REPLACE
Urgency of Action	PRIORITY 3
Purpose of Action	LEVEL 2

Question	Response
SITE	
PAVING	
DOT Sidewalk	
Concrete	
Deficiency Photo1
