NYC Department of Education
Building Condition Assessment Survey 2023 - 2024

Architectural Inspection

Asset: P.S. 399 - BROOKLYN, 2707 ALBERMARLE ROAD, New York, 11226

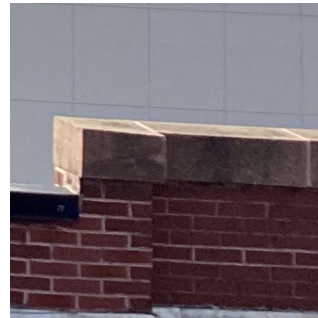
Roof 1 - Near CH side
 No violations recorded.

CAST STONE: DETERIORATED BED JOINT

10
 L.F.
 REPOINT
 PRIORITY 3
 LEVEL 2

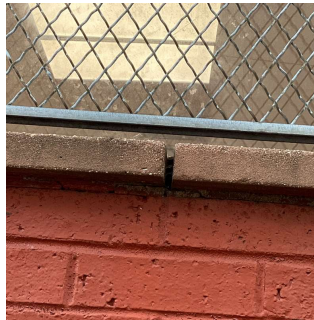
Facade C - Exit 2

BRICK: MASONRY SILLS - DETERIORATED JOINTS

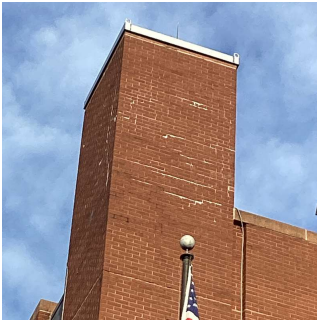
Violations	Facade C No violations recorded.
Deficiency	BRICK: EFFLORESCENCE
Roof Plan reference	K399

Deficiency Quantity	30
Quantity Uom	S.F.
Potential Action	MAINTENANCE
Urgency of Action	PRIORITY 1
Purpose of Action	LEVEL 1
Deficiency Photo1

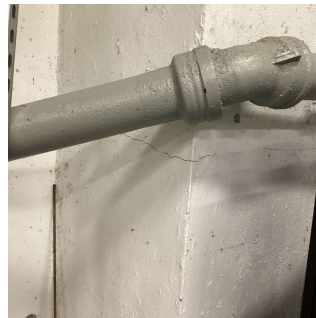
STEEL COLUMNS/BEAMS: DETERIORATED CONCRETE FIREPROOFING

Question	Response
INTERIOR	
STRUCTURAL	
COLUMNS/BEAMS/BEARING WALLS	Inspected
	Basement - Boiler Room
Violations	No violations recorded.
FLOOR STRUCTURE	Inspected
Condition	3 - Fair
Deficiency	CONCRETE SLAB ON GRADE: THRU CRACKS
Deficiency Location/Instance	Sub-Basement - Electrical Panel Room, Boiler Room
Deficiency Quantity	30
Quantity Uom	S.F.
Potential Action	REPAIR
Urgency of Action	PRIORITY 3
Purpose of Action	LEVEL 5
Deficiency Photo1	 
Violations	Basement - Electrical Panel Room No violations recorded.
FOUNDATION WALLS	Inspected
Material Type(s)	Concrete
Condition	2 - Between Good and Fair
Deficiency	No deficiencies recorded
ROOF STRUCTURE	Inspected
Condition	3 - Fair
Deficiency	CONCRETE COLUMNS AND BEAMS: CRACKED/SPALLED/REINFORCEMENT EXPOSED
Deficiency Location/Instance	Bulkhead
Deficiency Quantity	10
Quantity Uom	S.F.
Potential Action	REPLACE
Urgency of Action	PRIORITY 4
Purpose of Action	LEVEL 5
Deficiency Photo1

REPLACE

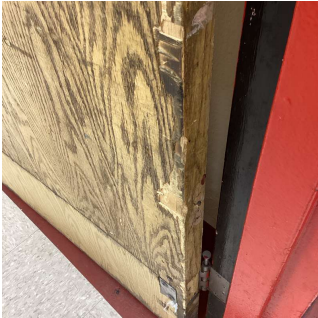
Question	Response
INTERIOR	
STRUCTURAL	Inspected
VAULTS-BUNKERS	Does not Exist
AUDITORIUM	Does not Exist
CAFETERIA	Inspected
Instance on 1st Floor	Inspected
Ceiling	
Instance on 1st Floor	Inspected
Condition	1 - Good
Deficiency	No deficiencies recorded
Door(s)	
Instance on 1st Floor	Inspected
Condition	5 - Poor
Deficiency	WOOD: DETERIORATED DOOR
Deficiency Location/Instance	Entrance from Multi-Purpose Room, Exit 4 Vestibule
Deficiency Quantity	3
Quantity Uom	EACH
Potential Action	MAINTENANCE
Urgency of Action	PRIORITY 3
Purpose of Action	LEVEL 2
Deficiency Photo1

Violations	Entrance from Multi-Purpose Room No violations recorded.
Fixed Equipment	
Instance on 1st Floor	Does not Exist
Floor Finish	
Instance on 1st Floor	Inspected
Condition	1 - Good
Deficiency	No deficiencies recorded
Sliding-folding Partition	
Instance on 1st Floor	Not Required
Stage	
Instance on 1st Floor	Does not Exist
Walls	
Instance on 1st Floor	Inspected

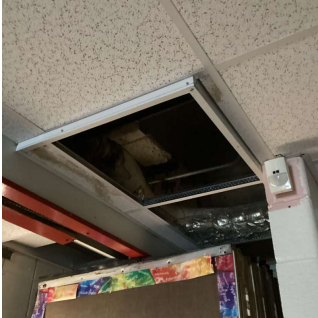
Question	Response
INTERIOR	
MULTI-PURPOSE ROOM	
Ceiling	
Deficiency Location/Instance	Stage
Deficiency Quantity	10
Quantity Uom	S.F.
Potential Action	REPLACE
Urgency of Action	PRIORITY 3
Purpose of Action	LEVEL 2
Deficiency Photo1

Violations	Stage No violations recorded.
Door(s)	
Instance on 1st Floor	Inspected
Condition	5 - Poor
Deficiency	WOOD: DETERIORATED DOOR
Deficiency Location/Instance	Room 116 (Stage), Main Entrance, Exit 4 Vestibule
Deficiency Quantity	4
Quantity Uom	EACH
Potential Action	MAINTENANCE
Urgency of Action	PRIORITY 3
Purpose of Action	LEVEL 2
Deficiency Photo1

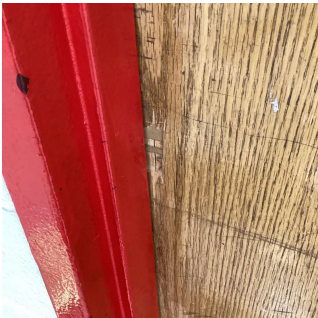
Violations	Room 116 (Stage) No violations recorded.
Fixed Equipment	
Instance on 1st Floor	Does not Exist
Floor Finish	
Instance on 1st Floor	Inspected
Condition	1 - Good
Deficiency	No deficiencies recorded
Sliding-folding Partition	
Instance on 1st Floor	Inspected
Condition	4 - Between Fair and Poor

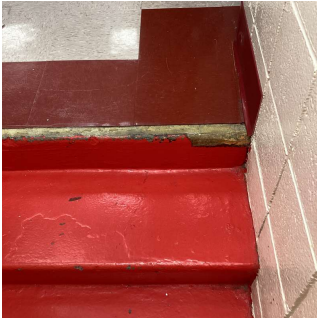
Violations	Center No violations recorded.
Stage	
Instance on 1st Floor	Inspected
Stage	Inspected
Instance on 1st Floor	Inspected
Condition	2 - Between Good and Fair
Deficiency	DAMAGED STEPS
Deficiency Location/Instance	Right Side
Deficiency Quantity	10
Quantity Uom	S.F.
Potential Action	REPLACE
Urgency of Action	PRIORITY 3
Purpose of Action	LEVEL 2
Deficiency Photo1

Violations	Right Side No violations recorded.
Deficiency	RAILINGS/MISSING
Deficiency Location/Instance	Right Side
Deficiency Quantity	10
Quantity Uom	L.F.
Potential Action	REPLACE
Urgency of Action	PRIORITY 5

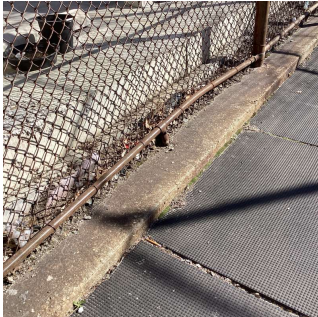
Violations	Rogers Avenue No violations recorded.
Deficiency Deficiency Location/Instance Deficiency Quantity Quantity Uom Potential Action Urgency of Action Purpose of Action Deficiency Photo1	CHAIN LINK: DAMAGED POST/RAIL Near Playground 20 L.F. REPLACE PRIORITY 3 LEVEL 2

Violations	Near Playground No violations recorded.
Deficiency Deficiency Location/Instance Deficiency Quantity Quantity Uom Potential Action Urgency of Action Purpose of Action Deficiency Photo1	CHAIN LINK: RUST - MAJOR Near Playground, Albemarle Road 1,600 S.F. REPLACE PRIORITY 3 LEVEL 2

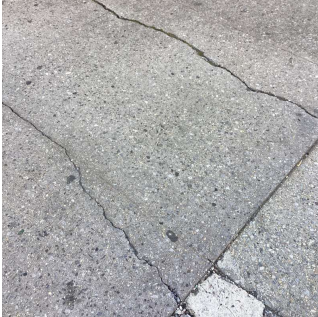
Question	Response
SITE	
PAVING	Inspected
Site Sidewalks & Walkways	
Concrete	
Deficiency Photo1	 
Violations	Albemarle Road No violations recorded.
Pavers	Does not Exist
DOT Sidewalk	Inspected
Asphalt	Does not Exist
Concrete	Inspected
Condition	4 - Between Fair and Poor
Deficiency	HEAVING
Deficiency Location/Instance	Albemarle Road
Deficiency Quantity	100
Quantity Uom	S.F.
Potential Action	REPLACE
Urgency of Action	PRIORITY 5
Purpose of Action	LEVEL 6
Deficiency Photo1	 
Violations	Albemarle Road No violations recorded.
Deficiency	DAMAGED/DETERIORATED/MISSING SECTIONS
Deficiency Location/Instance	Rogers Avenue, Albemarle Road
Deficiency Quantity	1,350
Quantity Uom	S.F.
Potential Action	REPLACE
Urgency of Action	PRIORITY 3
Purpose of Action	LEVEL 2

Violations	Rogers Avenue No violations recorded.
Pavers	Does not Exist
PLAYGROUNDS	Inspected
Instance on Rear of Building	Inspected
Benches	
Instance on Rear of Building	Does not Exist
Fence	
Instance on Rear of Building	Does not Exist
Pavement	
Instance on Rear of Building	Does not Exist
Play Equipment	
Instance on Rear of Building	Inspected
Condition	2 - Between Good and Fair
Deficiency	No deficiencies recorded
Safety Surfacing	
Instance on Rear of Building	Inspected
Condition	2 - Between Good and Fair
Deficiency	No deficiencies recorded
Unpaved Area	
Instance on Rear of Building	Does not Exist
PLAYING SURFACE	Does not Exist
RETAINING WALLS	Does not Exist
SEATING	Inspected
Benches	Inspected
Concrete	Does not Exist
Metal/Wood/Plastic	Inspected
Condition	2 - Between Good and Fair
Deficiency	No deficiencies recorded
Bleachers	Does not Exist
SITE WALLS (NOT RETAINING WALLS)	Does not Exist
