NYC Department of Education
Building Condition Assessment Survey 2023 - 2024

Architectural Inspection

Asset: **I.S. 187 - BROOKLYN, 1171 65 STREET, New York, 11219**

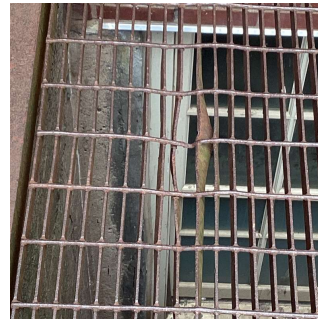
AW4

AREAWAY GRATINGS: MAJOR RUSTING / OR BROKEN

REPLACE

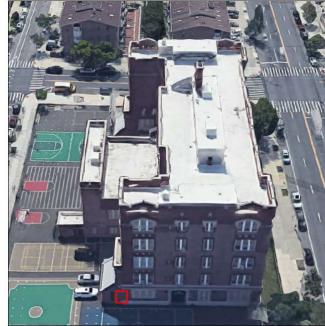
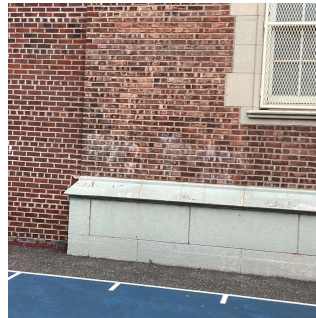
Facade B

BRICK: EFFLORESCENCE

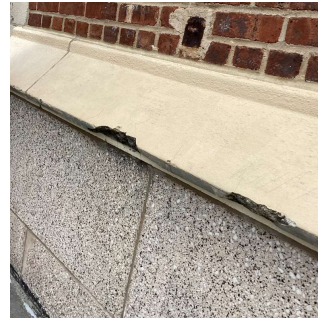
Facade M

STONE: CHIPPED/SPALLED/BROKEN PIECES - MAJOR

REPLACE

PRIORITY 4
LEVEL 2

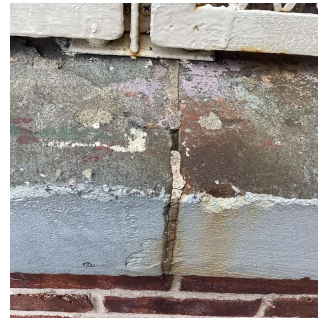
Facade F

BRICK: MASONRY SILLS - DETERIORATED JOINTS

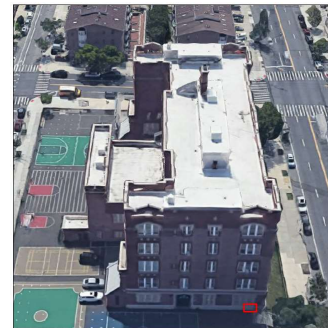
STONE: CHIPPED/SPALLED/BROKEN PIECES - MINOR

REPAIR

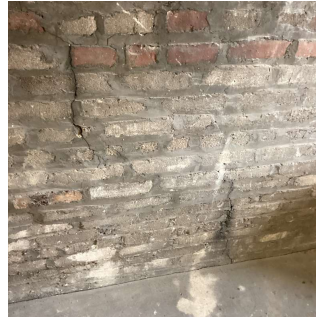
Roof 1 - BH1

| Deficiency | BULKHEAD/PENTHOUSE WALLS/INTERIOR: BRICK CRACKS/SPALLING |

| Deficiency Quantity | 10 |
| Potential Action | REPLACE |

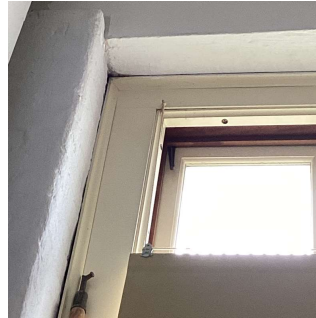
Facade A - Room 107
No violations recorded.

WOOD: AIR/WATER INFILTRATION, DETERIORATED JOINTS WITH DAMAGED CAULKING

30
L.F.
MAINTENANCE
PRIORITY 3
LEVEL 2

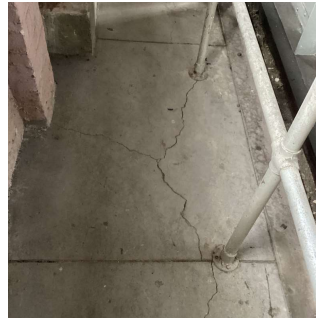
Roof 1 - PH

CONCRETE: CRACKS/SPALLED/REINFORCEMENT EXPOSED

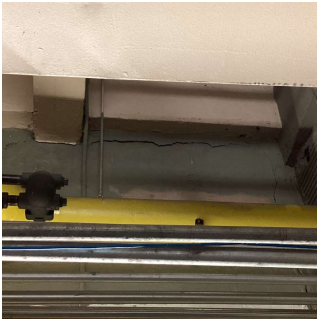
| Question | Response |
|---|--|
| Deficiency | CONCRETE: CRACKED/SPALLED/REINFORCEMENT EXPOSED |
| Deficiency Location/Instance | Stair D/Basement |
| Potential Action | REPAIR |

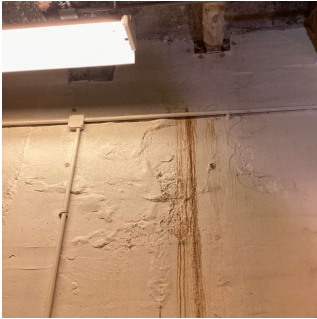
| Question | Response |
|---|--|
| Deficiency | CONCRETE: WATER INFILTRATION IN NON- INSTRUCTIONAL SPACE |
| Deficiency Location/Instance | Basement - Boiler Room (4 locations) |

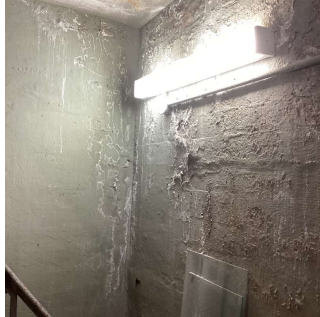
| Question | Response |
|---|--|
| Deficiency | WATER INFILTRATION IN NON- INSTRUCTIONAL SPACE |
| Deficiency Location/Instance | Basement - Ash Hoist Vault, Vault Tunnel |

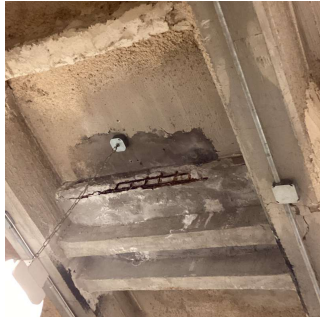
| Question | Response |
|---|--|
| Deficiency | CONCRETE: CRACKS/SPALLED/REINFORCEMENT EXPOSED |
| Potential Action | REPAIR |

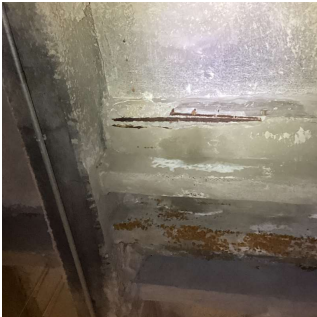
| Question | Response |
|---|--|
| Deficiency | CONCRETE: CRACKS/SPALLED/REINFORCEMENT EXPOSED |

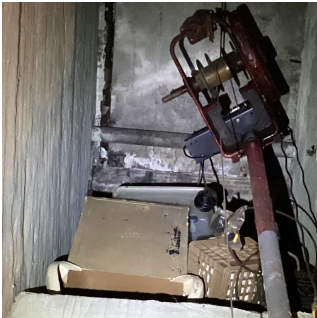
| Question | Response |
|--|--|
| Deficiency | CONCRETE: CRACKS/SPALLED/REINFORCEMENT EXPOSED |

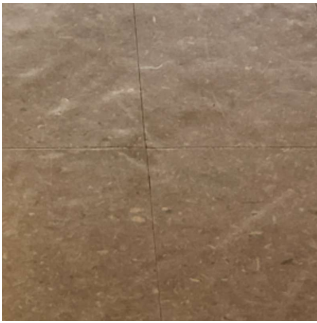
| Question | Response |
|---|--|
| | Right Side |

| Question | Response |
|---|--|
| Deficiency | VINYL TILES: DETERIORATED SUBSTRATE |
| Deficiency Location/Instance | Right Side |

| Question | Response |
|---|--|
| Potential Action | REPLACE |
