NYC Department of Education
Building Condition Assessment Survey 2023 - 2024

Architectural Inspection

Asset: LIBERATION DIPLOMA PLUS H.S. - K, 2865 WEST 19TH STREET, New York, 11224

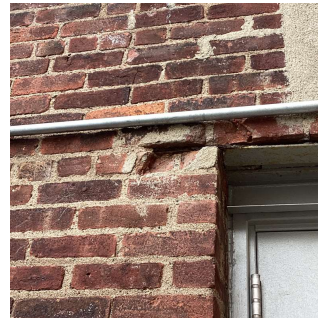
Facade D

BRICK: MAJOR / THRU CRACKS

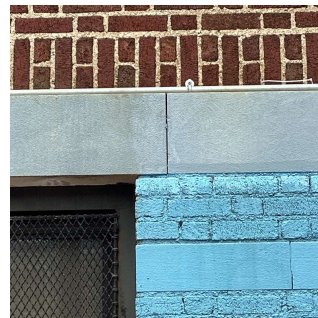
Facade A

STONE: DETERIORATED JOINTS

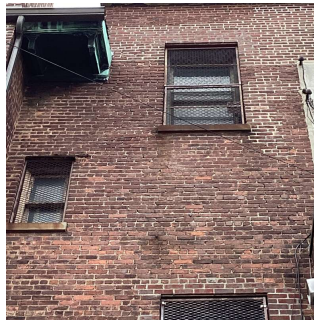
Facade G

BRICK: DETERIORATED JOINTS

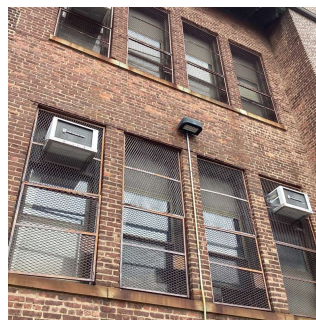
W. 19th Street

STEEL: MAJOR RUSTING

REPLACE

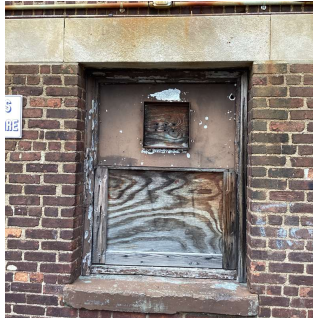
Facade G

| Deficiency | WOOD: DETERIORATED |

REPLACE WINDOW

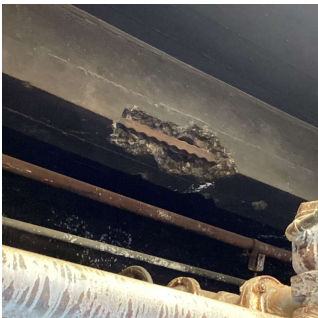
| Question | Response |
|---|--|
| Deficiency | STEEL COLUMNS/BEAMS: DETERIORATED CONCRETE FIREPROOFING |
| Deficiency Location/Instance | 1st Floor - Boiler Room |

| Question | Response |
|---|--|
| Potential Action | REPLACE |

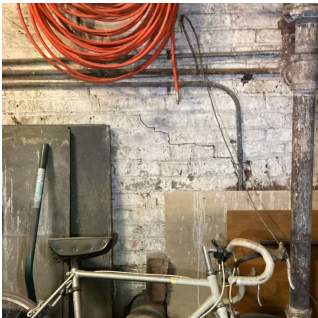
| Question | Response |
|---|--|
| Deficiency | CONCRETE BEARING WALL: CRACKED/SPALLED/REINFORCEMENT EXPOSED |
| Deficiency Location/Instance | 1st Floor - Boiler Room |

| Question | Response |
|---|--|
| Potential Action | REPAIR |
