**NYC Department of Education
Building Condition Assessment Survey 2023 - 2024**

Architectural Inspection

K802

Asset: CENT HEADQTRS (131 LIV) - K, 131 LIVINGSTON STREET, New York, 11201

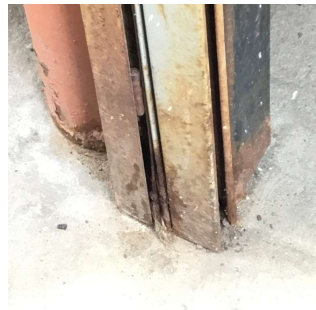
Facade D

ROLL-UP DOOR: DETERIORATED DOOR AND FRAME - MAJOR DETERIORATION

300
S.F.
REPLACE
PRIORITY 4
LEVEL 2

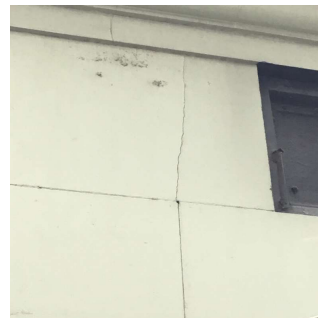
Facade D

STONE: CHIPPED/SPALLED/BROKEN PIECES - MAJOR

REPLACE

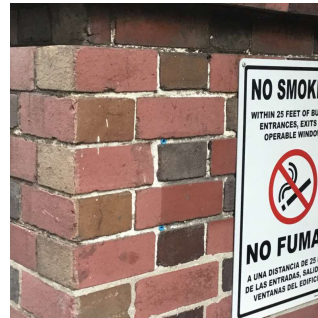
Facade D

BRICK: DETERIORATED JOINTS

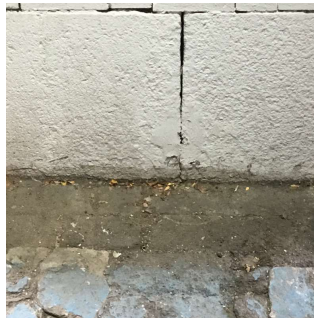
Facade D

STONE: DETERIORATED JOINTS

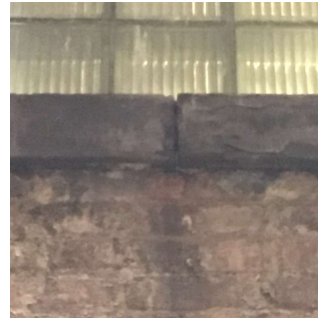
Courtyard

BRICK: MASONRY SILLS - DETERIORATED JOINTS

PRIORITY 3
LEVEL 2

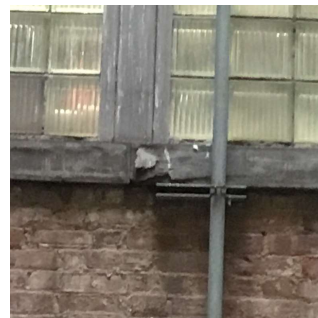
Courtyard

BRICK: DETERIORATED MASONRY SILLS - MAJOR

REMOVE AND REPLACE

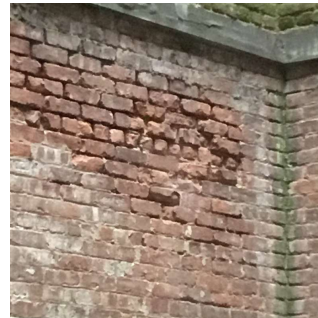
Courtyard

BRICK: MAJOR / THRU CRACKS

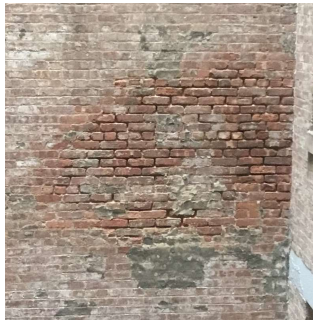
Courtyard

BRICK: DETERIORATED JOINTS

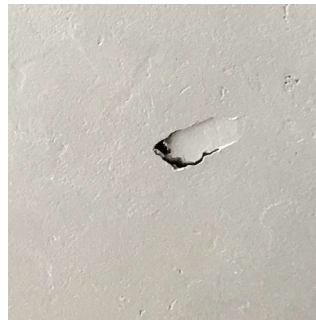
Loading Dock

CONCRETE: MAJOR CRACKS/SPALLING

40
S.F.
REPLACE
PRIORITY 4
LEVEL 2

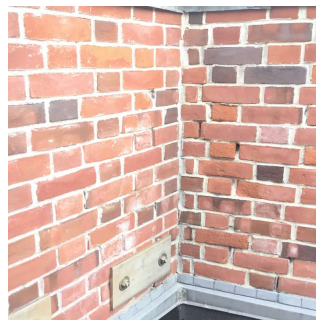
Roof 1

BRICK: DETERIORATED JOINTS

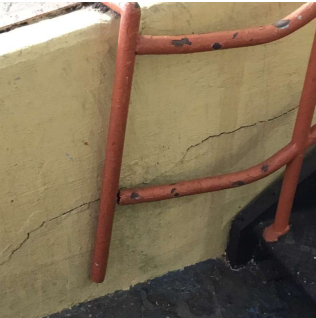
Question	Response
EXTERIOR	
ROOF	Inspected
Specialties	Inspected
ROOF/GRAVITY TANK	
Condition	2 - Between Good and Fair
Deficiency	No deficiencies recorded
STAIRS/RAMPS: EXTERIOR	Inspected
BUILDING CHEEK/FLANK WALLS	Inspected
Condition	3 - Fair
Deficiency	CAST IN PLACE CONCRETE: CRACKS/SPALLING - MINOR
Roof Plan reference

Deficiency Quantity	30
Quantity Uom	S.F.
Potential Action	REPAIR
Urgency of Action	PRIORITY 3
Purpose of Action	LEVEL 2
Deficiency Photo1

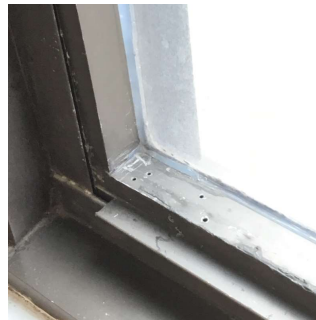
Facade A - Room 201

Question	Response
EXTERIOR	
WINDOWS	
EXTERIOR GUARDS	
Elevation	 
Deficiency Quantity	30
Quantity Uom	S.F.
Potential Action	REPLACE
Urgency of Action	PRIORITY 4
Purpose of Action	LEVEL 2
Deficiency Photo1	 
Violations	Facade E No violations recorded.
LINTELS	Inspected
Condition	2 - Between Good and Fair
Deficiency	No deficiencies recorded
WINDOWS	Inspected
Material Type(s)	Aluminum, Solid Wood, Steel
Instance on Aluminum - Double Hung: All Facades	Inspected
Instance Condition	3 - Fair
Instance Quantity	7,000
Instance Quantity Uom	S.F.
Are these windows insulated	Yes
Installation Year	1988
Source of Installation	Custodial Staff
Deficiency	ALUMINUM - DOUBLE HUNG: DETERIORATED

30
S.F.
REPLACE WINDOW
PRIORITY 4
LEVEL 2

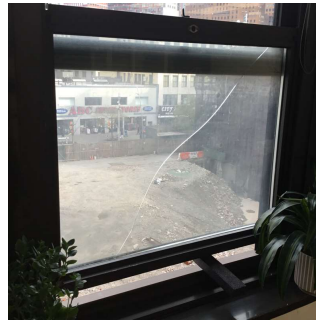
ALUMINUM - DOUBLE HUNG: BROKEN PANE

Facade C - Room 408B (Facade A - Room 601C, Facade B - 501B similar)

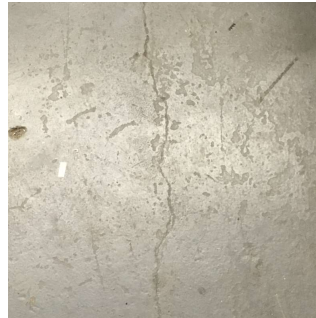
CONCRETE SLAB ON GRADE: THRU CRACKS

Basement Storage Room (Dry Storage Room, Gas Meter Room, Boiler Room similar)

REPAIR

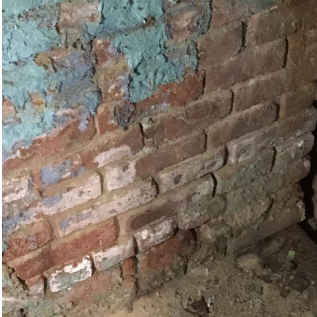
Violations	Basement Corridor No violations recorded.
ROOF STRUCTURE	
Condition	Inspected 2 - Between Good and Fair
Deficiency	No deficiencies recorded
VAULTS-BUNKERS	
Foundation Walls	
Condition	Inspected 3 - Fair
Deficiency	DETERIORATED JOINTS
Deficiency Location/Instance	Vault
Deficiency Quantity	50
Quantity Uom	S.F.
Potential Action	REPOINT
Urgency of Action	PRIORITY 3
Purpose of Action	LEVEL 5

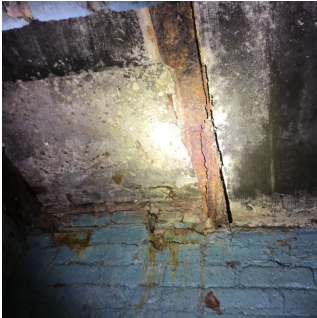
Violations	Vault No violations recorded.
Slab Structure	Inspected
Condition	3 - Fair
Deficiency	STEEL COLUMNS/BEAMS: MAJOR RUSTING
Deficiency Location/Instance	Vault
Deficiency Quantity	20
Quantity Uom	S.F.
Potential Action	REPLACE
Urgency of Action	PRIORITY 4
Purpose of Action	LEVEL 5
Deficiency Photo1

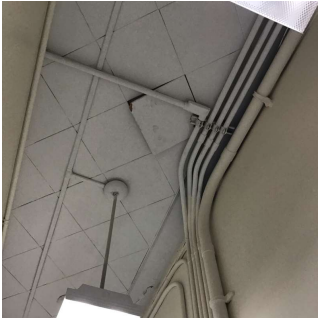
Question	Response
INTERIOR	
CLASSROOMS/CORRIDORS/ADMIN SPACES	
Ceiling	
Deficiency	ACOUSTIC TILES ON PLASTER: DAMAGED/MISSING
Deficiency Location/Instance	Room 609,506,409,408C,Corridor near Room 607, and others
Deficiency Quantity	120
Quantity Uom	S.F.
Potential Action	REPLACE
Urgency of Action	PRIORITY 3
Purpose of Action	LEVEL 2
Deficiency Photo1

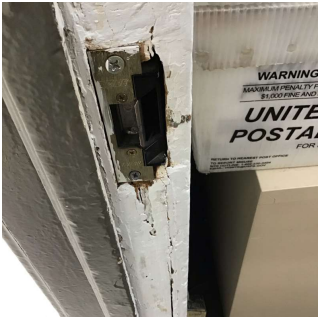
Violations	Corridor near Room 607 No violations recorded.
Door(s)	Inspected
Condition	5 - Poor
Deficiency	WOOD: DETERIORATED DOOR AND FRAME
Deficiency Location/Instance	Room 201
Deficiency Quantity	1
Quantity Uom	EACH
Potential Action	MAINTENANCE
Urgency of Action	PRIORITY 3
Purpose of Action	LEVEL 2
Deficiency Photo1

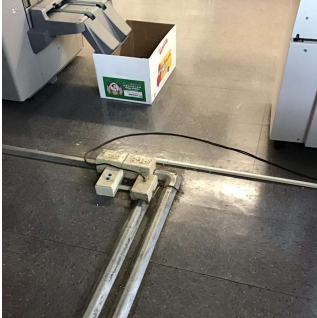
Violations	Room 404 No violations recorded.
Deficiency	VINYL TILES: TRIPPING HAZARD - ELECTRICAL OUTLET
Deficiency Location/Instance	Room 604A
Deficiency Quantity	10
Quantity Uom	S.F.
Potential Action	REMOVE
Urgency of Action	PRIORITY 5
Purpose of Action	LEVEL 6
Deficiency Photo1

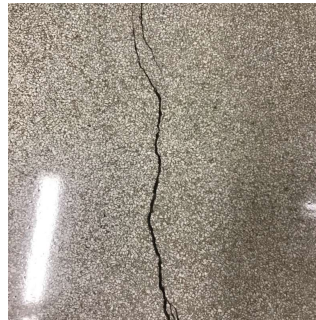
Main Entrance Lobby

TERRAZZO: CRACKS

REPLACE

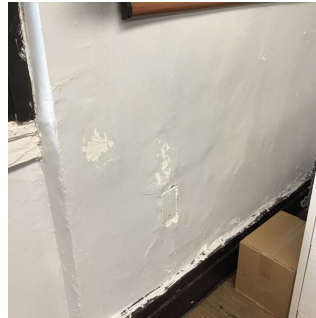
Room 501B

PLASTER: CRACKS/SPALLING - ACTIVE LEAK

REPLACE

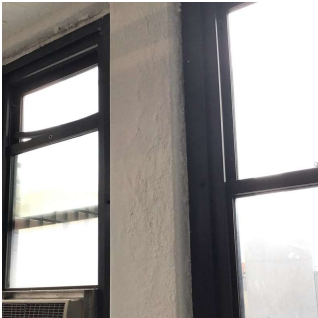
Question	Response
INTERIOR	
CLASSROOMS/CORRIDORS/ADMIN SPACES	
Walls	
Violations	No violations recorded.
Deficiency	PLASTER: CRACKS/SPALLING
Deficiency Location/Instance	Room 604A, 507,408A,Corridor near Room 607,507, and others
Deficiency Quantity	150
Quantity Uom	S.F.
Potential Action	REPLACE
Urgency of Action	PRIORITY 3
Purpose of Action	LEVEL 2
Deficiency Photo1

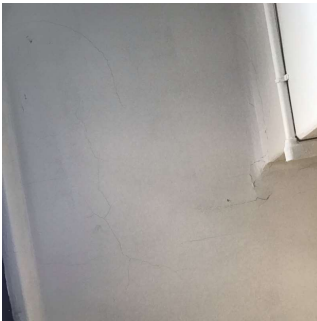
Violations	No violations recorded.
Specialties	Does not Exist
GYMNASIUM	Does not Exist
INTERIOR DOOR HARDWARE	Inspected
Condition	3 - Fair
Deficiency	No deficiencies recorded
INTERIOR GUARDS	Does not Exist
KITCHEN	Does not Exist
LIBRARY	Does not Exist
LOCKER ROOM	Does not Exist
MULTI-PURPOSE ROOM	Does not Exist
SCIENCE DEMO ROOM	Does not Exist
SCIENCE LAB	Does not Exist
SCIENCE PREP ROOM	Does not Exist
SHOWER ROOM	Does not Exist
STAIRS/RAMPS: INTERIOR	Inspected
Do Letter Stair Signs Exist?	Yes
Ceiling	Inspected
Condition	2 - Between Good and Fair
Deficiency	PLASTER: CRACKS/SPALLING

Deficiency Location/Instance	Stair B/6
Deficiency Quantity	10
Quantity Uom	S.F.
Potential Action	REPLACE
Urgency of Action	PRIORITY 3
Purpose of Action	LEVEL 2

Question	Response
INTERIOR	
STAIRS/RAMPS: INTERIOR	
Ceiling	
Deficiency Photo1

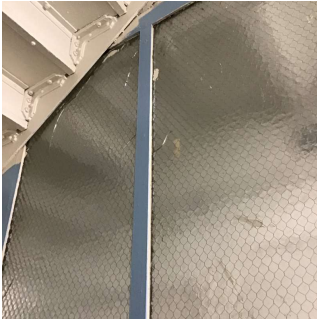
Violations	Stair B/6 No violations recorded.
Door(s)	Inspected
Condition	2 - Between Good and Fair
Deficiency	No deficiencies recorded
Partition	Inspected
Condition	3 - Fair
Deficiency	GLASS PANEL: DAMAGED/DETERIORATED
Deficiency Location/Instance	Stair B/5,4,3,2
Deficiency Quantity	70
Quantity Uom	S.F.
Potential Action	REPLACE
Urgency of Action	PRIORITY 3
Purpose of Action	LEVEL 2
Deficiency Photo1

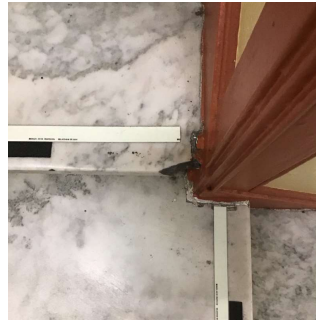
Stair A/3

Violations	Stair B/3 No violations recorded.
Railings	Inspected
Condition	2 - Between Good and Fair
Deficiency	No deficiencies recorded
Stairs and Landings	Inspected
Condition	5 - Poor
Deficiency	STONE: BROKEN/MISSING
Deficiency Location/Instance	Stair A/3, Main Entrance Lobby
Deficiency Quantity	20
Quantity Uom	S.F.
Potential Action	REPLACE
Urgency of Action	PRIORITY 3
Purpose of Action	LEVEL 2

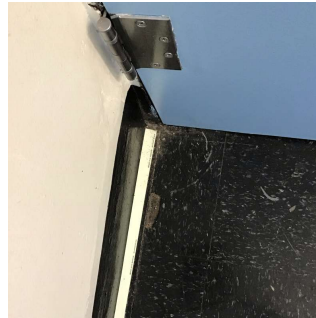
Stair B/6

VINYL TILES: BROKEN/DETERIORATED/MISSING TILES

REPLACE

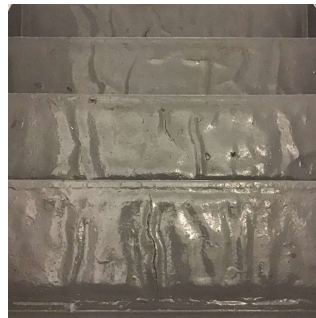
ROLLED ASPHALT: CRACKS

Question	Response
INTERIOR	
STAIRS/RAMPS: INTERIOR	
Stairs and Landings	
Deficiency	ROLLED ASPHALT: CRACKS
Deficiency Location/Instance	Stair B/Penthouse
Deficiency Quantity	10
Quantity Uom	S.F.
Potential Action	REPLACE
Urgency of Action	PRIORITY 5
Purpose of Action	LEVEL 6
Deficiency Photo1	 
Violations	Stair B/Penthouse No violations recorded.
Deficiency	TERRAZZO: CRACKS
Deficiency Location/Instance	Stair A/1,2,3,4,5, and others
Deficiency Quantity	100
Quantity Uom	S.F.
Potential Action	REPLACE
Urgency of Action	PRIORITY 3
Purpose of Action	LEVEL 2
Deficiency Photo1	 
Violations	Stair A/2 No violations recorded.
Walls	Inspected
Condition	2 - Between Good and Fair
Deficiency	PLASTER: CRACKS/SPALLING
Deficiency Location/Instance	Stair A/2, B/6,5
Deficiency Quantity	30
Quantity Uom	S.F.
Potential Action	REPLACE
Urgency of Action	PRIORITY 3
Purpose of Action	LEVEL 2

REPLACE

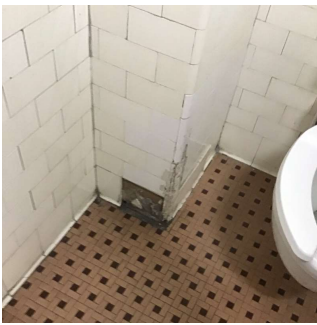
CERAMIC TILE: BROKEN/ MISSING

REPLACE

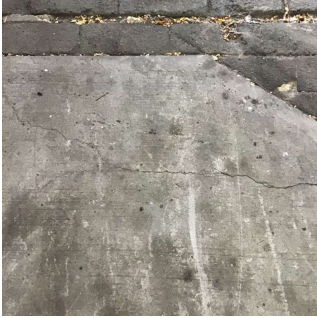
Violations	2nd Floor - Mens No violations recorded.
TOILET ROOMS - STUDENTS	Does not Exist
LIFE SAFETY	Inspected
F.D. HOLDING AREA	Does not Exist
STEEL STAIRS	Does not Exist
SITE	Inspected
CONTAINERIZATION	Does not Exist
Drainage System for Asphalt	Does not Exist
Drainage System for Concrete	Inspected
Catch Basins/Manhole - Surrounded by concrete	Inspected
Condition	2 - Between Good and Fair
Deficiency	No deficiencies recorded
Culverts - Concrete Covering	Does not Exist
Drainage System for Soil	Does not Exist
DRINKING FOUNTAINS	Does not Exist
FENCES	Does not Exist
IRRIGATION SYSTEM	Does not Exist
PAVING	Inspected
Student Non-Use	Inspected
Gravel Exists?	No
Asphalt	Does not Exist
Concrete	Inspected
Condition	3 - Fair
Deficiency	DAMAGED/DETERIORATED/MISSING SECTIONS
Deficiency Location/Instance	Near loading area
Deficiency Quantity	50
Quantity Uom	S.F.

Potential Action	REPLACE
Urgency of Action	PRIORITY 3
Purpose of Action	LEVEL 2

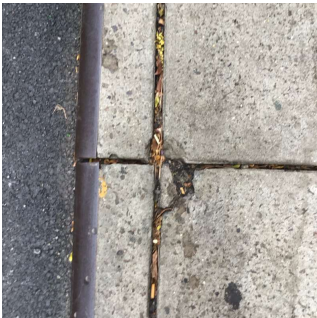
Along Red Hook Lane

Violations	Near loading area No violations recorded.
Pavers	Inspected
Condition	3 - Fair
Deficiency	DAMAGED/MISSING
Deficiency Location/Instance	Near Loading Area
Deficiency Quantity	50
Quantity Uom	S.F.
Potential Action	REPLACE
Urgency of Action	PRIORITY 3
Purpose of Action	LEVEL 2
Deficiency Photo1	No photo recorded
Violations	No violations recorded.
Student Use	Does not Exist
Site Sidewalks & Walkways	Does not Exist
DOT Sidewalk	Inspected
Asphalt	Does not Exist
Concrete	Inspected
Condition	4 - Between Fair and Poor
Deficiency	DAMAGED/DETERIORATED/MISSING SECTIONS
Deficiency Location/Instance	Along Red Hook Lane, Livingston Street
Deficiency Quantity	725
Quantity Uom	S.F.
Potential Action	REPLACE
Urgency of Action	PRIORITY 3
Purpose of Action	LEVEL 2
Deficiency Photo1

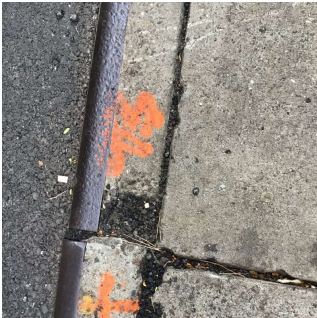
Question	Response
SITE	
PAVING	
DOT Sidewalk	
Concrete	
Violations	No violations recorded.
Deficiency	DAMAGED CURBS
Deficiency Location/Instance	Along Red Hook Lane, Livingston Street
Deficiency Quantity	95
Quantity Uom	L.F.
Potential Action	REPLACE
Urgency of Action	PRIORITY 3
Purpose of Action	LEVEL 2
Deficiency Photo1
