NYC Department of Education
Building Condition Assessment Survey 2023 - 2024

Architectural Inspection

K805

Asset: WATERS EDGE EDUCATIONAL COMPLEX - K, 49 FLATBUSH AVENUE EXT., New York, 11201

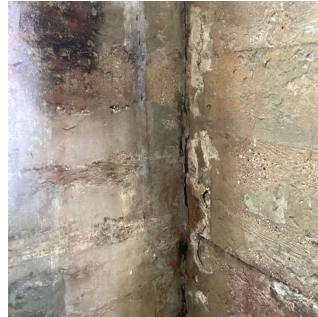
AW1

AREAWAY WALLS: CRACKS AND SPALLING

REPAIR

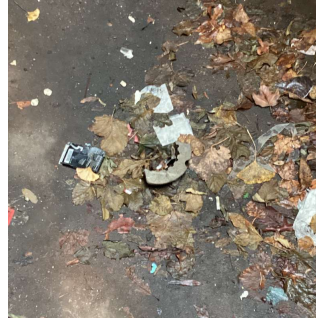
AW1
No violations recorded.

AREAWAY DRAINS: DETERIORATED

REPLACE

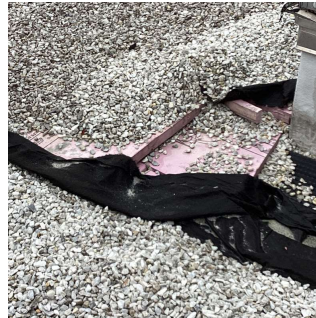
Roof 1

| Deficiency | IRMA: ROOFING: DAMAGED INSULATION |

| Potential Action | REPLACE |

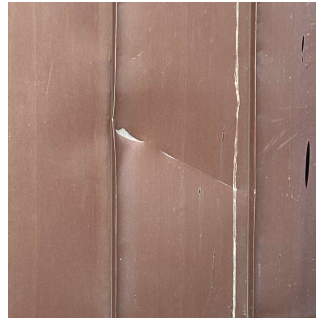
BH2

BULKHEAD/PENTHOUSE WALLS/EXTERIOR: DAMAGED METAL SIDING

25
S.F.
REPLACE
PRIORITY 4
LEVEL 2

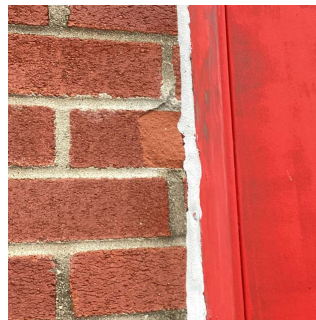
BH2

**BULKHEAD/PENTHOUSE WALLS/EXTERIOR:
CRACKS/SPALLING - MINOR**

REPAIR

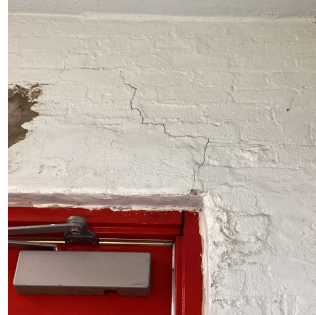
BH2

**BULKHEAD/PENTHOUSE WALLS/INTERIOR: BRICK
CRACKS/SPALLING**

25
S.F.
REPLACE
PRIORITY 4
LEVEL 2

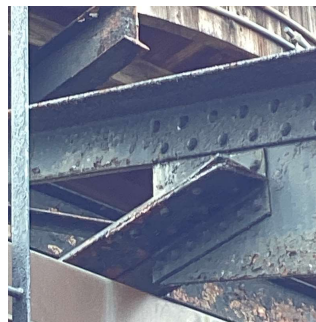
Roof 1
No violations recorded.

STEEL STRUCTURE: MAJOR RUSTING

40
S.F.
REPAIR
PRIORITY 4
LEVEL 2

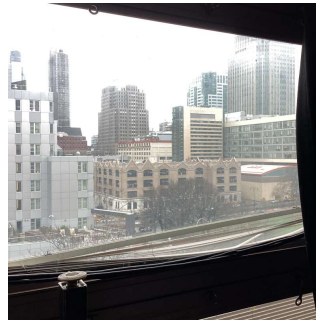
Facade C - Room 610
No violations recorded.

ALUMINUM - OTHER: INOPERABLE INTEGRAL BLIND

2,100
S.F.
REPLACE GLAZING
PRIORITY 3
LEVEL 2

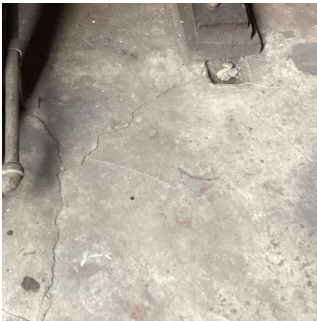
| Question | Response |
|---|--|
| Violations | Inspected Roof Tank Penthouse No violations recorded. |

| Question | Response |
|---|--|
| Deficiency | CONCRETE: CRACKS/SPALLED/REINFORCEMENT EXPOSED |

| Question | Response |
|---|--|
| Potential Action | REPAIR |

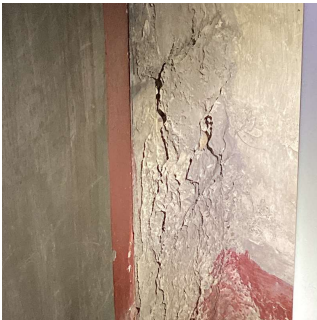
| Question | Response |
|---|--|
| Violations | Electrical Panel Room No violations recorded. |

| Question | Response |
|---|--|
| Deficiency | CONCRETE: CRACKED/SPALLED/REINFORCEMENT EXPOSED |

| Question | Response |
|---|--|
| Potential Action | REPAIR |

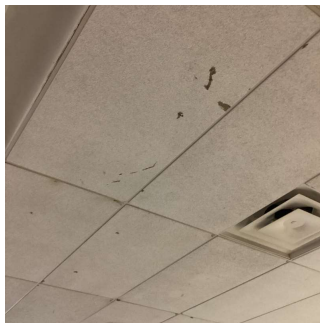
| Question | Response |
|---|--|
| Violations | Center No violations recorded. |

| Question | Response |
|---|---|
| Deficiency | ACOUSTIC TILES: DAMAGED/MISSING |

| Question | Response |
|---|---|
| Potential Action | REPLACE |

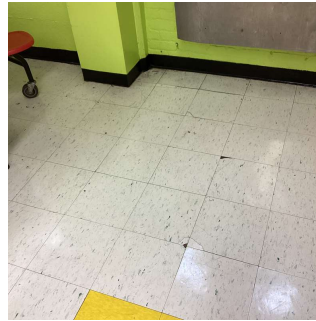
Near Windows

| Question | Response |
|---|--|
| Deficiency | VINYL TILES: BROKEN/DETERIORATED/MISSING TILES |

| Question | Response |
|---|--|
| Potential Action | REPLACE |

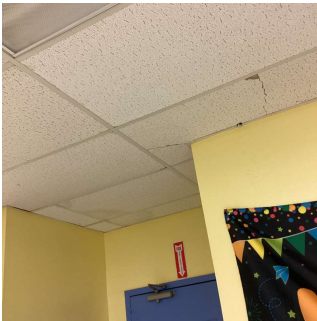
| Question | Response |
|--|--|
| Violations | Corridor near room B17 No violations recorded. |

| Question | Response |
|--|--|
| Deficiency | ACOUSTIC TILES: DAMAGED/MISSING |

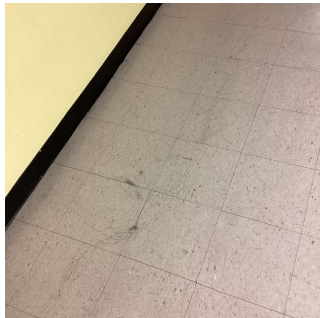
| Question | Response |
|--|--|
| Violations | Corridor near Room B17 No violations recorded. |

| Question | Response |
|--|--|
| Deficiency | VINYL TILES: DETERIORATED SUBSTRATE |
| Deficiency Location/Instance | Corridor near Room B18, B17, B14, 509, 505 and others |

| Question | Response |
|--|--|
| Potential Action | REPLACE |
| Urgency of Action | PRIORITY 3 |

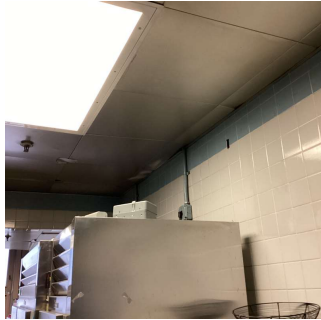
| Question | Response |
|--|--|
| Violations | Servery No violations recorded. |

| Question | Response |
|--|--|
| Deficiency | METAL PAN: DAMAGED/MISSING |
| Deficiency Location/Instance | Servery |

| Question | Response |
|--|--|
| Potential Action | REPLACE |
| Urgency of Action | PRIORITY 3 |

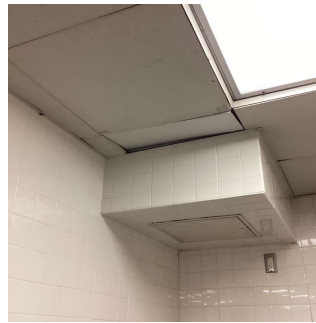
| Question | Response |
|--|--|
| Deficiency | METAL PAN: DAMAGED/MISSING |
| Deficiency Location/Instance | Near Servery |

| Question | Response |
|--|--|
| Potential Action | REPLACE |

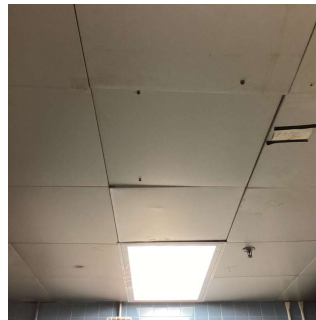
Center

METAL PAN: DAMAGED/MISSING

REPLACE

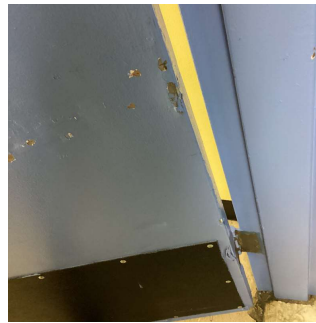
Entrance

METAL: DETERIORATED DOOR

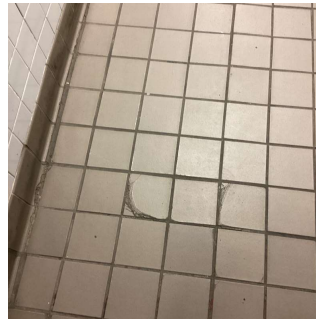
| Deficiency | CERAMIC TILE: BROKEN/MISSING TILES |
| Deficiency Location/Instance | Near food prep |

| Potential Action | REPLACE |
