**NYC Department of Education
Building Condition Assessment Survey 2023 - 2024**

Architectural Inspection

Asset: P.S. 361 (OLD 89) - BROOKLYN, 3109 NEWKIRK AVENUE, New York, 11226

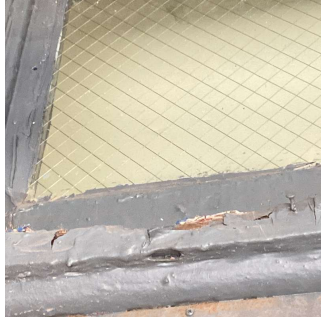
Question	Response
EXTERIOR	
DOORS	
TRANSOM/SIDE LIGHT	
Urgency of Action	PRIORITY 4
Purpose of Action	LEVEL 2
Deficiency Photo1

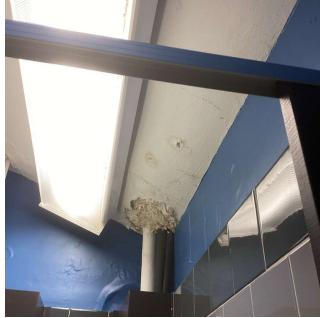
Question	Response
INTERIOR	
TOILET ROOMS - STUDENTS	
Ceiling	
Potential Action	REPLACE
Urgency of Action	PRIORITY 3
Purpose of Action	LEVEL 2
Deficiency Photo1

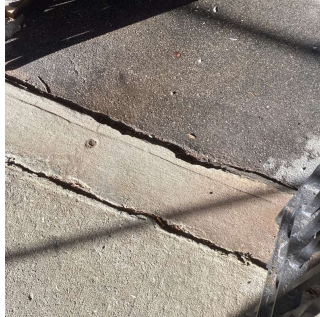
Question	Response
SITE	
PAVING	
Site Sidewalks & Walkways	
Concrete	
Deficiency Photo1

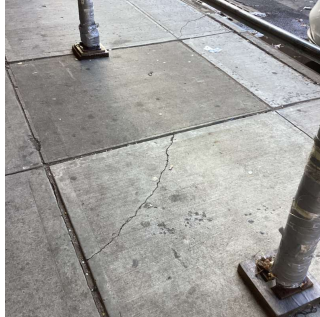
Question	Response
SITE	
PAVING	
DOT Sidewalk	
Concrete	
Deficiency Photo1
