**NYC Department of Education**  
**Building Condition Assessment Survey 2023 - 2024**

Architectural Inspection

**Asset:** P.S. 28 (ECC) - QUEENS, 109-10 47TH AVE, New York, 11368

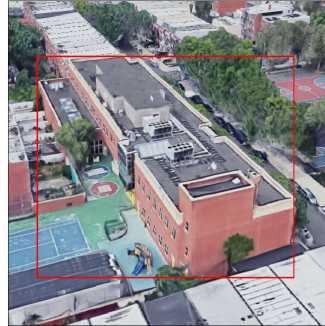
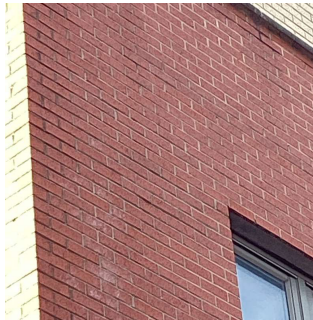
Facade A

BRICK: DETERIORATED JOINTS

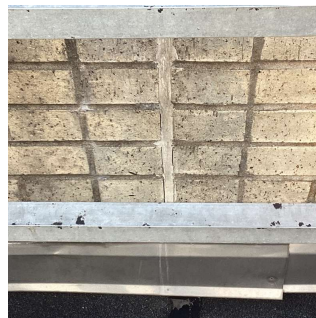
BRICK: DETERIORATED CONTROL/EXPANSION JOINT

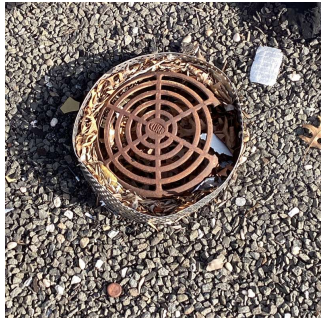
Violations	Roof 1 - Room 214 (Roof 1 - Rooms 207, 208, 209, 209A, 220, Corridor near Room 210) No violations recorded.
<b>ROOFING DRAINS</b>	Inspected
Condition	5 - Poor
Deficiency	DETERIORATED
Roof Plan reference	Q028
Deficiency Quantity	4
Quantity Uom	EACH
Potential Action	REPLACE
Urgency of Action	PRIORITY 4
Purpose of Action	LEVEL 2
Deficiency Photo1

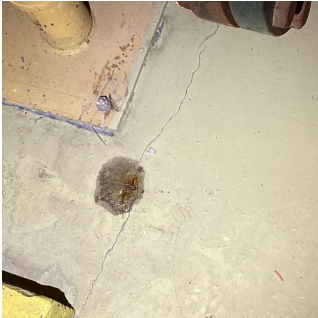
Question	Response
<b>INTERIOR</b>	
<b>STRUCTURAL</b>	
<b>COLUMNS/BEAMS/BEARING WALLS</b>	Inspected
Violations	No violations recorded.
<b>FLOOR STRUCTURE</b>	Inspected
Condition	3 - Fair
Deficiency	CONCRETE SLAB ON GRADE: THRU CRACKS
Deficiency Location/Instance	Basement
Deficiency Quantity	100
Quantity Uom	S.F.
Potential Action	REPAIR
Urgency of Action	PRIORITY 3
Purpose of Action	LEVEL 5
Deficiency Photo1

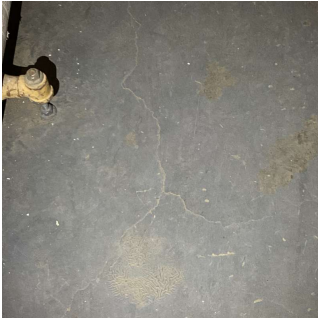
Violations	Boiler Room (Oil Tank Room, Electrical Panel Room, Sprinkler Main Room similar) No violations recorded.
Deficiency	CONCRETE: CRACKS/SPALLED/REINFORCEMENT EXPOSED
Deficiency Location/Instance	PH
Deficiency Quantity	40
Quantity Uom	S.F.
Potential Action	REPAIR
Urgency of Action	PRIORITY 3
Purpose of Action	LEVEL 5
Deficiency Photo1

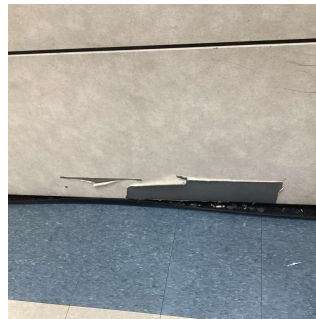
Center

MOVABLE PANELS: DAMAGED

REPLACE

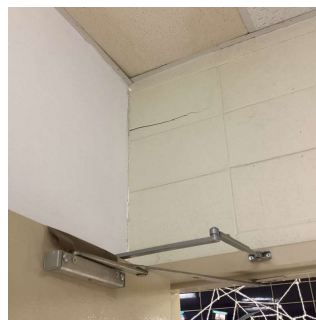
MASONRY: CRACKS/SPALLING

REPLACE
