NYC Department of Education
Building Condition Assessment Survey 2023 - 2024

Architectural Inspection

Asset: P.S. 81 - QUEENS, 559 CYPRESS AVENUE, New York, 11385

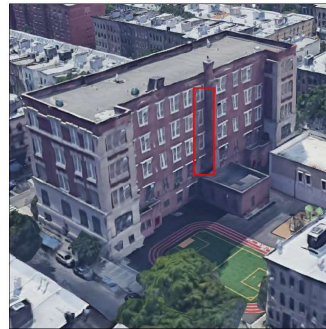
| Question | Response |
|---|---|
| Deficiency | BRICK: WATER INFILTRATION IN INSTRUCTIONAL SPACE |

REPAIR

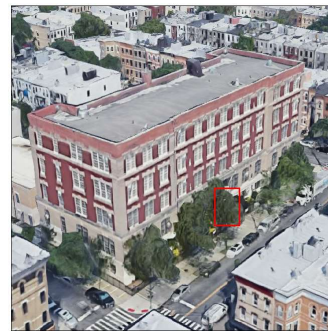
STONE: CHIPPED/SPALLED/BROKEN PIECES - MINOR

REPAIR

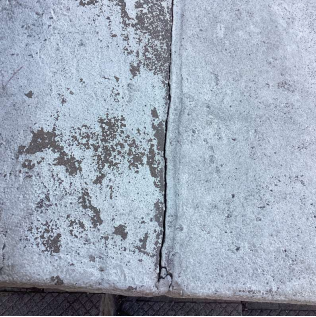
| Question | Response |
|---|--|
| Deficiency | STONE: DETERIORATED JOINTS AT COPING STONES |

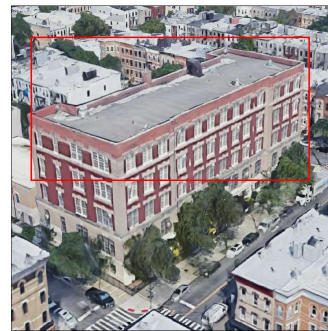
| Deficiency | ALUMINUM - DOUBLE HUNG: INOPERABLE BALANCE |

| Potential Action | REPLACE BALANCES |

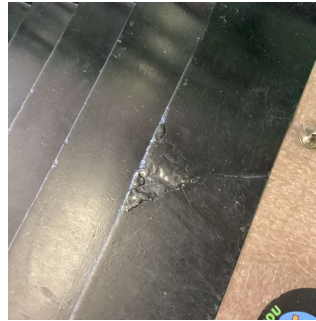
Main Entrance

VINYL TILES: BROKEN/DETERIORATED/MISSING TILES

REPLACE

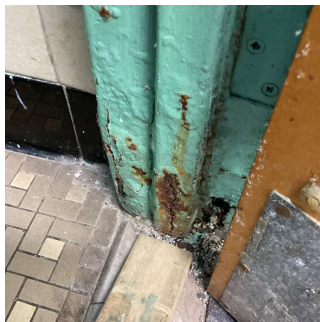
| Question | Response |
|---|--|
| Violations | Room 100 No violations recorded. |

| Question | Response |
|---|--|
| Deficiency | METAL: DETERIORATED DOOR AND FRAME |

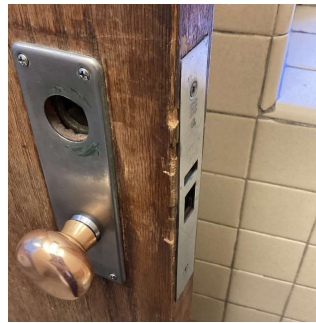
Room 209

| Question | Response |
|---|--|
| Deficiency | WOOD: DETERIORATED DOOR |

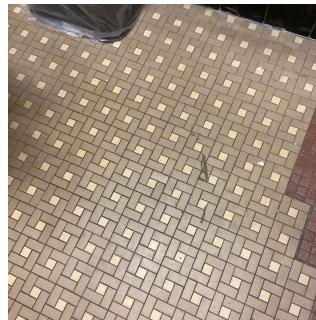
Kitchen

CERAMIC TILE: BROKEN/MISSING TILES

REPLACE

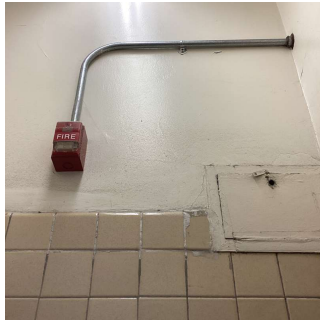
| Question | Response |
|---|---|
| Violations | Room 209 No violations recorded. |

| Question | Response |
|---|---|
| Deficiency | PLASTER: CRACKS/SPALLING |

| Question | Response |
|---|---|
| Potential Action | REPLACE |

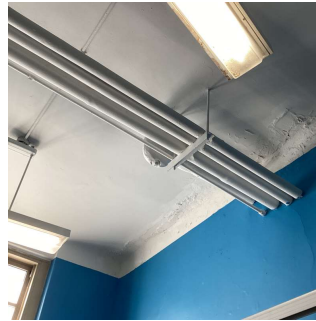
Room 409A

| Question | Response |
|---|---|
| Deficiency | PLASTER: CRACKS/SPALLING |

| Question | Response |
|---|---|
| Potential Action | REPLACE |

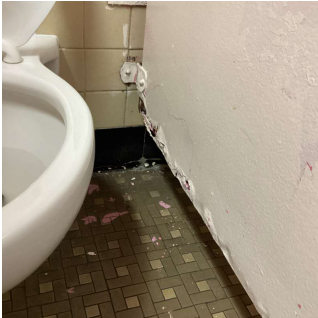
| Question | Response |
|---|--|
| | Girls - Cafeteria |

| Question | Response |
|---|--|
| Deficiency | RUST - MAJOR |

| Question | Response |
|---|--|
| Potential Action | REPLACE |
