NYC Department of Education
Building Condition Assessment Survey 2023 - 2024

Architectural Inspection

Asset: P.S. 88 - QUEENS, 60-85 CATALPA AVENUE, New York, 11385

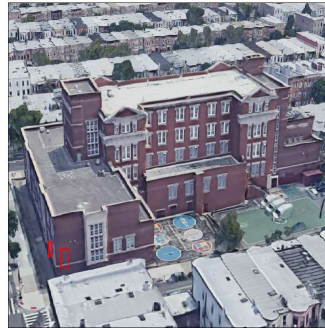
Facade H

BRICK: MINOR CRACKS AND SPALLING

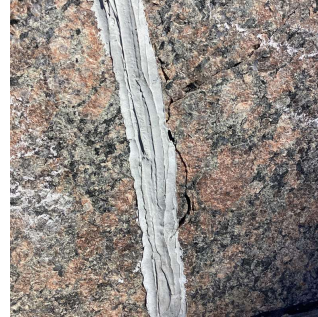
Facade F

STONE: CHIPPED/SPALLED/BROKEN PIECES - MINOR

REPAIR

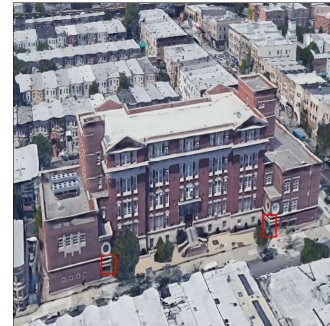
GLASS BLOCK: DETERIORATED JOINTS

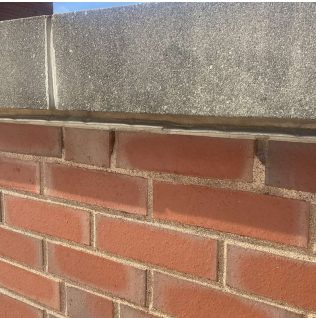
Deficiency	BRICK: DETERIORATED JOINTS
Roof Plan reference

Deficiency Quantity	20
Quantity Uom	S.F.
Potential Action	REPOINT
Urgency of Action	PRIORITY 4
Purpose of Action	LEVEL 2
Deficiency Photo1

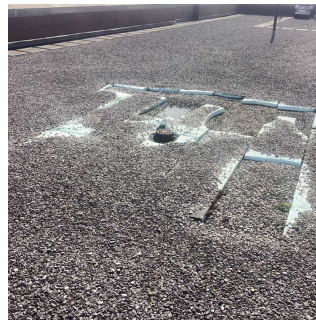
Roof 3
 No violations recorded.

Roof 6
Instance Quantity	18,000
Instance Quantity Uom	S.F.
Does the roof have major mechanical equipment sitting on Dunnage Steel less than 18" above the Roofing?	No
Does this roof instance have a Sustainable Roof System?	No
Do solar panels exist on these roofs?	No
Is/Are the roof(s) suitable for Solar Panel installation?	Yes
Installation Year	1996
Source of Installation	Custodial Staff
Deficiency	IRMA: ROOFING: DAMAGED INSULATION
Roof Plan reference

Deficiency Quantity	200
Quantity Uom	S.F.
Potential Action	REPLACE
Urgency of Action	PRIORITY 4
Purpose of Action	LEVEL 2
Deficiency Photo1

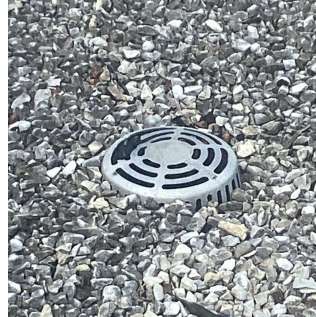
Roof 6

DETERIORATED

REPLACE

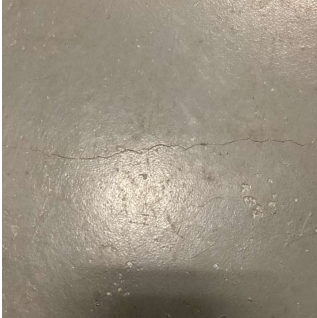
Question	Response
INTERIOR	
STRUCTURAL	
FLOOR STRUCTURE	
Violations	No violations recorded.
Deficiency	CONCRETE SLAB ON GRADE: THRU CRACKS
Deficiency Location/Instance	Sub-basement - Emergency Generator Room, Fire Pump Room, Boiler Room
Deficiency Quantity	60
Quantity Uom	S.F.
Potential Action	REPAIR
Urgency of Action	PRIORITY 3
Purpose of Action	LEVEL 5
Deficiency Photo1

Violations	Sub-basement - Emergency Generator Room No violations recorded.
FOUNDATION WALLS	
Material Type(s)	Inspected Concrete
Condition	2 - Between Good and Fair
Deficiency	No deficiencies recorded
ROOF STRUCTURE	
Condition	Inspected 2 - Between Good and Fair
Deficiency	No deficiencies recorded
VAULTS-BUNKERS	
	Does not Exist
AUDITORIUM	
Instance on 1st Floor (500 Seats)	Inspected Inspected
Ceiling	
Instance on 1st Floor (500 Seats)	Inspected
Condition	2 - Between Good and Fair
Deficiency	No deficiencies recorded
Door(s)	
Instance on 1st Floor (500 Seats)	Inspected

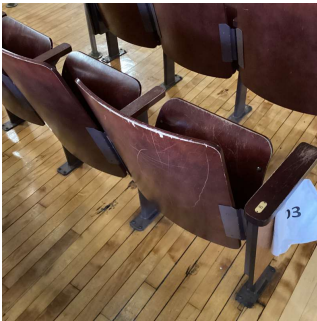
Question	Response
INTERIOR	
AUDITORIUM	
Fixed Seating	
Deficiency Photo1

Violations	Seat B/115 No violations recorded.
Floor Finish	
Instance on 1st Floor (500 Seats)	Inspected
Condition	2 - Between Good and Fair
Deficiency	WOOD: DAMAGED/DETERIORATED
Deficiency Location/Instance	Near Seat H/115, Near Stage
Deficiency Quantity	20
Quantity Uom	S.F.
Potential Action	REPLACE
Urgency of Action	PRIORITY 3
Purpose of Action	LEVEL 2
Deficiency Photo1

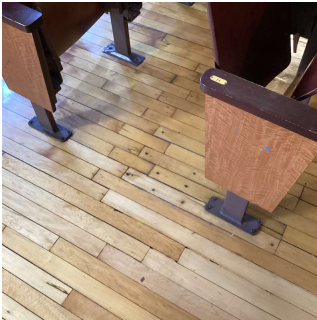
Violations	Near Seat H/115 No violations recorded.
Sliding-folding Partition	
Instance on 1st Floor (500 Seats)	Does not Exist
Stage	
Instance on 1st Floor (500 Seats)	Inspected
Stage	
Instance on 1st Floor (500 Seats)	Inspected
Condition	2 - Between Good and Fair
Deficiency	No deficiencies recorded
Stage Curtain Rigging	
Instance on 1st Floor (500 Seats)	Inspected
Condition	5 - Poor
Deficiency	INOPERABLE
Deficiency Location/Instance	Right Side
Deficiency Quantity	1
Quantity Uom	EACH

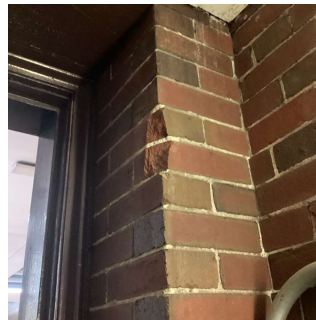
Exit 9 Vestibule

Deficiency	BRICK: CRACKS/SPALLING
Deficiency Location/Instance	Exit 9 Vestibule, Exit 10 Vestibule
Deficiency Quantity	20
Quantity Uom	S.F.
Potential Action	REPLACE
Urgency of Action	PRIORITY 3
Purpose of Action	LEVEL 2
Deficiency Photo1

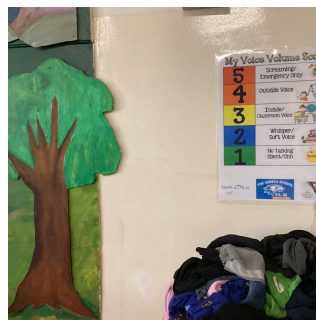
Deficiency	PLASTER: CRACKS/SPALLING
Deficiency Location/Instance	Right Side
Deficiency Quantity	10
Quantity Uom	S.F.
Potential Action	REPLACE
Urgency of Action	PRIORITY 3
Purpose of Action	LEVEL 2
Deficiency Photo1

Question	Response
INTERIOR	
AUDITORIUM	
Walls	
Violations	Right Side No violations recorded.
Window Curtains/Shades/Blinds	
Instance on 1st Floor (500 Seats)	Inspected
Condition	2 - Between Good and Fair
Deficiency	No deficiencies recorded
CAFETERIA	
Instance on Ground Floor	Inspected
Ceiling	
Instance on Ground Floor	Inspected
Condition	2 - Between Good and Fair
Deficiency	GYPSUM BOARD: DAMAGED/DETERIORATED
Deficiency Location/Instance	Center, Near Windows, near Serving area
Deficiency Quantity	30
Quantity Uom	S.F.
Potential Action	REPLACE
Urgency of Action	PRIORITY 3
Purpose of Action	LEVEL 2
Deficiency Photo1

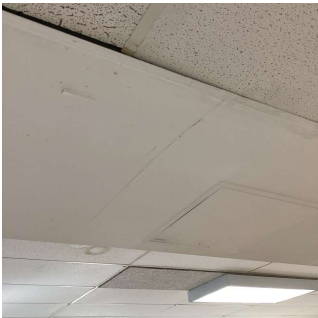
Violations	Center No violations recorded.
Deficiency	ACOUSTIC TILES: DAMAGED/MISSING
Deficiency Location/Instance	Near Windows, Near Entrance, Near Room 025, Near Exit 6, Near Serving area and others
Deficiency Quantity	80
Quantity Uom	S.F.
Potential Action	REPLACE
Urgency of Action	PRIORITY 3
Purpose of Action	LEVEL 2

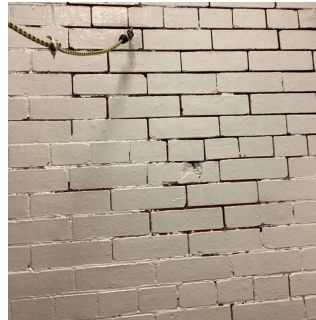
Exit 6 Vestibule

BRICK: CRACKS/SPALLING

REPLACE

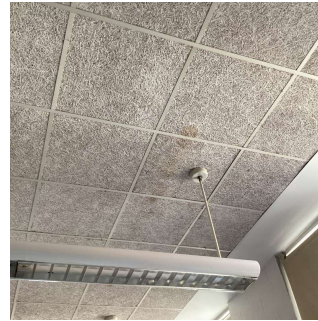
Room 127

TECTUM: DAMAGED/MISSING

REPLACE

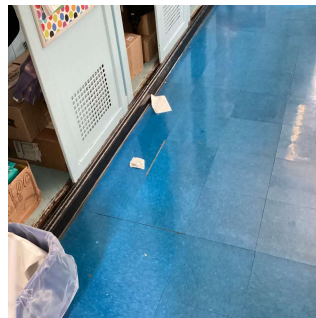
VINYL TILES: BROKEN/DETERIORATED/MISSING TILES

Question	Response
INTERIOR	
CLASSROOMS/CORRIDORS/ADMIN SPACES	
Floor Finish	
Violations	Room 401 No violations recorded.
Deficiency	VINYL TILES: DETERIORATED SUBSTRATE
Deficiency Location/Instance	Rooms 405, 404, 403, 401, 250 and others
Deficiency Quantity	60
Quantity Uom	S.F.
Potential Action	REPLACE
Urgency of Action	PRIORITY 3
Purpose of Action	LEVEL 2
Deficiency Photo1

REPLACE

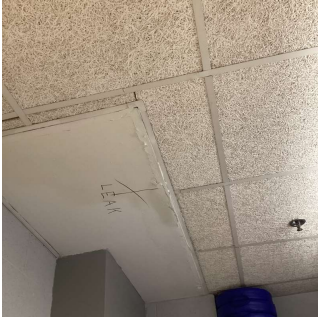
Corridor near Room 450
Violations	No violations recorded.
Specialties	Does not Exist
GYMNASIUM	Inspected
Instance on 1st Floor	Inspected
Ceiling	
Instance on 1st Floor	Inspected
Condition	2 - Between Good and Fair
Deficiency	GYP SUM BOARD: DAMAGED/DETERIORATED
Deficiency Location/Instance	Office
Deficiency Quantity	10
Quantity Uom	S.F.
Potential Action	REPLACE
Urgency of Action	PRIORITY 3
Purpose of Action	LEVEL 2
Deficiency Photo1

Office
Violations	No violations recorded.
Door(s)	
Instance on 1st Floor	Inspected
Condition	2 - Between Good and Fair

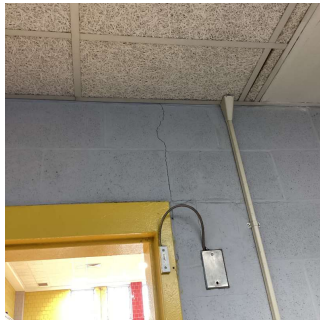
Question	Response
INTERIOR	
GYMNASIUM	
Door(s)	
Deficiency	No deficiencies recorded
Fixed Equipment	
Instance on 1st Floor	Inspected
Condition	2 - Between Good and Fair
Deficiency	No deficiencies recorded
Floor Finish	
Instance on 1st Floor	Inspected
Condition	2 - Between Good and Fair
Deficiency	No deficiencies recorded
Seating	
Instance on 1st Floor	Does not Exist
Sliding-folding Partition	
Instance on 1st Floor	Does not Exist
Stage	
Instance on 1st Floor	Does not Exist
Walls	
Instance on 1st Floor	Inspected
Condition	2 - Between Good and Fair
Deficiency	MASONRY: CRACKS/SPALLING
Deficiency Location/Instance	Office
Deficiency Quantity	10
Quantity Uom	S.F.
Potential Action	REPLACE
Urgency of Action	PRIORITY 3
Purpose of Action	LEVEL 2
Deficiency Photo1

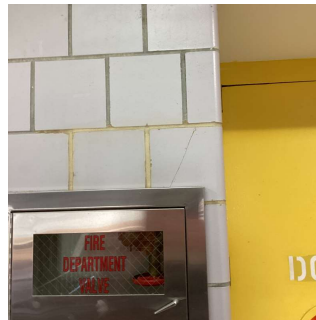
Stair A/1

GLAZED BLOCK: CRACKS/SPALLING

REPLACE

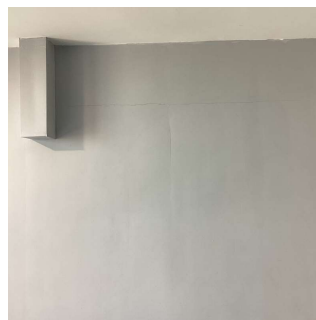
GYPSUM BOARD: DETERIORATED

Question	Response
INTERIOR	
STAIRS/RAMPS: INTERIOR	Inspected
Walls	Inspected
Violations	Stair B/4 No violations recorded.
TOILET ROOMS - STAFF	Inspected
Ceiling	Inspected
Condition	2 - Between Good and Fair
Deficiency	No deficiencies recorded
Door(s)	Inspected
Condition	5 - Poor
Deficiency	METAL: DETERIORATED DOOR
Deficiency Location/Instance	Rooms 119, 012
Deficiency Quantity	2
Quantity Uom	EACH
Potential Action	MAINTENANCE
Urgency of Action	PRIORITY 3
Purpose of Action	LEVEL 2
Deficiency Photo1

REPLACE

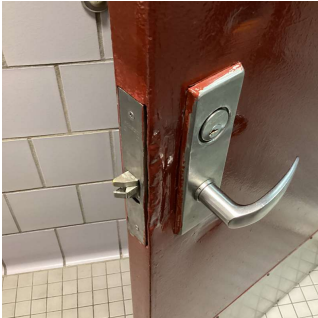
Violations	Room 119 No violations recorded.
Floor Finish	Inspected
Condition	2 - Between Good and Fair
Deficiency	No deficiencies recorded
Stalls	Inspected
Condition	2 - Between Good and Fair
Deficiency	No deficiencies recorded
Walls	Inspected
Condition	2 - Between Good and Fair
Deficiency	No deficiencies recorded
TOILET ROOMS - STUDENTS	Inspected
Ceiling	Inspected
Condition	2 - Between Good and Fair
Deficiency	GYPSUM BOARD: DAMAGED/DETERIORATED

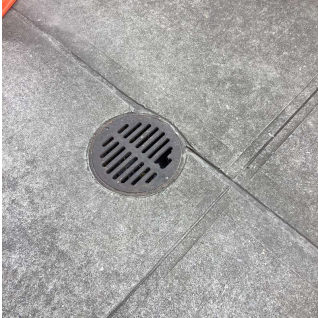
Question	Response
SITE	
Drainage System for Asphalt	Inspected
Catch Basins/Manhole - Surrounded by asphalt	Inspected
Condition	2 - Between Good and Fair
Deficiency	No deficiencies recorded
Culverts - Asphalt Covering	Does not Exist
Drainage System for Concrete	Inspected
Catch Basins/Manhole - Surrounded by concrete	Inspected
Condition	3 - Fair
Deficiency	DAMAGED COVER
Deficiency Location/Instance	Fresh-Pond Road
Deficiency Quantity	1
Quantity Uom	EACH
Potential Action	REPLACE
Urgency of Action	PRIORITY 3
Purpose of Action	LEVEL 2
Deficiency Photo1

Fresh-Pond Road
Violations	No violations recorded.
Culverts - Concrete Covering	Does not Exist
Drainage System for Soil	Does not Exist
DRINKING FOUNTAINS	Does not Exist
FENCES	Inspected
Condition	4 - Between Fair and Poor
Deficiency	CONCRETE CURB: DAMAGED/DETERIORATED
Deficiency Location/Instance	Catalpa Avenue
Deficiency Quantity	40
Quantity Uom	S.F.
Potential Action	REPLACE

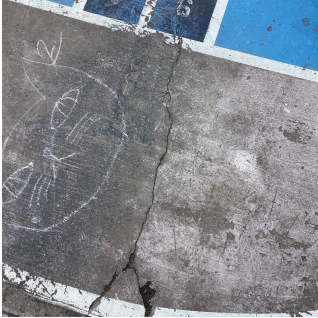
Question	Response
SITE	
PAVING	
Student Use	
Concrete	
Urgency of Action	PRIORITY 3
Purpose of Action	LEVEL 2
Deficiency Photo1

Violations	Schoolyard No violations recorded.
Pavers	Does not Exist
Site Sidewalks & Walkways	Inspected
Asphalt	Does not Exist
Concrete	Inspected
Condition	3 - Fair
Deficiency	CRACKS - MAJOR
Deficiency Location/Instance	Exit 4
Deficiency Quantity	50
Quantity Uom	S.F.
Potential Action	REPLACE
Urgency of Action	PRIORITY 3
Purpose of Action	LEVEL 2
Deficiency Photo1	 
Violations	Exit 4 No violations recorded.
Pavers	Inspected
Condition	2 - Between Good and Fair
Deficiency	DAMAGED/MISSING
Deficiency Location/Instance	Near Exits 1, 2, 3
Deficiency Quantity	40
Quantity Uom	S.F.
Potential Action	REPLACE
Urgency of Action	PRIORITY 3
Purpose of Action	LEVEL 2

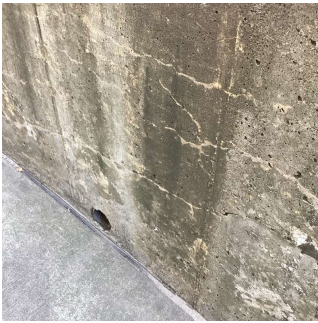
Question	Response
SITE	
RETAINING WALLS	
Purpose of Action	LEVEL 2
Deficiency Photo1

Violations	68th Road No violations recorded.
SEATING	Inspected
Benches	Inspected
Concrete	Inaccessible
Metal/Wood/Plastic	Inaccessible
Bleachers	Does not Exist
SITE WALLS (NOT RETAINING WALLS)	Does not Exist
STAIRS/RAMPS: EXTERIOR	Inaccessible
ARTWORK	Inspected
Instance	Interior - Entrance Stairs - 50006
Instance Photo
