NYC Department of Education
Building Condition Assessment Survey 2023 - 2024

Architectural Inspection

Asset: P.S. 95 - QUEENS, 179-01 90TH AVENUE, New York, 11432

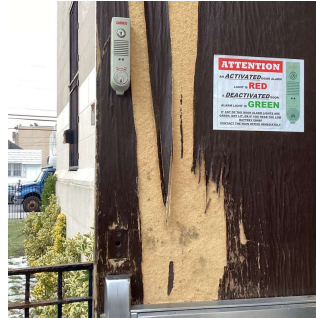
Facade K

METAL CLAD: DETERIORATED DOOR AND FRAME - MAJOR DETERIORATION

Quantity Uom	EACH
Potential Action	REPLACE
Urgency of Action	PRIORITY 4
Purpose of Action	LEVEL 2
Deficiency Photo1

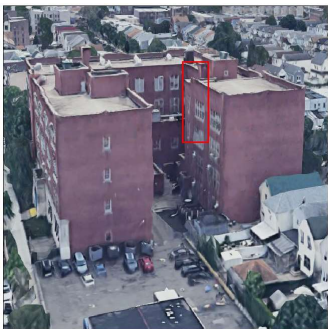
Question	Response
EXTERIOR	
DOORS	Inspected
TRANSOM/SIDE LIGHT	
Violations	Facade B No violations recorded.
EXTERIOR WALLS	Inspected
Material Type(s)	Masonry
Replacement Quantity	43,000
Replacement Uom	S.F.
Instance on All Facades	Inspected
Instance Condition	3 - Fair
Instance Quantity	43,000
Instance Quantity Uom	S.F.
Deficiency	BRICK: DETERIORATED JOINTS
Roof Plan reference	Q095

Deficiency Quantity	400
Quantity Uom	S.F.
Potential Action	REPOINT
Urgency of Action	PRIORITY 3
Purpose of Action	LEVEL 2
Deficiency Photo1

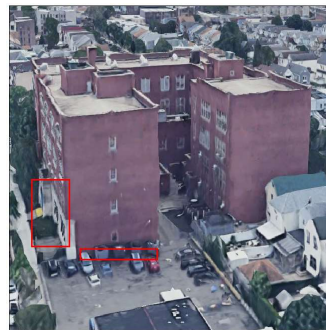
STUCCO CEMENT SURFACE: CRACKS, SPALLING

S.F.
REPLACE
PRIORITY 4
LEVEL 2

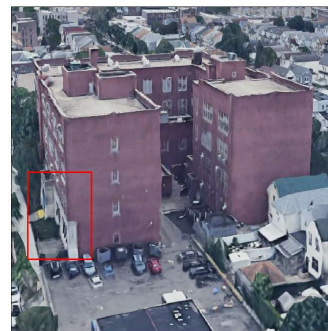
STONE: CHIPPED/SPALLED/BROKEN PIECES - MINOR

100
S.F.
REPAIR
PRIORITY 3
LEVEL 2

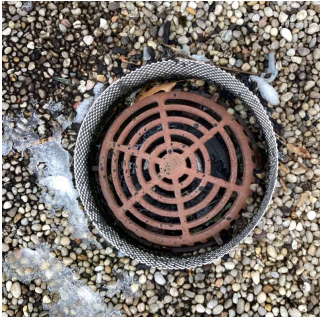
DETERIORATED

5
EACH
REPLACE
PRIORITY 4
LEVEL 2

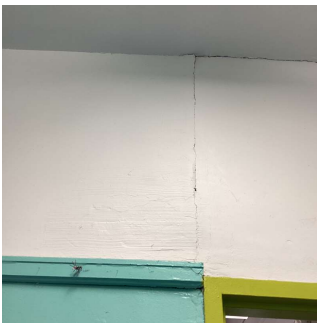
Question	Response
INTERIOR	
CLASSROOMS/CORRIDORS/ADMIN SPACES	
Walls	
Deficiency Photo1

Violations	Corridor near Room 317 No violations recorded.
Specialties	Does not Exist
GYMNASIUM	
Instance on 4th Floor	Inspected
Ceiling	Inspected
Instance on 4th Floor	Inspected
Condition	2 - Between Good and Fair
Deficiency	No deficiencies recorded
Door(s)	Inspected
Instance on 4th Floor	Inspected
Condition	2 - Between Good and Fair
Deficiency	No deficiencies recorded
Fixed Equipment	Inspected
Instance on 4th Floor	Inspected
Condition	2 - Between Good and Fair
Deficiency	No deficiencies recorded
Floor Finish	Inspected
Instance on 4th Floor	Inspected
Condition	2 - Between Good and Fair
Deficiency	No deficiencies recorded
Seating	Does not Exist
Instance on 4th Floor	Does not Exist
Sliding-folding Partition	Does not Exist
Instance on 4th Floor	Does not Exist
Stage	Does not Exist
Instance on 4th Floor	Does not Exist
Walls	Inspected

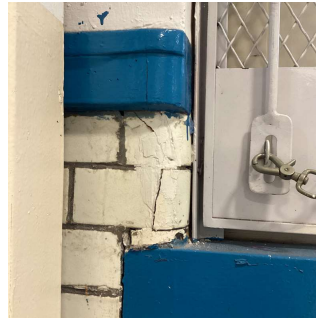
Near Windows

BRICK: CRACKS/SPALLING

REPLACE

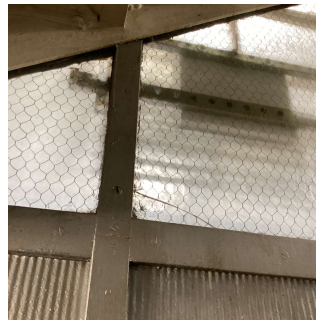
Stair AB/1

GLASS PANEL: DAMAGED/DETERIORATED

REPLACE

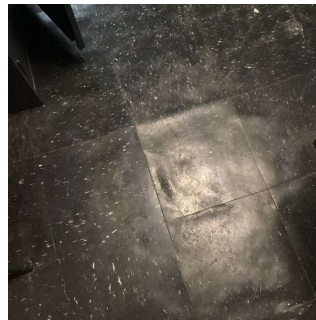
Kitchen

STONE: BROKEN/MISSING TILES

REPLACE

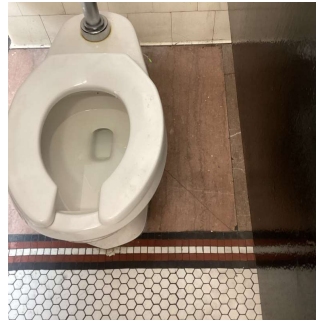
Girls 4th Floor

CERAMIC TILE: BROKEN/MISSING TILES

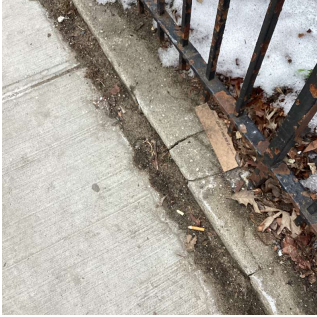
Violations	90th Avenue No violations recorded.
Deficiency	CONCRETE CURB: DAMAGED/DETERIORATED
Deficiency Location/Instance	90th Street, 179th Place, 179th Street
Deficiency Quantity	375
Quantity Uom	S.F.
Potential Action	REPLACE
Urgency of Action	PRIORITY 3
Purpose of Action	LEVEL 2
Deficiency Photo1

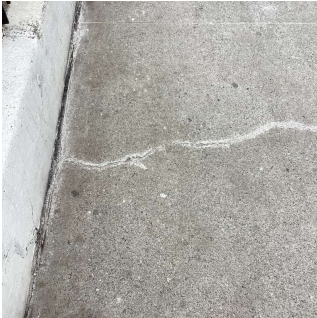
Question	Response
SITE	
PAVING	
Site Sidewalks & Walkways	
Asphalt	Inspected
Violations	No violations recorded.
Concrete	Inspected
Condition	3 - Fair
Deficiency	DAMAGED/DETERIORATED/MISSING SECTIONS
Deficiency Location/Instance	Near Exit 1
Deficiency Quantity	50
Quantity Uom	S.F.
Potential Action	REPLACE
Urgency of Action	PRIORITY 3
Purpose of Action	LEVEL 2
Deficiency Photo1

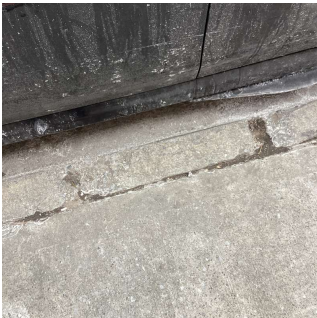
Violations	Near Exit 1 No violations recorded.
Pavers	Does not Exist
DOT Sidewalk	Inspected
Asphalt	Does not Exist
Concrete	Inspected
Condition	3 - Fair
Deficiency	DAMAGED CURBS
Deficiency Location/Instance	90th Street, 179th Place, 179th Street
Deficiency Quantity	245
Quantity Uom	L.F.
Potential Action	REPLACE
Urgency of Action	PRIORITY 3
Purpose of Action	LEVEL 2
Deficiency Photo1
