NYC Department of Education
Building Condition Assessment Survey 2023 - 2024

Architectural Inspection

Asset: P.S. 101 - QUEENS, 2 RUSSELL PLACE, New York, 11375

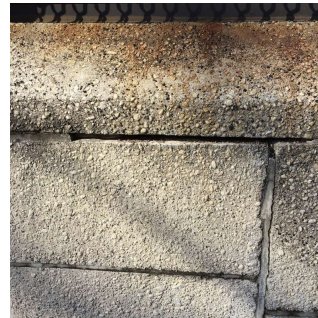
Facade H

STONE: DETERIORATED JOINTS

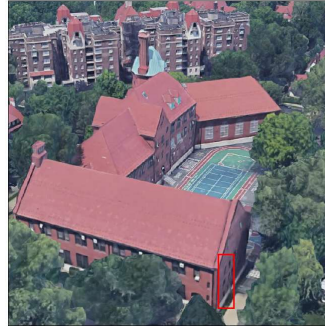
BRICK: DETERIORATED CONTROL/EXPANSION JOINTS

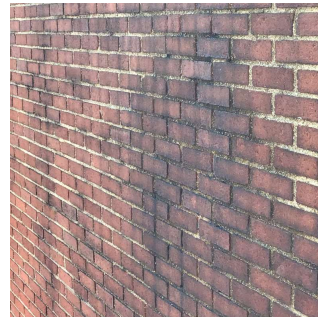
Facade A

BRICK: DETERIORATED JOINTS

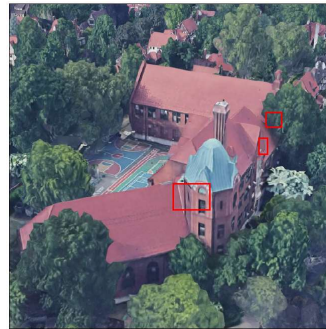
BROKEN/ DENTED BLADES

40
S.F.
REPLACE
PRIORITY 4
LEVEL 2

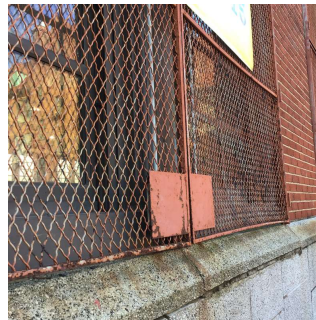
EXTERIOR GUARDS

500
S.F.
REPLACE
PRIORITY 4
LEVEL 2

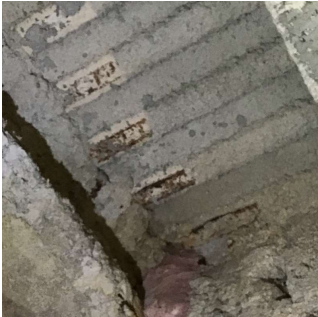
Basement - Vault
Violations	No violations recorded.
Slab Structure	Inspected
Condition	3 - Fair
Deficiency	METAL DECK AND CONCRETE: DETERIORATED
Deficiency Location/Instance	Basement - Vault
Deficiency Quantity	30
Quantity Uom	S.F.
Potential Action	REPAIR
Urgency of Action	PRIORITY 3
Purpose of Action	LEVEL 5

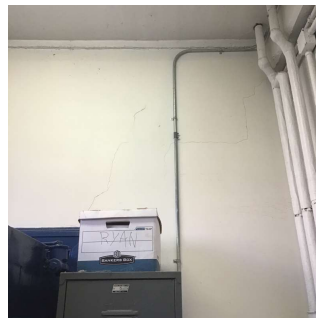
Vestibule Right of Stage

PLASTER: CRACKS/SPALLING

REPLACE

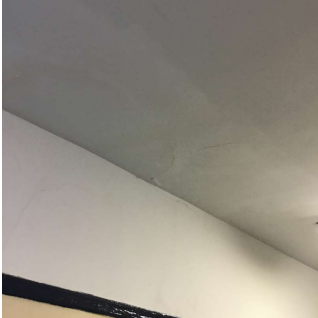
Question	Response
INTERIOR	
CAFETERIA	
Floor Finish	
Deficiency Photo1	 
Violations	Near Main Entrance No violations recorded.
Sliding-folding Partition	
Instance on 2nd Floor	Does not Exist
Stage	
Instance on 2nd Floor	Does not Exist
Walls	
Instance on 2nd Floor	Inspected
Condition	2 - Between Good and Fair
Deficiency	No deficiencies recorded
Window Curtains/Shades/Blinds	
Instance on 2nd Floor	Does not Exist
CLASSROOMS/CORRIDORS/ADMIN SPACES	
Ceiling	Inspected
Condition	2 - Between Good and Fair
Deficiency	ACOUSTIC TILES ON PLASTER: DAMAGED/MISSING
Deficiency Location/Instance	Room 303
Deficiency Quantity	25
Quantity Uom	S.F.
Potential Action	REPLACE
Urgency of Action	PRIORITY 3
Purpose of Action	LEVEL 2
Deficiency Photo1	 
Violations	Room 303 No violations recorded.
Deficiency	PLASTER: CRACKS/SPALLING
Deficiency Location/Instance	Corridor near room 262
Deficiency Quantity	15
Quantity Uom	S.F.
Potential Action	REPLACE

Violations	Corridor near room 262 No violations recorded.
Door(s)	
Condition	Inspected 5 - Poor
Deficiency	WOOD: DETERIORATED DOOR
Deficiency Location/Instance	Rooms 103, 204,303, 304, 307
Deficiency Quantity	5
Quantity Uom	EACH
Potential Action	MAINTENANCE
Urgency of Action	PRIORITY 3
Purpose of Action	LEVEL 2
Deficiency Photo1

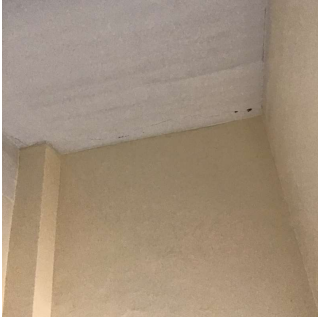
Question	Response
INTERIOR	
SCIENCE PREP ROOM	Does not Exist
SHOWER ROOM	Inspected
Instance on 1st Floor	Inaccessible
STAIRS/RAMPS: INTERIOR	Inspected
Do Letter Stair Signs Exist?	Yes
Ceiling	Inspected
Condition	2 - Between Good and Fair
Deficiency	PLASTER: CRACKS/SPALLING
Deficiency Location/Instance	Stair D/2
Deficiency Quantity	20
Quantity Uom	S.F.
Potential Action	REPLACE
Urgency of Action	PRIORITY 3
Purpose of Action	LEVEL 2
Deficiency Photo1

Violations	Stair D/2 No violations recorded.
Door(s)	Inspected
Condition	2 - Between Good and Fair
Deficiency	No deficiencies recorded
Partition	Does not Exist
Railings	Inspected
Condition	2 - Between Good and Fair
Deficiency	No deficiencies recorded
Stairs and Landings	Inspected
Condition	3 - Fair
Deficiency	STONE: WORN-OUT TREAD/NOSINGS
Deficiency Location/Instance	Main Lobby, Exit 3 Vestibule
Deficiency Quantity	185
Quantity Uom	S.F.
Potential Action	REPLACE
Urgency of Action	PRIORITY 3

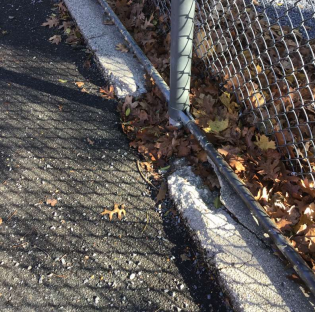
Violations	Rear Schoolyard No violations recorded.
Deficiency	CONCRETE CURB: DAMAGED/DETERIORATED
Deficiency Location/Instance	Rear Schoolyard
Deficiency Quantity	60
Quantity Uom	S.F.
Potential Action	REPLACE
Urgency of Action	PRIORITY 3
Purpose of Action	LEVEL 2
Deficiency Photo1

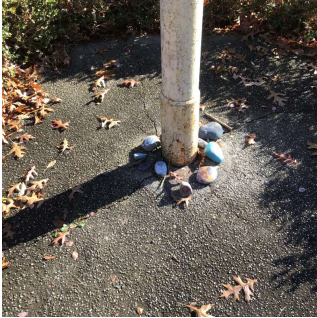
Question	Response
SITE	
IRRIGATION SYSTEM	Does not Exist
PAVING	Inspected
Student Non-Use	Inspected
Gravel Exists?	No
Asphalt	Does not Exist
Concrete	Inspected
Condition	2 - Between Good and Fair
Deficiency	CRACKS - MAJOR
Deficiency Location/Instance	Flag Post Walkway
Deficiency Quantity	25
Quantity Uom	S.F.
Potential Action	REPLACE
Urgency of Action	PRIORITY 3
Purpose of Action	LEVEL 2
Deficiency Photo1

Flag Post Walkway
Violations	No violations recorded.
Pavers	Does not Exist
Student Use	Inspected
Gravel Exists?	No
Asphalt	Inspected
Condition	4 - Between Fair and Poor
Deficiency	CRACKS - MAJOR
Deficiency Location/Instance	Along Schoolyard
Deficiency Quantity	2,500
Quantity Uom	S.F.
Potential Action	REPLACE
Urgency of Action	PRIORITY 3
Purpose of Action	LEVEL 2
Deficiency Photo1

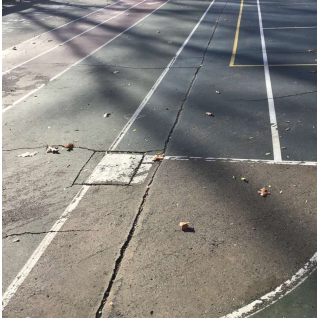
Along Schoolyard
Violations	No violations recorded.
Concrete	Inspected

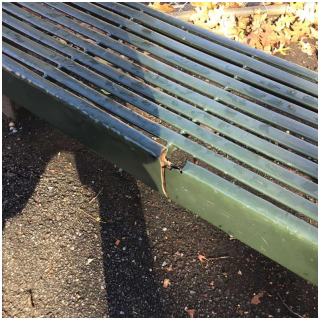
Violations	Along Slocum Crescent No violations recorded.
Pavers	Inspected
Condition	2 - Between Good and Fair
Deficiency	No deficiencies recorded
PLAYGROUNDS	Inspected
Instance on Schoolyard	Inspected
Benches	
Instance on Schoolyard	Inspected
Condition	5 - Poor
Deficiency	DAMAGED/DETERIORATED
Deficiency Location/Instance	Left Side
Deficiency Quantity	1
Quantity Uom	EACH
Potential Action	REPLACE
Urgency of Action	PRIORITY 5
Purpose of Action	LEVEL 6
Deficiency Photo1

Violations	Left Side No violations recorded.
Deficiency	DAMAGED/DETERIORATED
Deficiency Location/Instance	Right Side
Deficiency Quantity	2
Quantity Uom	EACH
Potential Action	REPLACE
Urgency of Action	PRIORITY 3
Purpose of Action	LEVEL 2
