NYC Department of Education
Building Condition Assessment Survey 2023 - 2024

Architectural Inspection

Asset: P.S. 163 - QUEENS, 159-01 59 AVENUE, New York, 11365

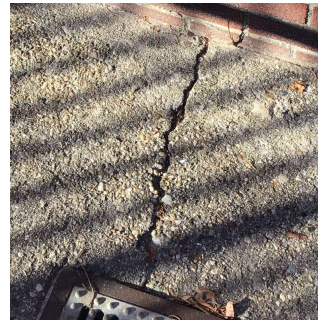
AW4
No violations recorded.

AREAWAY SLAB: CRACKS AND SPALLING

20
S.F.
REPLACE
PRIORITY 4
LEVEL 2

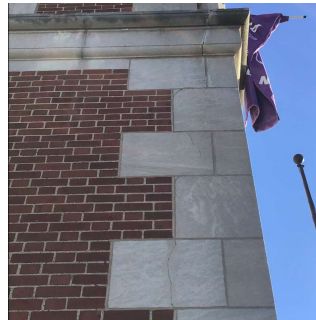
Facade B

STONE: CRACKS AT BUILDING CORNERS

REPLACE

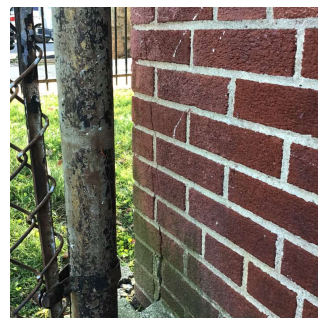
BRICK: CRACKS/DISPLACED/SPALLED BRICK AT BUILDING CORNERS

40
S.F.
REMOVE AND REBUILD
PRIORITY 4
LEVEL 2

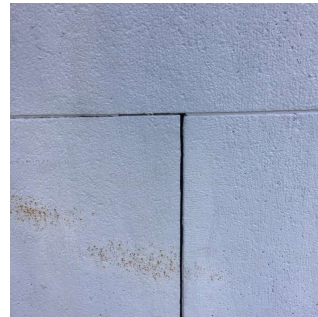
Facade B

STONE: DETERIORATED JOINTS

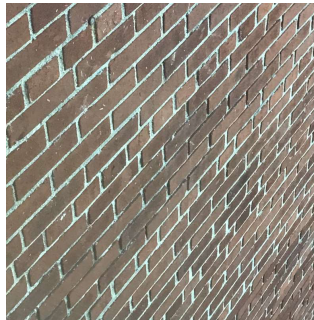
Facade B

BRICK: DETERIORATED JOINTS

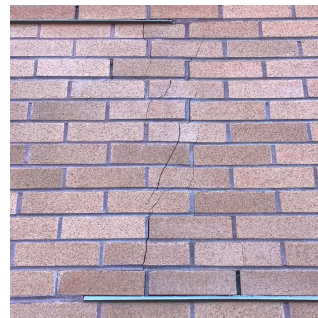
Facade K

BRICK: MAJOR / THRU CRACKS

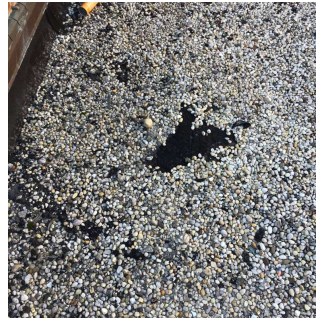
Roof 1

BUILT-UP: FLASHING: DRIP EDGE/GRAVEL STOP DAMAGED

REPLACE

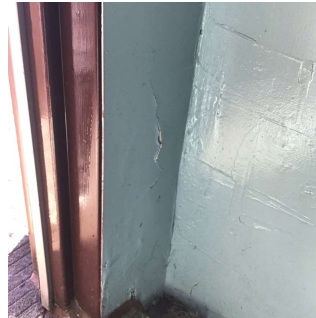
BH2

BULKHEAD/PENTHOUSE WALLS/EXTERIOR: DETERIORATED JOINTS

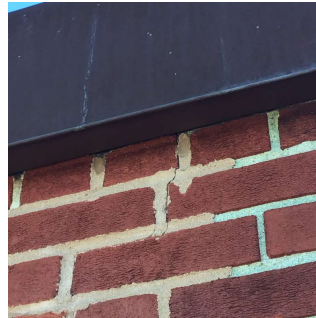
BH1

**BULKHEAD/PENTHOUSE WALLS/EXTERIOR:
 CRACKS/SPALLING - MINOR**

20
 S.F.
 REPAIR
 PRIORITY 3
 LEVEL 2

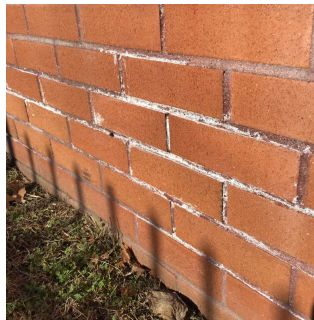
Facade A

Deficiency	BRICK: DETERIORATED JOINTS
------------	----------------------------

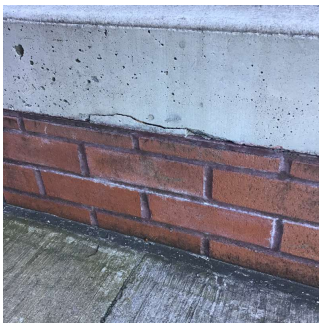
Deficiency	CAST IN PLACE CONCRETE: CRACKS/SPALLING - MINOR
------------	---

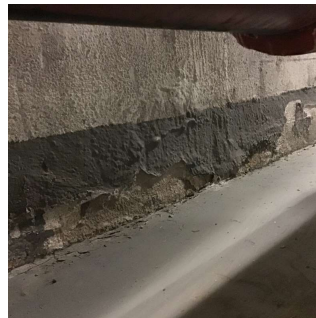
Boiler Room

CONCRETE: WATER INFILTRATION IN NON- INSTRUCTIONAL SPACE

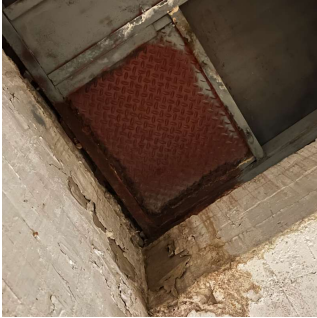
Question	Response
INTERIOR	
STRUCTURAL	
VAULTS-BUNKERS	
Slab Structure	Inspected
Violations	No violations recorded.
Vault/Ash Hoist Doors and Framing	Inspected
Condition	5 - Poor
Deficiency	DETERIORATED/DAMAGED VAULT/ASH HOIST DOORS AND FRAMING
Deficiency Location/Instance	Vault
Deficiency Quantity	3
Quantity Uom	EACH
Potential Action	REPLACE
Urgency of Action	PRIORITY 4
Purpose of Action	LEVEL 2
Deficiency Photo1

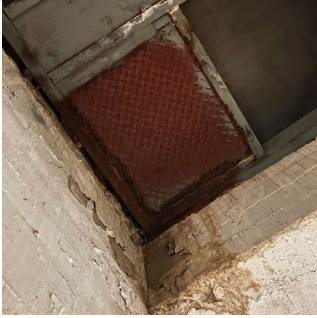
Violations	No violations recorded.
Deficiency	WATER INFILTRATION
Deficiency Location/Instance	Vault
Deficiency Quantity	10
Quantity Uom	S.F.
Potential Action	REPAIR
Urgency of Action	PRIORITY 5
Purpose of Action	LEVEL 2
Deficiency Photo1

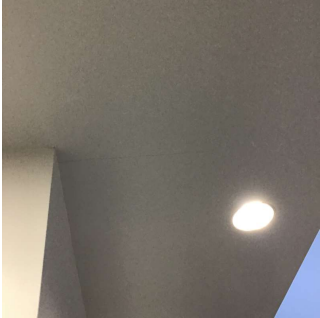
Near Entrance

Deficiency	GYPSUM BOARD: DAMAGED/DETERIORATED
------------	------------------------------------

Potential Action	REPLACE
------------------	---------

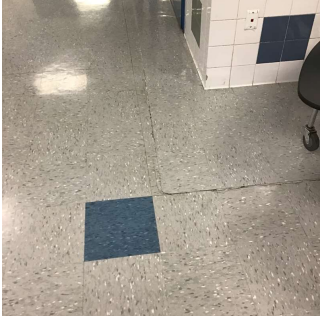
Near a room C003F

Deficiency	VINYL TILES: DETERIORATED SUBSTRATE
------------	-------------------------------------

Potential Action	REPLACE
------------------	---------

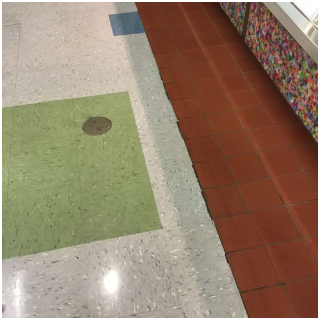
Question	Response
INTERIOR	
CAFETERIA	
Floor Finish	
Violations	No violations recorded.
Deficiency	VINYL TILES: BROKEN/DETERIORATED/MISSING TILES
Deficiency Location/Instance	Near Serving area, Center
Deficiency Quantity	10
Quantity Uom	S.F.
Potential Action	REPLACE
Urgency of Action	PRIORITY 3
Purpose of Action	LEVEL 2
Deficiency Photo1

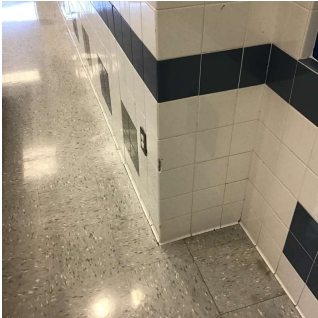
Violations	Near Serving area No violations recorded.
Sliding-folding Partition	
Instance on Basement	Does not Exist
Stage	
Instance on Basement	Does not Exist
Walls	
Instance on Basement	Inspected
Condition	2 - Between Good and Fair
Deficiency	CERAMIC TILE: BROKEN/ MISSING
Deficiency Location/Instance	Right Side, Near Main Entrance
Deficiency Quantity	20
Quantity Uom	S.F.
Potential Action	REPLACE
Urgency of Action	PRIORITY 3
Purpose of Action	LEVEL 2
Deficiency Photo1

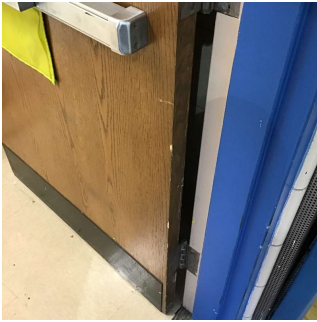
Question	Response
INTERIOR	
GYMNASIUM	
Ceiling	
Deficiency Photo1	 
Violations	Right Side Near Windows No violations recorded.
Door(s)	
Instance on 1st Floor	Inspected
Condition	5 - Poor
Deficiency	WOOD: DETERIORATED DOOR
Deficiency Location/Instance	Main Entrance, Small Storage Room
Deficiency Quantity	4
Quantity Uom	EACH
Potential Action	MAINTENANCE
Urgency of Action	PRIORITY 3
Purpose of Action	LEVEL 2
Deficiency Photo1

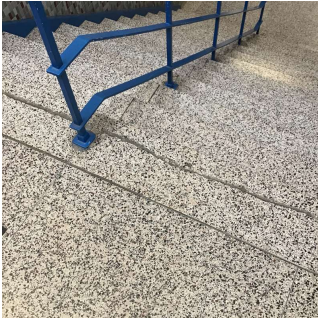
Question	Response
INTERIOR	
STAIRS/RAMPS: INTERIOR	
Stairs and Landings	
Deficiency	TERRAZZO: CRACKS
Deficiency Location/Instance	Stair H/Basement, Corridor near Gymnasium
Deficiency Quantity	20
Quantity Uom	S.F.
Potential Action	REPLACE
Urgency of Action	PRIORITY 3
Purpose of Action	LEVEL 2
Deficiency Photo1

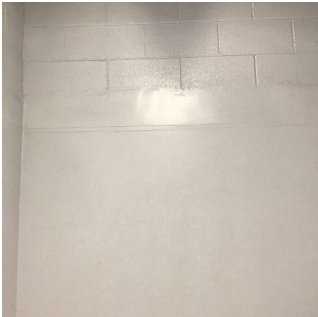
Violations	Stair H/Basement No violations recorded.
Walls	Inspected
Condition	2 - Between Good and Fair
Deficiency	GYPSUM BOARD: DETERIORATED
Deficiency Location/Instance	Stair E/1
Deficiency Quantity	10
Quantity Uom	S.F.
Potential Action	REPLACE
Urgency of Action	PRIORITY 3
Purpose of Action	LEVEL 2
Deficiency Photo1

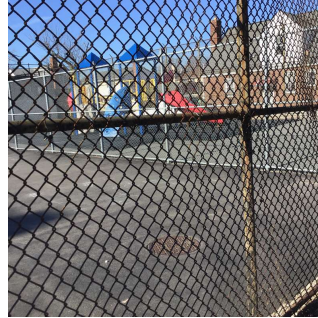
160th Street
Violations	No violations recorded.
Deficiency	CHAIN LINK: RUST - MAJOR
Deficiency Location/Instance	160th Street, Schoolyard
Deficiency Quantity	2,100
Quantity Uom	S.F.

REPLACE
PRIORITY 3
LEVEL 2

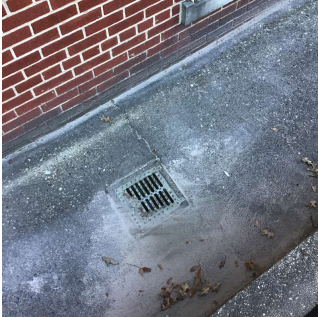
Question	Response
SITE	
FENCES	Inspected
	59th Avenue
Violations	No violations recorded.
IRRIGATION SYSTEM	Does not Exist
PAVING	Inspected
Student Non-Use	Inspected
Gravel Exists?	No
Asphalt	Does not Exist
Concrete	Inspected
Condition	2 - Between Good and Fair
Deficiency	CRACKS - MAJOR
Deficiency Location/Instance	160th Street
Deficiency Quantity	25
Quantity Uom	S.F.
Potential Action	REPLACE
Urgency of Action	PRIORITY 3
Purpose of Action	LEVEL 2
Deficiency Photo1

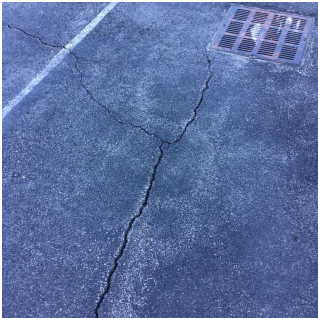
160th Street
Violations	No violations recorded.
Pavers	Does not Exist
Student Use	Inspected
Gravel Exists?	No
Asphalt	Inspected
Condition	4 - Between Fair and Poor
Deficiency	CRACKS - MAJOR
Deficiency Location/Instance	Schoolyard
Deficiency Quantity	2,200
Quantity Uom	S.F.
Potential Action	REPLACE
Urgency of Action	PRIORITY 3
Purpose of Action	LEVEL 2

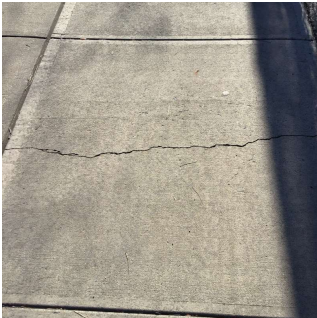
160th Street
Violations	No violations recorded.
Deficiency	DAMAGED/DETERIORATED/MISSING SECTIONS
Deficiency Location/Instance	160th Street, 159th Street, 59th Avenue
Deficiency Quantity	200
Quantity Uom	S.F.
Potential Action	REPLACE
Urgency of Action	PRIORITY 3
Purpose of Action	LEVEL 2
Deficiency Photo1
