**NYC Department of Education**  
**Building Condition Assessment Survey 2023 - 2024**

Architectural Inspection

**Asset:** P.S. 195 - QUEENS, 253-50 149 AVENUE, New York, 11422

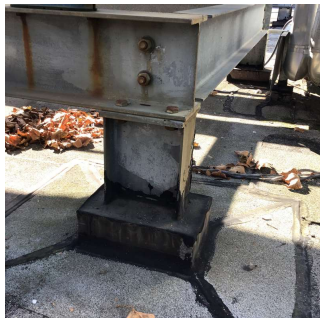
Violations	Penthouse No violations recorded.
<b>CUPOLA/ SPIRES/ TOWERS</b>	Does not Exist
<b>DORMER</b>	Does not Exist
<b>DUNNAGE STEEL</b>	Inspected
Condition	3 - Fair
Deficiency	HEIGHT LESS THAN 18"
Roof Plan reference	Q195
Deficiency Quantity	100
Quantity Uom	L.F.
Potential Action	REPLACE
Urgency of Action	PRIORITY 3
Purpose of Action	LEVEL 2
Deficiency Photo1

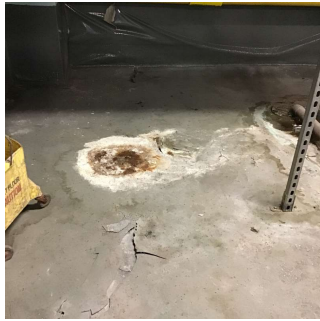
Question	Response
<b>INTERIOR</b>	
<b>STRUCTURAL</b>	Inspected
<b>COLUMNS/BEAMS/BEARING WALLS</b>	Inspected
Condition	2 - Between Good and Fair
Deficiency	No deficiencies recorded
<b>FLOOR STRUCTURE</b>	Inspected
Condition	5 - Poor
Deficiency	CONCRETE SLAB ON GRADE: WATER INFILTRATION IN NON-INSTRUCTIONAL SPACE
Deficiency Location/Instance	Basement - Boiler Room
Deficiency Quantity	300
Quantity Uom	S.F.
Potential Action	INSTALL WATERPROOFING
Urgency of Action	PRIORITY 5
Purpose of Action	LEVEL 5
Deficiency Photo1

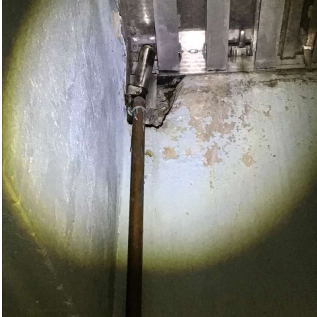
Question	Response
<b>INTERIOR</b>	
<b>STRUCTURAL</b>	
<b>FOUNDATION WALLS</b>	
Quantity Uom	S.F.
Potential Action	INSTALL WATERPROOFING
Urgency of Action	PRIORITY 5
Purpose of Action	LEVEL 5
Deficiency Photo1	 
Violations	Basement - Room 013 No violations recorded.
Deficiency	BRICK: WATER INFILTRATION IN ELECTRICAL PANEL ROOM
Deficiency Location/Instance	Basement - Electrical Panel Room
Deficiency Quantity	100
Quantity Uom	S.F.
Potential Action	INSTALL WATERPROOFING
Urgency of Action	PRIORITY 5
Purpose of Action	LEVEL 6
Deficiency Photo1	 
Violations	Basement - Electrical Panel Room No violations recorded.
<b>ROOF STRUCTURE</b>	
Condition	Inspected
Deficiency	2 - Between Good and Fair
Deficiency	No deficiencies recorded
<b>VAULTS-BUNKERS</b>	
Condition	Inspected
Deficiency	Inspected
Condition	3 - Fair
Deficiency	CRACKS, SPALLING
Deficiency Location/Instance	Basement - Ash Hoist Vault
Deficiency Quantity	10
Quantity Uom	S.F.

Potential Action	REPAIR
Urgency of Action	PRIORITY 4
Purpose of Action	LEVEL 5

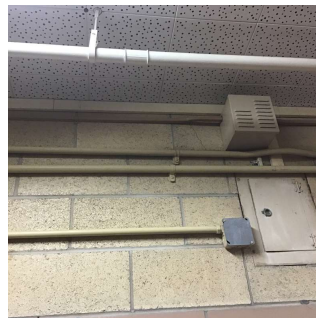
MASONRY: CRACKS/SPALLING

REPLACE

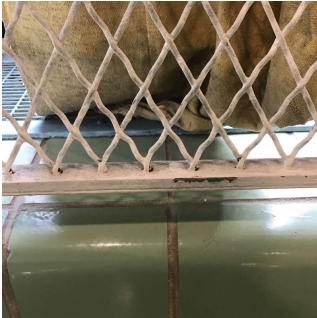
Violations	Along Windows No violations recorded.
<b>Window Curtains/Shades/Blinds</b>	
Instance on 1st Floor	Inspected
Condition	3 - Fair
Deficiency	WORN/DAMAGED CURTAINS
Deficiency Location/Instance	Along Windows
Deficiency Quantity	200
Quantity Uom	S.F.
Potential Action	MAINTENANCE
Urgency of Action	PRIORITY 3
Purpose of Action	LEVEL 2
Deficiency Photo1

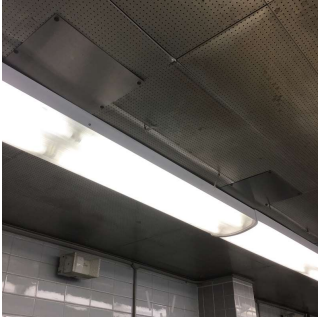
Question	Response
<b>INTERIOR</b>	
<b>KITCHEN</b>	Inspected
Instance on 1st Floor	Inspected
<b>Ceiling</b>	
Instance on 1st Floor	Inspected
Condition	3 - Fair
Deficiency	METAL PAN: DAMAGED/MISSING
Deficiency Location/Instance	Front, Center
Deficiency Quantity	40
Quantity Uom	S.F.
Potential Action	REPLACE
Urgency of Action	PRIORITY 3
Purpose of Action	LEVEL 2
Deficiency Photo1

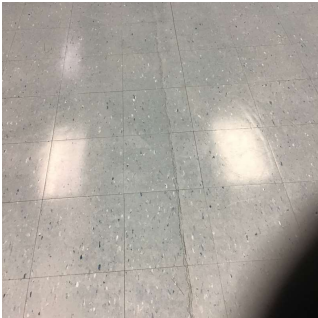
Question	Response
<b>INTERIOR</b>	
<b>MULTI-PURPOSE ROOM</b>	
<b>Door(s)</b>	
Condition	2 - Between Good and Fair
Deficiency	No deficiencies recorded
<b>Fixed Equipment</b>	
Instance on 1st Floor(1500SF)	Does not Exist
<b>Floor Finish</b>	
Instance on 1st Floor(1500SF)	Inspected
Condition	3 - Fair
Deficiency	VINYL TILES: DETERIORATED SUBSTRATE
Deficiency Location/Instance	Center, Rear, Front
Deficiency Quantity	100
Quantity Uom	S.F.
Potential Action	REPLACE
Urgency of Action	PRIORITY 3
Purpose of Action	LEVEL 2
Deficiency Photo1

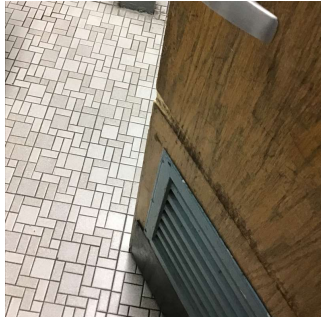
Question	Response
<b>INTERIOR</b>	
<b>STAIRS/RAMPS: INTERIOR</b>	Inspected
<b>Walls</b>	Inspected
Violations	No violations recorded.
<b>TOILET ROOMS - STAFF</b>	Inspected
<b>Ceiling</b>	Inspected
Condition	2 - Between Good and Fair
Deficiency	No deficiencies recorded
<b>Door(s)</b>	Inspected
Condition	5 - Poor
Deficiency	WOOD: DETERIORATED DOOR
Deficiency Location/Instance	Room 101, 102
Deficiency Quantity	2
Quantity Uom	EACH
Potential Action	MAINTENANCE
Urgency of Action	PRIORITY 3
Purpose of Action	LEVEL 2
Deficiency Photo1

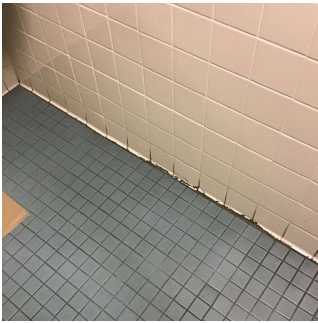
Question	Response
<b>INTERIOR</b>	
<b>TOILET ROOMS - STAFF</b>	
<b>Walls</b>	
Deficiency Photo1

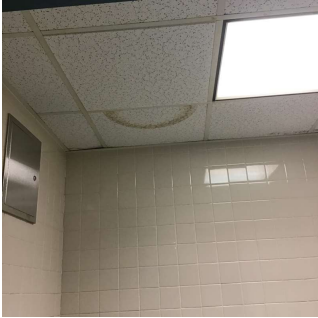
Violations	Room 207-1 No violations recorded.
<b>TOILET ROOMS - STUDENTS</b>	
<b>Ceiling</b>	Inspected
Condition	2 - Between Good and Fair
Deficiency	ACOUSTIC TILES: DAMAGED/MISSING
Deficiency Location/Instance	Inside Rooms 138, 142, 236, 240, 247 and others
Deficiency Quantity	120
Quantity Uom	S.F.
Potential Action	REPLACE
Urgency of Action	PRIORITY 3
Purpose of Action	LEVEL 2
Deficiency Photo1

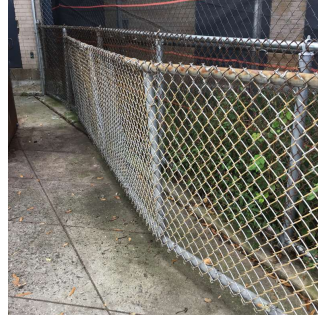
Question	Response
<b>INTERIOR</b>	
<b>TOILET ROOMS - STUDENTS</b>	
<b>Door(s)</b>	
Deficiency Photo1	 
	Room 123
Violations	No violations recorded.
<b>Floor Finish</b>	Inspected
Condition	2 - Between Good and Fair
Deficiency	No deficiencies recorded
<b>Stalls</b>	Inspected
Condition	2 - Between Good and Fair
Deficiency	No deficiencies recorded
<b>Walls</b>	Inspected
Condition	2 - Between Good and Fair
Deficiency	CERAMIC TILE: BROKEN/ MISSING
Deficiency Location/Instance	Room 213, 223, 240
Deficiency Quantity	30
Quantity Uom	S.F.
Potential Action	REPLACE
Urgency of Action	PRIORITY 3
Purpose of Action	LEVEL 2
Deficiency Photo1	 
	Room
Violations	No violations recorded.
<b>LIFE SAFETY</b>	Inspected
<b>F.D. HOLDING AREA</b>	Does not Exist
<b>STEEL STAIRS</b>	Does not Exist
<b>SITE</b>	Inspected
<b>CONTAINERIZATION</b>	Inspected
Condition	5 - Poor
Deficiency	FENCING DAMAGED
Deficiency Location/Instance	Along Weller Lane
Deficiency Quantity	450

Potential Action  
Urgency of Action  
Purpose of Action  
Deficiency Photo1

REPAIR  
PRIORITY 3  
LEVEL 2

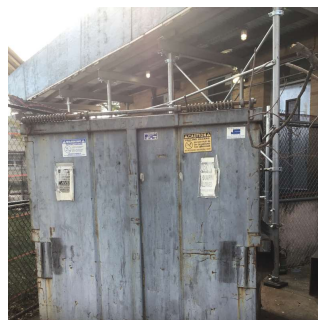
CONTAINER DAMAGED  
Along Weller Lane  
1  
EACH  
REPLACE  
PRIORITY 3  
LEVEL 2

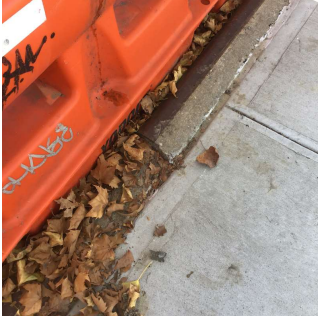
149th Road
Violations	No violations recorded.
<b>Pavers</b>	Inspected
Condition	3 - Fair
Deficiency	DAMAGED/MISSING
Deficiency Location/Instance	149th Road
Deficiency Quantity	90
Quantity Uom	S.F.
Potential Action	REPLACE
Urgency of Action	PRIORITY 3
Purpose of Action	LEVEL 2
Deficiency Photo1

Question	Response
<b>SITE</b>	
<b>PAVING</b>	
<b>DOT Sidewalk</b>	
<b>Concrete</b>	
Urgency of Action	PRIORITY 3
Purpose of Action	LEVEL 2
Deficiency Photo1	 
	Along 149th Avenue
Violations	No violations recorded.
Deficiency	HEAVING
Deficiency Location/Instance	149th Road
Deficiency Quantity	25
Quantity Uom	S.F.
Potential Action	REPLACE
Urgency of Action	PRIORITY 3
Purpose of Action	LEVEL 2
Deficiency Photo1	 
	149th Road
Violations	No violations recorded.
Deficiency	DAMAGED CURBS
Deficiency Location/Instance	149th Road
Deficiency Quantity	10
Quantity Uom	L.F.
Potential Action	REPLACE
Urgency of Action	PRIORITY 3
Purpose of Action	LEVEL 2

Question	Response
<b>SITE</b>	
<b>PAVING</b>	
<b>DOT Sidewalk</b>	
<b>Concrete</b>	Inspected
Deficiency Photo1

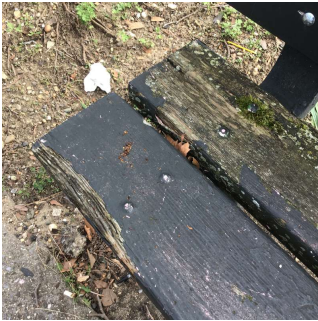
Violations	Along 149th Road No violations recorded.
<b>Bleachers</b>	Does not Exist
<b>SITE WALLS (NOT RETAINING WALLS)</b>	Does not Exist
<b>STAIRS/RAMPS: EXTERIOR</b>	Does not Exist

Question	Response
<b>SITE</b>	
<b>PLAYGROUNDS</b>	
<b>Play Equipment</b>	
Instance on Schoolyard	Inspected
Condition	1 - Good
Deficiency	No deficiencies recorded
<b>Safety Surfacing</b>	
Instance on Schoolyard	Inspected
Condition	1 - Good
Deficiency	No deficiencies recorded
<b>Unpaved Area</b>	
Instance on Schoolyard	Does not Exist
<b>PLAYING SURFACE</b>	Does not Exist
<b>RETAINING WALLS</b>	Does not Exist
<b>SEATING</b>	Inspected
<b>Benches</b>	Inspected
<b>Concrete</b>	Does not Exist
<b>Metal/Wood/Plastic</b>	Inspected
Condition	4 - Between Fair and Poor
Deficiency	DAMAGED/DETERIORATED
Deficiency Location/Instance	Along 149th Road
Deficiency Quantity	2
Quantity Uom	EACH
Potential Action	REPLACE
Urgency of Action	PRIORITY 3
Purpose of Action	LEVEL 2
Deficiency Photo1
