NYC Department of Education
Building Condition Assessment Survey 2023 - 2024

Architectural Inspection

Asset: P.S. 200 - QUEENS, 70-10 164 STREET, New York, 11365

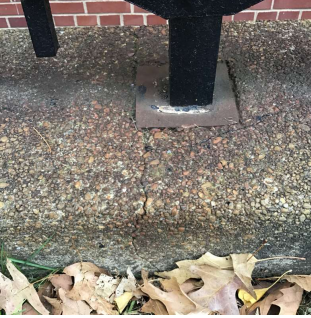
Violations	AW4 No violations recorded.
AWNINGS AND CANOPIES	
Does not Exist	
CHIMNEY	
Material Type(s)	Inspected Masonry
Condition	3 - Fair
Deficiency	BRICK: DETERIORATED JOINTS
Roof Plan reference

Question	Response
Architectural	
EXTERIOR	Inspected
AREAWAY	Inspected
Instance on AW1-AW4	Inspected
Instance Condition	3 - Fair
Instance Quantity	4
Instance Quantity Uom	EACH
Deficiency	AREAWAY WALLS: CRACKS AND SPALLING

Deficiency Quantity	40
Quantity Uom	S.F.
Potential Action	REPAIR
Urgency of Action	PRIORITY 3
Purpose of Action	LEVEL 2
Deficiency Photo1

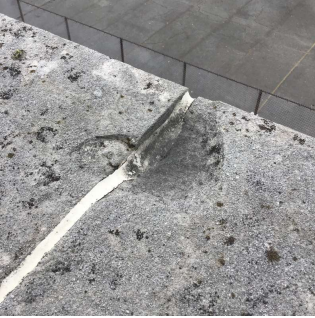
Roof 1 No violations recorded.
Deficiency	CAST STONE: CRACKED/BROKEN PIECES

Deficiency Quantity	200
Quantity Uom	L.F.
Potential Action	REPLACE-IN-KIND
Urgency of Action	PRIORITY 4
Purpose of Action	LEVEL 2
Deficiency Photo1

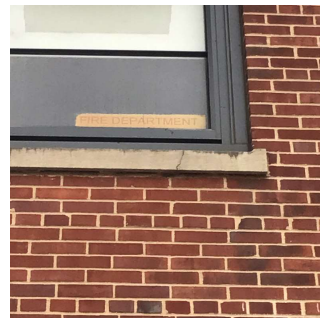
BRICK: DETERIORATED MASONRY SILLS - MINOR

100
L.F.
REPAIR
PRIORITY 3
LEVEL 2

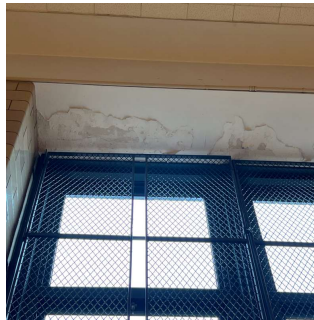
Facade A - Gymnasium

BRICK: WATER INFILTRATION IN INSTRUCTIONAL SPACE

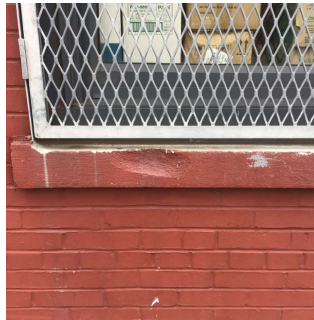
Facade F

BRICK: DETERIORATED MASONRY SILLS - MAJOR

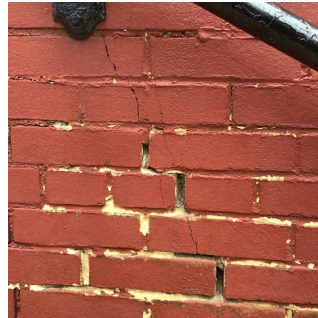
Facade E

BRICK: MINOR CRACKS AND SPALLING

PRIORITY 3
LEVEL 2

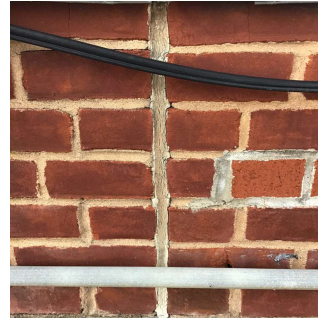
Roof 1	
Violations	No violations recorded.
Deficiency	BRICK: DETERIORATED CONTROL/EXPANSION JOINT

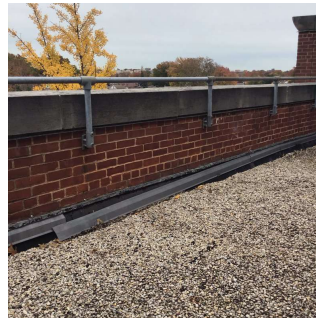
Roof 5

BUILT-UP: FLASHING: CAP FLASHING DAMAGED

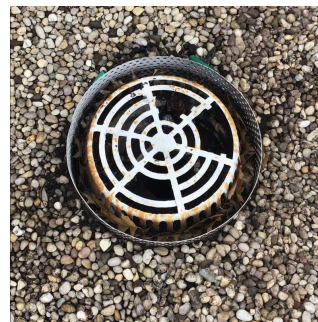
Roof 2
No violations recorded.

DETERIORATED

4
EACH
REPLACE
PRIORITY 4
LEVEL 2

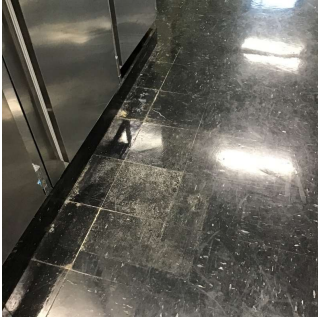
Question	Response
INTERIOR	
CAFETERIA	
Door(s)	
Instance on 1st Floor	Inspected
Condition	2 - Between Good and Fair
Deficiency	No deficiencies recorded
Fixed Equipment	
Instance on 1st Floor	Does not Exist
Floor Finish	
Instance on 1st Floor	Inspected
Condition	2 - Between Good and Fair
Deficiency	VINYL TILES: BROKEN/DETERIORATED/MISSING TILES
Deficiency Location/Instance	Left Side near freezers, Near Kitchen
Deficiency Quantity	20
Quantity Uom	S.F.
Potential Action	REPLACE
Urgency of Action	PRIORITY 3
Purpose of Action	LEVEL 2
Deficiency Photo1

Violations	Left Side near freezers No violations recorded.
Sliding-folding Partition	
Instance on 1st Floor	Does not Exist
Stage	
Instance on 1st Floor	Does not Exist
Walls	
Instance on 1st Floor	Inspected
Condition	2 - Between Good and Fair
Deficiency	GLAZED BLOCK: CRACKS/SPALLING
Deficiency Location/Instance	Near Kitchen
Deficiency Quantity	10
Quantity Uom	S.F.
Potential Action	REPLACE

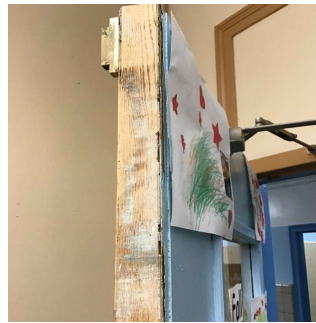
Room 111

Violations	Corridor near Room 118 No violations recorded.
Door(s)	
Condition	Inspected
Condition	5 - Poor
Deficiency	WOOD: DETERIORATED DOOR
Deficiency Location/Instance	Rooms 315, 314, 313, 308, 111 and others
Deficiency Quantity	12
Quantity Uom	EACH
Potential Action	MAINTENANCE
Urgency of Action	PRIORITY 3
Purpose of Action	LEVEL 2

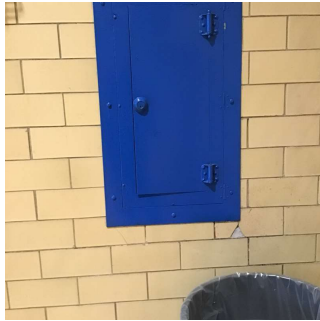
Left Side
Violations	No violations recorded.
Deficiency	PLASTER: CRACKS/SPALLING
Deficiency Location/Instance	Storage Room, Office
Deficiency Quantity	60
Quantity Uom	S.F.
Potential Action	REPLACE
Urgency of Action	PRIORITY 3
Purpose of Action	LEVEL 2
Deficiency Photo1

Question	Response
INTERIOR	
GYMNASIUM	
Walls	
Deficiency Photo1

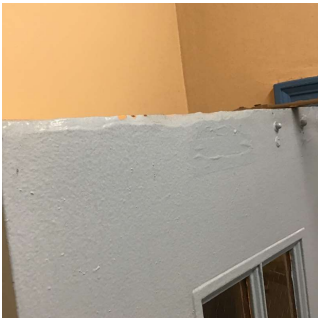
Room 319
Violations	No violations recorded.
SCIENCE PREP ROOM	Does not Exist
SHOWER ROOM	Inspected
Instance on 3rd Floor - Inside Gymnasium	Inaccessible
Instance on Room 324	Inaccessible
STAIRS/RAMPS: INTERIOR	Inspected
Do Letter Stair Signs Exist?	Yes
Ceiling	Inspected
Condition	2 - Between Good and Fair
Deficiency	No deficiencies recorded
Door(s)	Inspected
Condition	2 - Between Good and Fair
Deficiency	METAL: DETERIORATED DOOR
Deficiency Location/Instance	Stair A/3
Deficiency Quantity	1
Quantity Uom	EACH
Potential Action	MAINTENANCE
Urgency of Action	PRIORITY 3
Purpose of Action	LEVEL 2
Deficiency Photo1

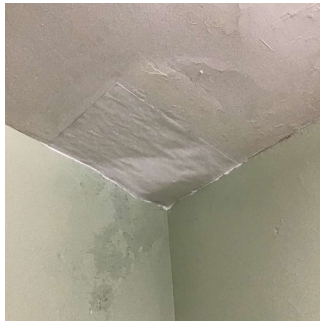
Question	Response
INTERIOR	
TOILET ROOMS - STAFF	
Ceiling	
Deficiency Photo1

Violations	Room 121 No violations recorded.
Door(s)	
Condition	Inspected 5 - Poor
Deficiency	WOOD: DETERIORATED DOOR
Deficiency Location/Instance	Rooms 124, 121, 118, inside Rooms 324, 221
Deficiency Quantity	5
Quantity Uom	EACH
Potential Action	MAINTENANCE
Urgency of Action	PRIORITY 3
Purpose of Action	LEVEL 2
Deficiency Photo1

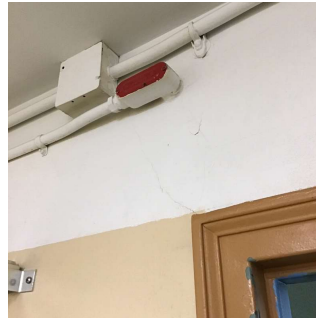
Room 124

PLASTER: CRACKS/SPALLING

REPLACE

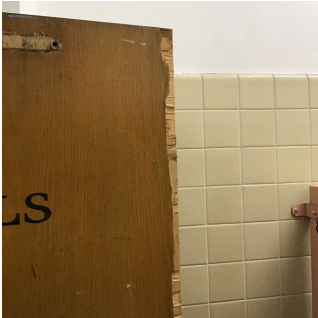
Question	Response
INTERIOR	
TOILET ROOMS - STAFF	Inspected
Walls	Inspected
Violations	Room 124 No violations recorded.
TOILET ROOMS - STUDENTS	Inspected
Ceiling	Inspected
Condition	2 - Between Good and Fair
Deficiency	No deficiencies recorded
Door(s)	Inspected
Condition	5 - Poor
Deficiency	WOOD: DETERIORATED DOOR
Deficiency Location/Instance	Rooms 318, 304, 118, 112, 111A
Deficiency Quantity	5
Quantity Uom	EACH
Potential Action	MAINTENANCE
Urgency of Action	PRIORITY 3
Purpose of Action	LEVEL 2
Deficiency Photo1

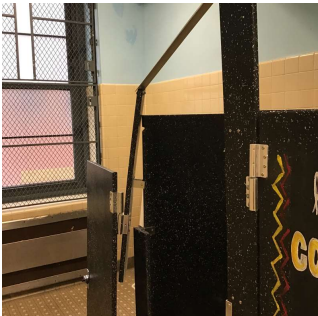
Violations	Room 118 No violations recorded.
Floor Finish	Inspected
Condition	2 - Between Good and Fair
Deficiency	No deficiencies recorded
Stalls	Inspected
Condition	5 - Poor
Deficiency	BROKEN/MISSING
Deficiency Location/Instance	Room 310
Deficiency Quantity	1
Quantity Uom	EACH
Potential Action	REPLACE
Urgency of Action	PRIORITY 5
Purpose of Action	LEVEL 6
Deficiency Photo1

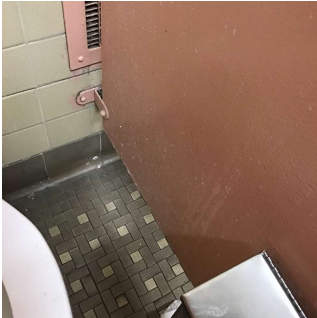
Question	Response
INTERIOR	
TOILET ROOMS - STUDENTS	Inspected
Stalls	
Violations	Room 310 No violations recorded.
Deficiency	RUST - MAJOR
Deficiency Location/Instance	Rooms 118, 204
Deficiency Quantity	8
Quantity Uom	EACH
Potential Action	REPLACE
Urgency of Action	PRIORITY 3
Purpose of Action	LEVEL 2
Deficiency Photo1

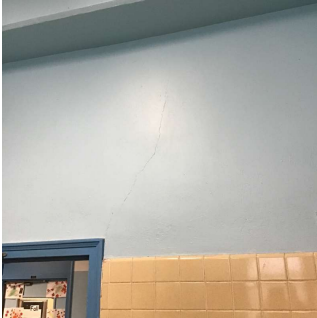
Violations	Room 118 No violations recorded.
Walls	Inspected
Condition	2 - Between Good and Fair
Deficiency	PLASTER: CRACKS/SPALLING
Deficiency Location/Instance	Rooms 112, 118, 204, 304, 318
Deficiency Quantity	60
Quantity Uom	S.F.
Potential Action	REPLACE
Urgency of Action	PRIORITY 3
Purpose of Action	LEVEL 2
Deficiency Photo1

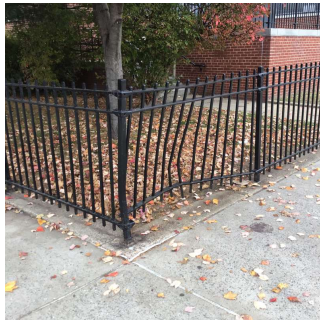
Violations	Room 112 No violations recorded.
LIFE SAFETY	Inspected
F.D. HOLDING AREA	Does not Exist
STEEL STAIRS	Does not Exist
SITE	Inspected
CONTAINERIZATION	Does not Exist
Drainage System for Asphalt	Does not Exist
Drainage System for Concrete	Inspected
Catch Basins/Manhole - Surrounded by concrete	Inspected
Condition	2 - Between Good and Fair
Deficiency	No deficiencies recorded
Culverts - Concrete Covering	Does not Exist
Drainage System for Soil	Does not Exist
DRINKING FOUNTAINS	Does not Exist
FENCES	Inspected
Condition	3 - Fair
Deficiency	WROUGHT IRON: DAMAGED/DETERIORATED
Deficiency Location/Instance	164th Street
Deficiency Quantity	280
Quantity Uom	S.F.
Potential Action	REPLACE
Urgency of Action	PRIORITY 3
Purpose of Action	LEVEL 2
Deficiency Photo1

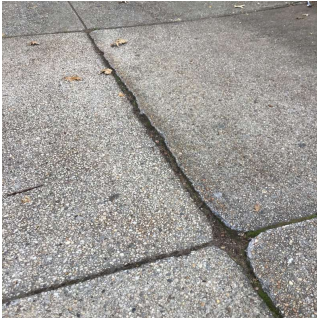
Question	Response
SITE	
PAVING	
Site Sidewalks & Walkways	
Concrete	
Deficiency	HEAVING
Deficiency Location/Instance	Near New York City Parks
Deficiency Quantity	200
Quantity Uom	S.F.
Potential Action	REPLACE
Urgency of Action	PRIORITY 3
Purpose of Action	LEVEL 2
Deficiency Photo1

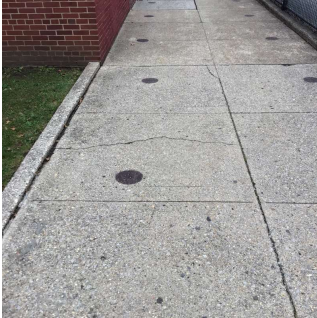
Violations	Near New York City Parks No violations recorded.
Deficiency	CRACKS - MAJOR
Deficiency Location/Instance	Jewel Avenue, Near New York City Parks, 71st Avenue
Deficiency Quantity	800
Quantity Uom	S.F.
Potential Action	REPLACE
Urgency of Action	PRIORITY 3
Purpose of Action	LEVEL 2
Deficiency Photo1

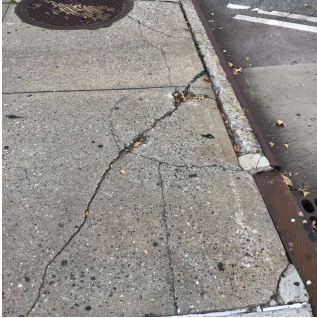
Violations	Near New York City Parks No violations recorded.
Pavers	Does not Exist
DOT Sidewalk	Inspected
Asphalt	Does not Exist
Concrete	Inspected
Condition	4 - Between Fair and Poor
Deficiency	DAMAGED/DETERIORATED/MISSING SECTIONS
Deficiency Location/Instance	Jewel Avenue, 164th Street, 71st Avenue
Deficiency Quantity	700
Quantity Uom	S.F.

Question	Response
SITE	
PAVING	
DOT Sidewalk	
Concrete	
Urgency of Action	PRIORITY 3
Purpose of Action	LEVEL 2
Deficiency Photo1

Potential Action	REPLACE
