NYC Department of Education
Building Condition Assessment Survey 2023 - 2024

Architectural Inspection

Q322

Asset: P.S. 14 ANNEX - QUEENS, 89-11 43RD AVENUE, New York, 11373

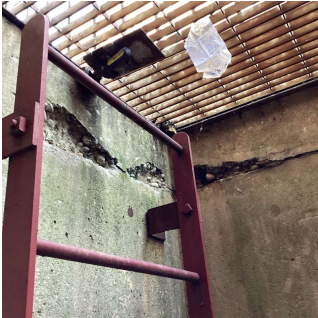
Violations	AW1 No violations recorded.
Deficiency	AREAWAY WALLS: CRACKS AND SPALLING
Roof Plan reference

Deficiency Quantity	20
Quantity Uom	S.F.
Potential Action	REPLACE
Urgency of Action	PRIORITY 4
Purpose of Action	LEVEL 2
Deficiency Photo1

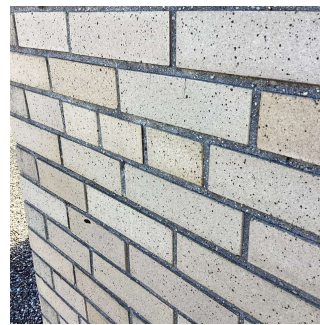
CH
 No violations recorded.

BRICK: DETERIORATED JOINTS

80
 S.F.
 REPOINT
 PRIORITY 3
 LEVEL 2

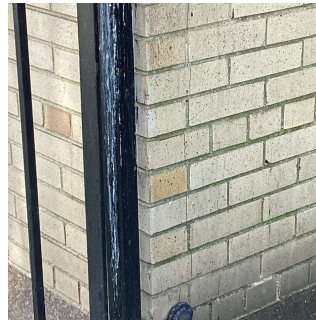
Facade E

BRICK: CRACKS/DISPLACED/SPALLED BRICK AT BUILDING CORNERS

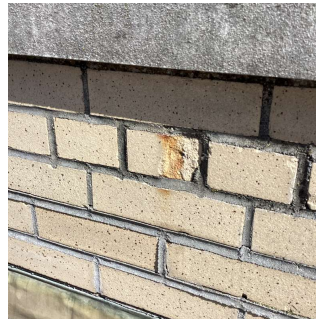
Roof 1

BRICK: MINOR CRACKS, SPALLING

REPAIR

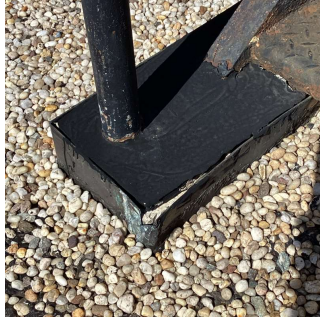
BUILT-UP: FLASHING: PITCH POCKET DETERIORATED - MAJOR

REPLACE

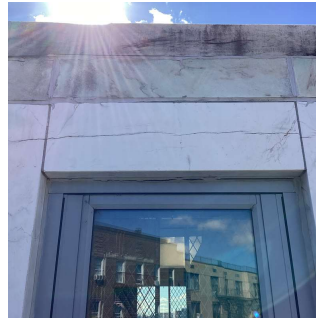
BH2

Deficiency **BULKHEAD/PENTHOUSE WALLS/EXTERIOR: CRACKS/SPALLING - MAJOR**

10
S.F.
REPLACE
PRIORITY 4
LEVEL 2

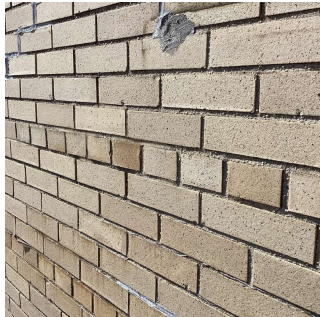
BULKHEAD/PENTHOUSE WALLS/EXTERIOR: DETERIORATED JOINTS

350
S.F.
REPOINT
PRIORITY 3
LEVEL 2

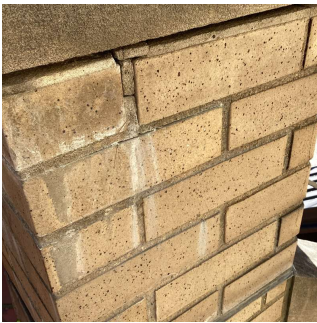
BRICK: DETERIORATED JOINTS

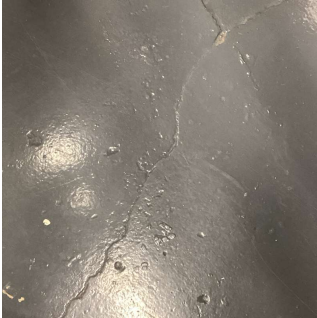
Question	Response
INTERIOR	
STRUCTURAL	
FLOOR STRUCTURE	
Deficiency	CONCRETE SLAB ON GRADE: THRU CRACKS
Deficiency Location/Instance	Boiler Room, Electrical Panel Room
Deficiency Quantity	40
Quantity Uom	S.F.
Potential Action	REPAIR
Urgency of Action	PRIORITY 3
Purpose of Action	LEVEL 5
Deficiency Photo1

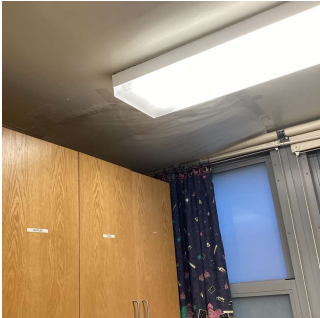
Violations	Near Stair B No violations recorded.
Window Curtains/Shades/Blinds	
Instance on Basement	Does not Exist
CLASSROOMS/CORRIDORS/ADMIN SPACES	
Ceiling	
Condition	2 - Between Good and Fair
Deficiency	PLASTER: CRACKS/SPALLING - ACTIVE LEAK
Deficiency Location/Instance	Room 115
Deficiency Quantity	20
Quantity Uom	S.F.
Potential Action	REPLACE
Urgency of Action	PRIORITY 5
Purpose of Action	LEVEL 2
Deficiency Photo1

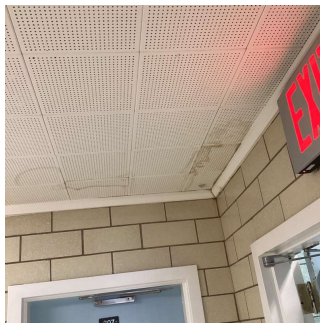
Violations	Room 115 No violations recorded.
Deficiency	ACOUSTIC TILES: DAMAGED/MISSING
Deficiency Location/Instance	Corridor near Rooms 307, 210, 102
Deficiency Quantity	30
Quantity Uom	S.F.
Potential Action	REPLACE
Urgency of Action	PRIORITY 3
Purpose of Action	LEVEL 2

Corridor near Room 307
Violations	No violations recorded.
Door(s)	Inspected
Condition	5 - Poor
Deficiency	WOOD: DETERIORATED DOOR
Deficiency Location/Instance	Rooms 304, 102
Deficiency Quantity	2
Quantity Uom	EACH
Potential Action	MAINTENANCE
Urgency of Action	PRIORITY 3
Purpose of Action	LEVEL 2
Deficiency Photo1

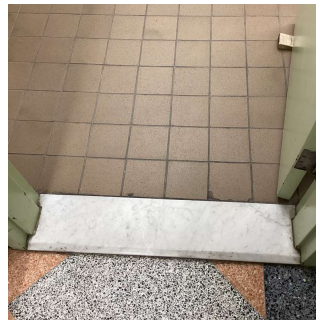
Instance on Basement	Inspected
Condition	2 - Between Good and Fair
Deficiency	QUARRY TILE: BROKEN/MISSING TILES
Deficiency Location/Instance	Main Entrance
Deficiency Quantity	10
Quantity Uom	S.F.
Potential Action	REPLACE
Urgency of Action	PRIORITY 3
Purpose of Action	LEVEL 2
Deficiency Photo1

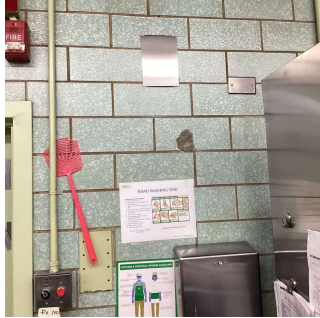
Instance on Basement	Inspected
Condition	2 - Between Good and Fair
Deficiency	GLAZED BLOCK: CRACKS/SPALLING
Deficiency Location/Instance	Near Storage Room, Near Exit 4
Deficiency Quantity	30
Quantity Uom	S.F.

Question	Response
INTERIOR	
KITCHEN	
Walls	
Potential Action	REPLACE
Urgency of Action	PRIORITY 3
Purpose of Action	LEVEL 2
Deficiency Photo1

Near Storage Room
Violations	No violations recorded.
LIBRARY	Does not Exist
LOCKER ROOM	Does not Exist
MULTI-PURPOSE ROOM	Does not Exist
SCIENCE DEMO ROOM	Does not Exist
SCIENCE LAB	Does not Exist
SCIENCE PREP ROOM	Does not Exist
SHOWER ROOM	Does not Exist
STAIRS/RAMPS: INTERIOR	Inspected
Do Letter Stair Signs Exist?	Yes
Ceiling	Inspected
Condition	2 - Between Good and Fair
Deficiency	PLASTER: CRACKS/SPALLING - ACTIVE LEAK
Deficiency Location/Instance	Stair A/3, B/3
Deficiency Quantity	40
Quantity Uom	S.F.
Potential Action	REPLACE
Urgency of Action	PRIORITY 5
Purpose of Action	LEVEL 2
Deficiency Photo1

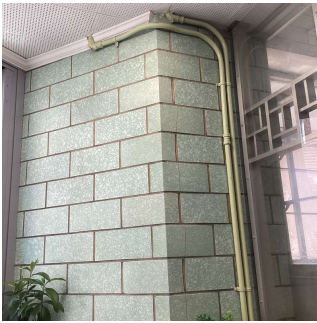
Violations	Stair B/Basement No violations recorded.
Walls	Inspected
Condition	2 - Between Good and Fair
Deficiency	GLAZED BLOCK: CRACKS/SPALLING
Deficiency Location/Instance	Stairs A/1, Basement, B/1
Deficiency Quantity	30
Quantity Uom	S.F.
Potential Action	REPLACE
Urgency of Action	PRIORITY 3
Purpose of Action	LEVEL 2
Deficiency Photo1

Violations	Stair B/1 No violations recorded.
TOILET ROOMS - STAFF	
Ceiling	Inspected
Condition	3 - Fair

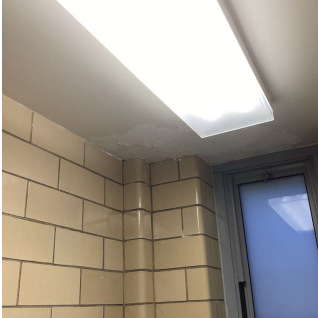
Deficiency	PLASTER: CRACKS/SPALLING - ACTIVE LEAK

Question	Response
INTERIOR	
TOILET ROOMS - STAFF	
Ceiling	
Deficiency Location/Instance	Room 117
Deficiency Quantity	10
Quantity Uom	S.F.
Potential Action	REPLACE
Urgency of Action	PRIORITY 5
Purpose of Action	LEVEL 2
Deficiency Photo1

Violations	Room 117 No violations recorded.
Door(s)	Inspected
Condition	5 - Poor
Deficiency	WOOD: DETERIORATED DOOR
Deficiency Location/Instance	Inside Kitchen, Rooms 209, 309
Deficiency Quantity	3
Quantity Uom	EACH
Potential Action	MAINTENANCE
Urgency of Action	PRIORITY 3
Purpose of Action	LEVEL 2
Deficiency Photo1	 
Violations	Room 209 No violations recorded.
Floor Finish	Inspected
Condition	3 - Fair
Deficiency	CERAMIC TILE: BROKEN/MISSING TILES
Deficiency Location/Instance	Room 117
Deficiency Quantity	10
Quantity Uom	S.F.
Potential Action	REPLACE
Urgency of Action	PRIORITY 3
Purpose of Action	LEVEL 2

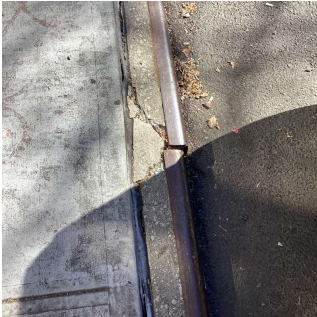
Violations	43rd Avenue No violations recorded.
Pavers	Inspected
Condition	2 - Between Good and Fair
Deficiency	No deficiencies recorded
DOT Sidewalk	Inspected
Asphalt	Does not Exist
Concrete	Inspected
Condition	3 - Fair
Deficiency	DAMAGED CURBS
Deficiency Location/Instance	43rd Avenue, Ithaca Street
Deficiency Quantity	40

Question	Response
SITE	
PAVING	
DOT Sidewalk	
Concrete	
Quantity Uom	L.F.
Potential Action	REPLACE
Urgency of Action	PRIORITY 3
Purpose of Action	LEVEL 2
Deficiency Photo1

43rd Avenue
Violations	No violations recorded.
Deficiency	HEAVING
Deficiency Location/Instance	43rd Avenue
Deficiency Quantity	25
Quantity Uom	S.F.
Potential Action	REPLACE
Urgency of Action	PRIORITY 5
Purpose of Action	LEVEL 6
Deficiency Photo1

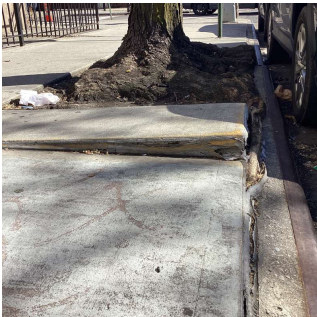
43rd Avenue
Violations	No violations recorded.
Deficiency	HEAVING
Deficiency Location/Instance	43rd Avenue
Deficiency Quantity	150
Quantity Uom	S.F.
Potential Action	REPLACE
Urgency of Action	PRIORITY 3
Purpose of Action	LEVEL 2

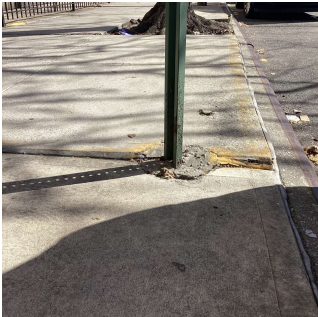
Question	Response
SITE	
PAVING	
DOT Sidewalk	
Concrete	
Deficiency Photo1

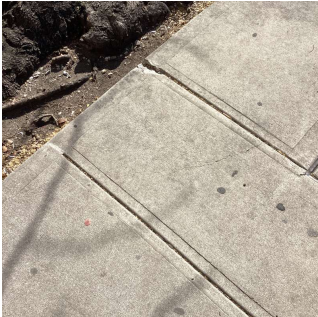
Violations	43rd Avenue No violations recorded.
Deficiency	DAMAGED/DETERIORATED/MISSING SECTIONS
Deficiency Location/Instance	43rd Avenue, Ithaca Street
Deficiency Quantity	225
Quantity Uom	S.F.
Potential Action	REPLACE
Urgency of Action	PRIORITY 3
Purpose of Action	LEVEL 2
Deficiency Photo1
