NYC Department of Education
Building Condition Assessment Survey 2023 - 2024

Architectural Inspection

Q397

Asset: **PRE-K CENTER @ 32-52 37TH STREET - QUEENS, 32-52 37TH STREET, New York, 11103**

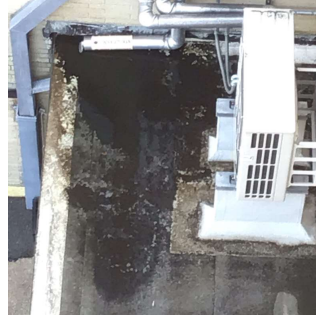
Roof 5

CLOGGED

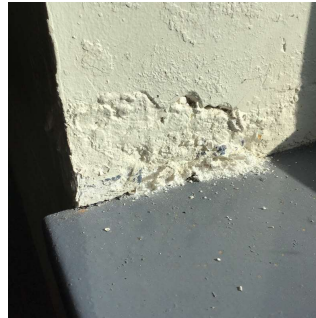
BH2

BULKHEAD/PENTHOUSE WALLS/INTERIOR: PLASTER CRACKS/SPALLING

REPLACE

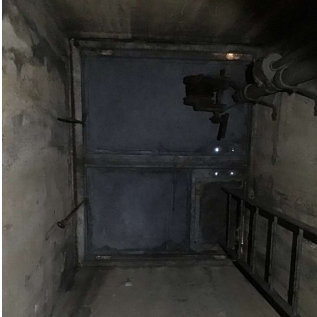
| Question | Response |
|--|--|
| Violations | Basement - Ash Hoist Door No violations recorded. |

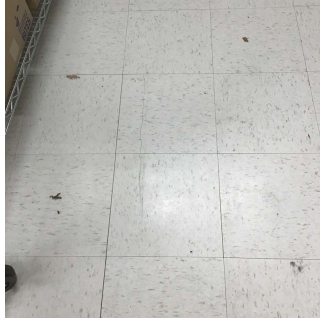
| Question | Response |
|---|--|
| | Room C06 |

| Question | Response |
|---|--|
| Deficiency | VINYL TILES: BROKEN/DETERIORATED/MISSING TILES |
| Deficiency Location/Instance | Rooms C06, C09 |

| Question | Response |
|---|--|
| Potential Action | REPLACE |

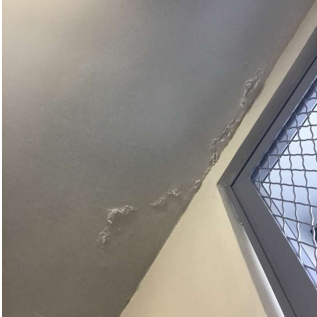
| Question | Response |
|---|--|
| Deficiency | PLASTER: CRACKS/SPALLING - ACTIVE LEAK |

| Question | Response |
|---|--|
| Deficiency Location/Instance | Stair D/1 |

| Question | Response |
|---|--|
| Potential Action | REPLACE |

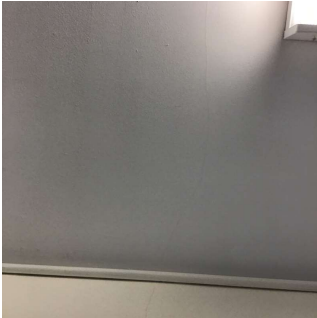
| Question | Response |
|---|--|
| Deficiency | PLASTER: CRACKS/SPALLING |
| Deficiency Location/Instance | Stair A/3 |

| Question | Response |
|---|--|
| Potential Action | REPLACE |

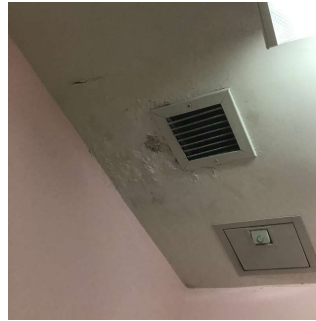
| Question | Response |
|---|---|
| Deficiency | PLASTER: CRACKS/SPALLING - ACTIVE LEAK |
| Deficiency Location/Instance | Room 301C |

| Question | Response |
|---|---|
| Potential Action | REPLACE |

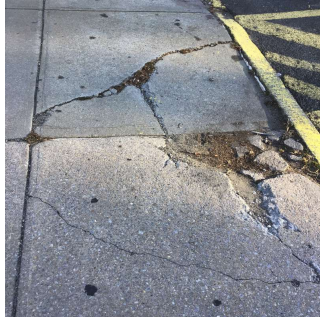
| Question | Response |
|---|--|
| Violations | 37th Street No violations recorded. |
| Deficiency | DAMAGED CURBS |
