**NYC Department of Education**  
**Building Condition Assessment Survey 2023 - 2024**

Architectural Inspection

Q739

**Asset:**        **YOUNG WOMEN'S LEADERSHIP ACADEMY- QUEENS, 23-15 NEWTOWN AVENUE,  
New York, 11102**

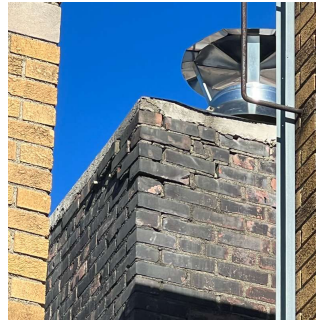
CH  
 No violations recorded.

Question	Response
<b>Architectural</b>	
<b>EXTERIOR</b>	Inspected
<b>AREAWAY</b>	Does not Exist
<b>AWNINGS AND CANOPIES</b>	Inspected
Condition	2 - Between Good and Fair
Deficiency	No deficiencies recorded
<b>CHIMNEY</b>	Inspected
Material Type(s)	Masonry
Condition	3 - Fair
Deficiency	BRICK: MAJOR / THRU CRACKS
Roof Plan reference	<p align="center"><b>Q739</b></p>
Deficiency Quantity	20
Quantity Uom	S.F.
Potential Action	REMOVE AND REBUILD
Urgency of Action	PRIORITY 4
Purpose of Action	LEVEL 2

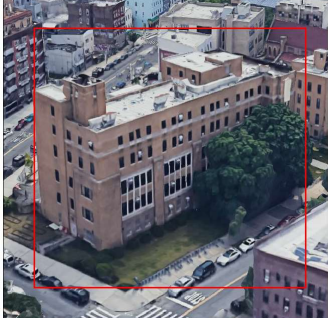
Question	Response
<b>EXTERIOR</b>	
<b>EXTERIOR WALLS</b>	
Material Type(s)	Masonry
Replacement Quantity	19,000
Replacement Uom	S.F.
Instance on All Facades	Inspected
Instance Condition	4 - Between Fair and Poor
Instance Quantity	19,000
Instance Quantity Uom	S.F.
Deficiency	BRICK: DETERIORATED JOINTS
Roof Plan reference	<p><b>Q739</b></p>

Deficiency Quantity	800
Quantity Uom	S.F.
Potential Action	REPOINT
Urgency of Action	PRIORITY 3
Purpose of Action	LEVEL 2
Deficiency Photo1

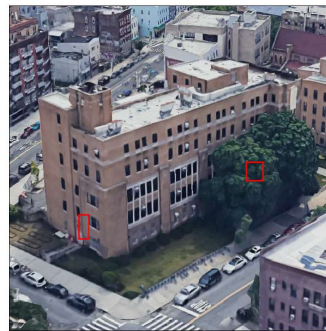
Violations	Facade C No violations recorded.
Deficiency	BRICK: DETERIORATED JOINTS

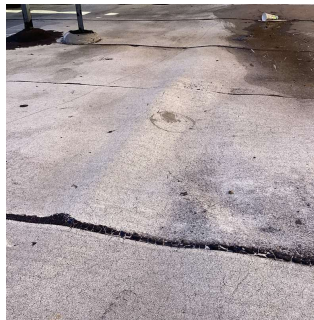
Roof 1

Deficiency MODIFIED BITUMEN: ROOFING: DELAMINATION

Deficiency Quantity	40
Quantity Uom	S.F.
Potential Action	REPLACE ROOFING WITHOUT MAJOR EQUIPMENT REMOVAL
Urgency of Action	PRIORITY 4
Purpose of Action	LEVEL 2
Deficiency Photo1

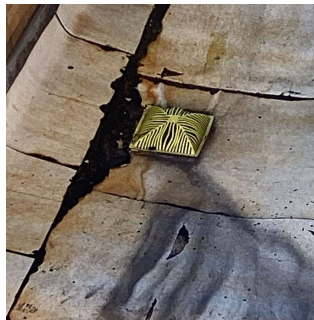
Condition	3 - Fair
Deficiency	DETERIORATED

1  
 EACH  
 REPLACE  
 PRIORITY 4  
 LEVEL 2

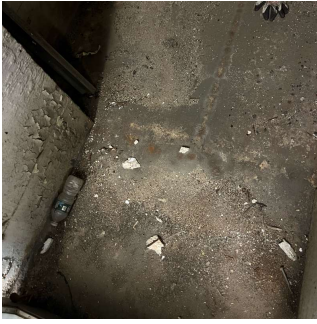
Violations	Boiler Room No violations recorded.
<b>FOUNDATION WALLS</b>	
Material Type(s)	Inspected Concrete
Condition	2 - Between Good and Fair
Deficiency	No deficiencies recorded
<b>ROOF STRUCTURE</b>	
Condition	Inspected 2 - Between Good and Fair
Deficiency	No deficiencies recorded
<b>VAULTS-BUNKERS</b>	
<b>Foundation Walls</b>	
Condition	Inspected 2 - Between Good and Fair
Deficiency	No deficiencies recorded
<b>Slab Structure</b>	
Condition	Inspected 3 - Fair
Deficiency	CONCRETE SLAB ON GRADE: THRU CRACKS
Deficiency Location/Instance	Vault
Deficiency Quantity	25
Quantity Uom	S.F.
Potential Action	REPAIR
Urgency of Action	PRIORITY 3
Purpose of Action	LEVEL 5
Deficiency Photo1

Violations	Vault No violations recorded.
<b>Vault/Ash Hoist Doors and Framing</b>	
Condition	Inspected 1 - Good
Deficiency	No deficiencies recorded

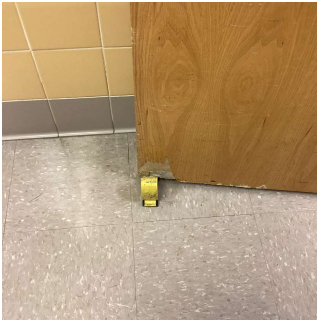
Question	Response
<b>INTERIOR</b>	
<b>CLASSROOMS/CORRIDORS/ADMIN SPACES</b>	
<b>Door(s)</b>	
Deficiency Photo1

Violations	Room 400 No violations recorded.
<b>Floor Finish</b>	Inspected
Condition	2 - Between Good and Fair
Deficiency	VINYL TILES: BROKEN/DETERIORATED/MISSING TILES
Deficiency Location/Instance	Room 119
Deficiency Quantity	20
Quantity Uom	S.F.
Potential Action	REPLACE
Urgency of Action	PRIORITY 3
Purpose of Action	LEVEL 2
Deficiency Photo1

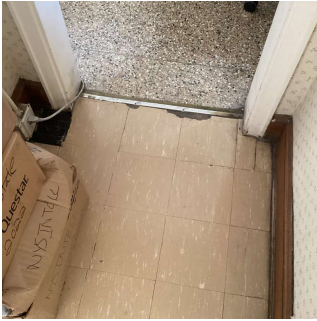
Violations	Room 119 No violations recorded.
Deficiency	TERRAZZO: CRACKS
Deficiency Location/Instance	Corridor near Rooms 207, 205, 202, Corridor near Exit , Room 117 and others
Deficiency Quantity	150
Quantity Uom	S.F.
Potential Action	REPLACE
Urgency of Action	PRIORITY 3
Purpose of Action	LEVEL 2

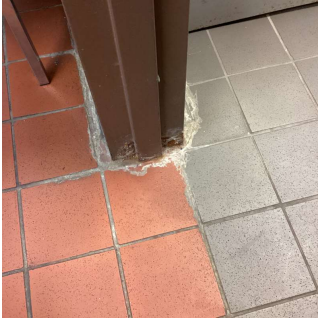
Question	Response
<b>INTERIOR</b>	
<b>KITCHEN</b>	
<b>Door(s)</b>	
Instance on 1st Floor	Inspected
Condition	4 - Between Fair and Poor
Deficiency	METAL: DETERIORATED DOOR AND FRAME
Deficiency Location/Instance	Rooms 001A, 001C
Deficiency Quantity	2
Quantity Uom	EACH
Potential Action	MAINTENANCE
Urgency of Action	PRIORITY 3
Purpose of Action	LEVEL 2
Deficiency Photo1

Violations	Room 001A No violations recorded.
<b>Floor Finish</b>	
Instance on 1st Floor	Inspected
Condition	2 - Between Good and Fair
Deficiency	No deficiencies recorded
<b>Walls</b>	
Instance on 1st Floor	Inspected
Condition	2 - Between Good and Fair
Deficiency	No deficiencies recorded
<b>LIBRARY</b>	Does not Exist
<b>LOCKER ROOM</b>	Does not Exist
<b>MULTI-PURPOSE ROOM</b>	Does not Exist
<b>SCIENCE DEMO ROOM</b>	Does not Exist
<b>SCIENCE LAB</b>	Inspected
Instance on Rooms 511, 513	Inspected
Alternative use	No
<b>Fixed Equipment</b>	
Instance on Rooms 511, 513	Inspected

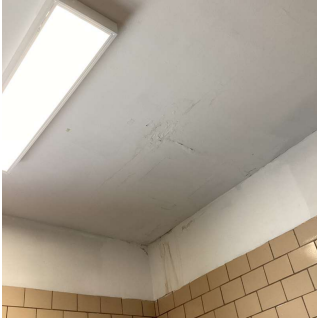
Question	Response
<b>INTERIOR</b>	
<b>TOILET ROOMS - STUDENTS</b>	
<b>Ceiling</b>	
Urgency of Action	PRIORITY 3
Purpose of Action	LEVEL 2
Deficiency Photo1

Room 313
Violations	No violations recorded.
<hr/>	
<b>Door(s)</b>	Inspected
Condition	5 - Poor
Deficiency	WOOD: DETERIORATED DOOR
Deficiency Location/Instance	Rooms 313, 212
Deficiency Quantity	2
Quantity Uom	EACH
Potential Action	MAINTENANCE
Urgency of Action	PRIORITY 3
Purpose of Action	LEVEL 2
Deficiency Photo1

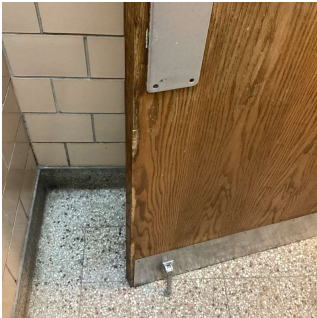
Room 313
Violations	No violations recorded.
<hr/>	
Deficiency	METAL: DETERIORATED DOOR
Deficiency Location/Instance	Room 005
Deficiency Quantity	1
Quantity Uom	EACH
Potential Action	MAINTENANCE
Urgency of Action	PRIORITY 3
Purpose of Action	LEVEL 2

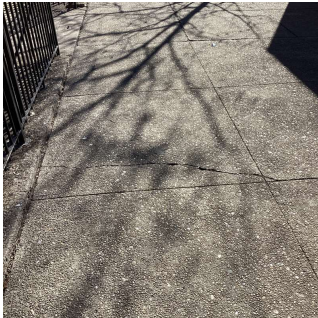
Question	Response
<b>SITE</b>	
<b>PAVING</b>	
<b>DOT Sidewalk</b>	
<b>Concrete</b>	
Deficiency Photo1

Newtown Avenue	
Violations	No violations recorded.
<b>Pavers</b>	Does not Exist
<b>PLAYGROUNDS</b>	Does not Exist
<b>PLAYING SURFACE</b>	Does not Exist
<b>RETAINING WALLS</b>	Does not Exist
<b>SEATING</b>	Does not Exist
<b>SITE WALLS (NOT RETAINING WALLS)</b>	Does not Exist
<b>STAIRS/RAMPS: EXTERIOR</b>	Does not Exist
<b>ARTWORK</b>	Does not Exist
