NYC Department of Education
Building Condition Assessment Survey 2023 - 2024

Architectural Inspection

Asset: **NORTH QUEENS COMMUNITY HS - Q, 141-25 77TH ROAD, New York, 11367**

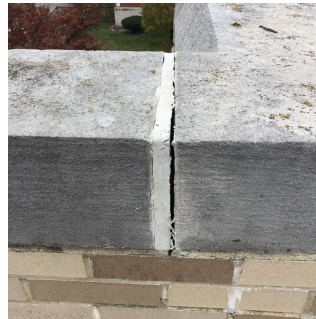
Roof 1

CAST STONE: DETERIORATED TRANSVERSE JOINTS

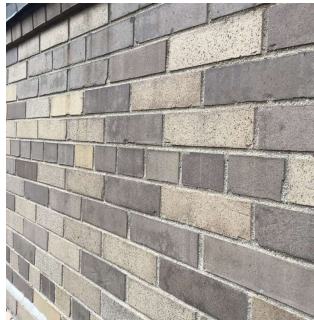
Facade A

BRICK: DETERIORATED JOINTS

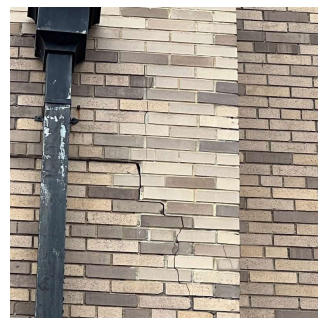
BRICK: CRACKS/DISPLACED/SPALLED BRICK AT BUILDING CORNERS

50
S.F.
REMOVE AND REBUILD
PRIORITY 4
LEVEL 2

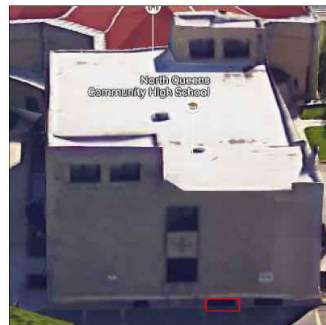
77th Road

BRICK: DETERIORATED MASONRY SILLS - MAJOR

REMOVE AND REPLACE

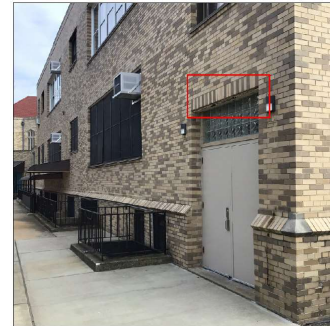
BRICK: RELIEVING ANGLES - MAJOR DETERIORATION

REPLACE

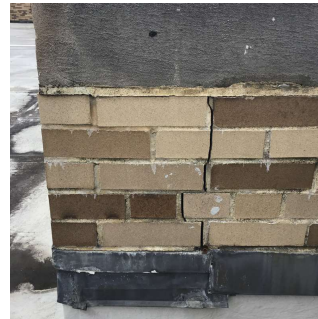
Roof 1

BRICK: MAJOR DETERIORATION/CRACKS

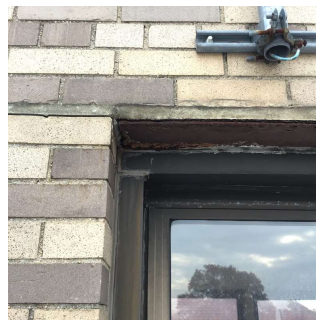
BH2
 No violations recorded.

**BULKHEAD/PENTHOUSE WINDOWS: DETERIORATED
LINTELS**

20
 L.F.
 REPLACE
 PRIORITY 4
 LEVEL 2

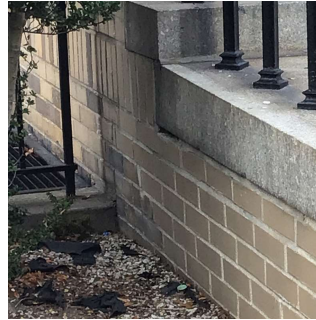
Facade A - Main Entrance

BRICK: DETERIORATED JOINTS

S.F.
 REPOINT
 PRIORITY 4
 LEVEL 2

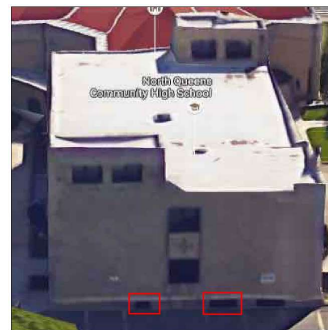
77th Road

RUST - MAJOR

REPLACE

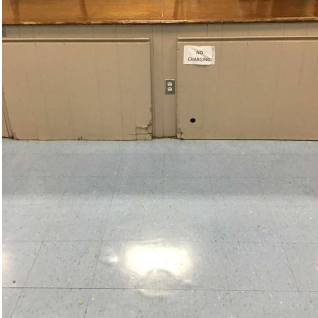
Violations	Rear No violations recorded.
Sliding-folding Partition	
Instance on Basement	Does not Exist
Stage	
Instance on Basement	Inspected
Stage	Inspected
Instance on Basement	Inspected
Condition	3 - Fair
Deficiency	DAMAGED FASCIA
Deficiency Location/Instance	Center, Left and Right Side

Question	Response
INTERIOR	
MULTI-PURPOSE ROOM	
Stage	
Stage	
Deficiency Quantity	30
Quantity Uom	S.F.
Potential Action	REPLACE
Urgency of Action	PRIORITY 3
Purpose of Action	LEVEL 2
Deficiency Photo1

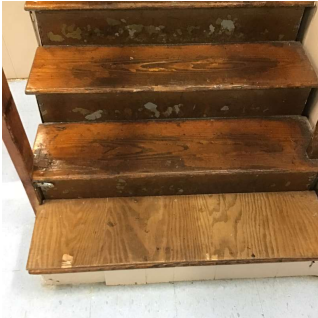
Left Side
Violations	No violations recorded.
Deficiency	DAMAGED STEPS
Deficiency Location/Instance	Left Side
Deficiency Quantity	10
Quantity Uom	S.F.
Potential Action	REPLACE
Urgency of Action	PRIORITY 3
Purpose of Action	LEVEL 2
Deficiency Photo1

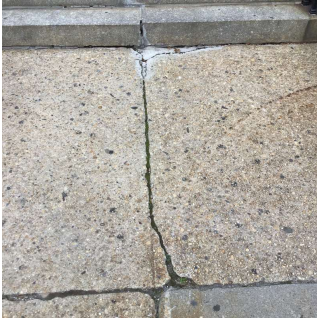
Question	Response
SITE	
FENCES	
Purpose of Action	LEVEL 2
Deficiency Photo1	 
Violations	77th Road No violations recorded.
IRRIGATION SYSTEM	Does not Exist
PAVING	Inspected
Student Non-Use	Inspected
Gravel Exists?	No
Asphalt	Does not Exist
Concrete	Inspected
Condition	3 - Fair
Deficiency	CRACKS - MAJOR
Deficiency Location/Instance	77th Road
Deficiency Quantity	75
Quantity Uom	S.F.
Potential Action	REPLACE
Urgency of Action	PRIORITY 3
Purpose of Action	LEVEL 2
Deficiency Photo1	 
Violations	77th Road No violations recorded.
Pavers	Does not Exist
Student Use	Does not Exist
Site Sidewalks & Walkways	Inspected
Asphalt	Does not Exist
Concrete	Inspected
Condition	3 - Fair
Deficiency	CRACKS - MAJOR
Deficiency Location/Instance	77th Road
Deficiency Quantity	50
Quantity Uom	S.F.

Question	Response
SITE	
PAVING	
Site Sidewalks & Walkways	
Concrete	
Potential Action	REPLACE
Urgency of Action	PRIORITY 3
Purpose of Action	LEVEL 2
Deficiency Photo1

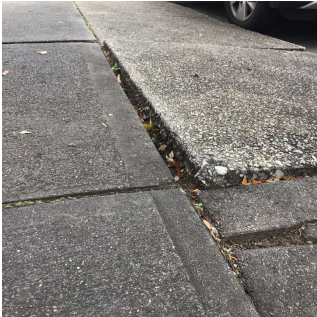
Violations	77th Road No violations recorded.
Deficiency	DAMAGED CURBS
Deficiency Location/Instance	77th Road
Deficiency Quantity	40
Quantity Uom	L.F.
Potential Action	REPLACE
Urgency of Action	PRIORITY 3
Purpose of Action	LEVEL 2
Deficiency Photo1	No photo recorded
Violations	No violations recorded.
Deficiency	DAMAGED/DETERIORATED/MISSING SECTIONS
Deficiency Location/Instance	77th Road
Deficiency Quantity	350
Quantity Uom	S.F.
Potential Action	REPLACE
Urgency of Action	PRIORITY 3
Purpose of Action	LEVEL 2
Deficiency Photo1
