**NYC Department of Education**  
**Building Condition Assessment Survey 2023 - 2024**

Architectural Inspection

**Asset:** P.S. 841- QUEENS, 48-25 37TH STREET, New York, 11104

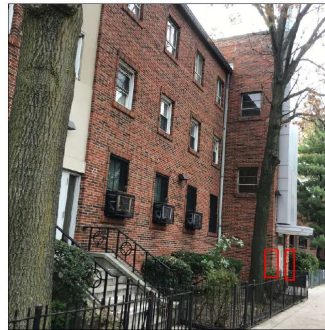
BRICK: MINOR CRACKS AND SPALLING

50

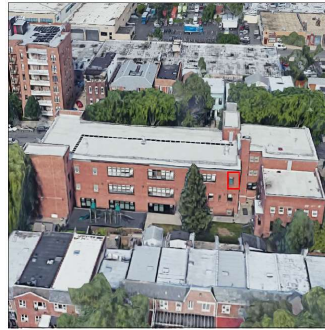
ALUMINUM - DOUBLE HUNG: BROKEN PANE

30  
 S.F.  
 MAINTENANCE  
 PRIORITY 3  
 LEVEL 2  
 No photo recorded  
 No violations recorded.

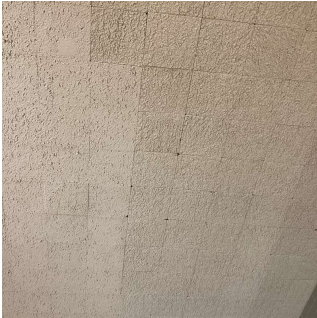
Violations	Near Servery No violations recorded.
Deficiency	ACOUSTIC TILES ON PLASTER: DAMAGED/MISSING
Deficiency Location/Instance	Near Servery, Center, Near Stage
Deficiency Quantity	40
Quantity Uom	S.F.
Potential Action	REPLACE
Urgency of Action	PRIORITY 3
Purpose of Action	LEVEL 2
Deficiency Photo1

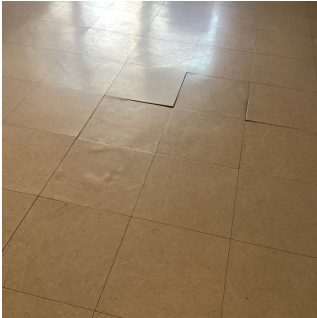
Question	Response
<b>INTERIOR</b>	
<b>CLASSROOMS/CORRIDORS/ADMIN SPACES</b>	
<b>Door(s)</b>	Inspected
	Room 204
Violations	No violations recorded.
<b>Floor Finish</b>	Inspected
Condition	2 - Between Good and Fair
Deficiency	VINYL TILES: BROKEN/DETERIORATED/MISSING TILES
Deficiency Location/Instance	Room 105, Corridor near Room 116, Exit 4
Deficiency Quantity	35
Quantity Uom	S.F.
Potential Action	REPLACE
Urgency of Action	PRIORITY 3
Purpose of Action	LEVEL 2
Deficiency Photo1

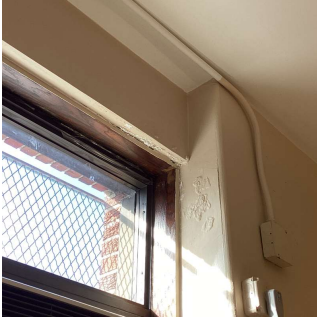
Room 105
Violations	No violations recorded.
<b>Walls</b>	Inspected
Condition	2 - Between Good and Fair
Deficiency	PLASTER: CRACKS/SPALLING
Deficiency Location/Instance	Room 209, Corridor near Room 203, Corridor near Stair B/1
Deficiency Quantity	30
Quantity Uom	S.F.
Potential Action	REPLACE
Urgency of Action	PRIORITY 3
Purpose of Action	LEVEL 2
Deficiency Photo1

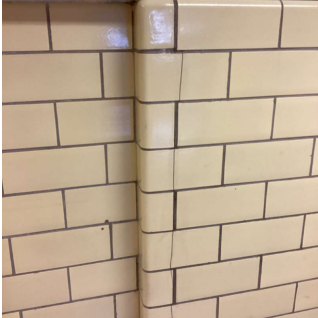
Room 209
Violations	No violations recorded.
Deficiency	GLAZED BLOCK: CRACKS/SPALLING

Deficiency Location/Instance	Corridor near Rooms B10, 202
Deficiency Quantity	20
Quantity Uom	S.F.
Potential Action	REPLACE

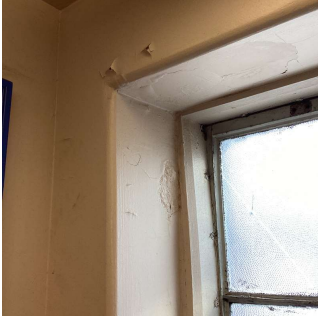
In Room 102
Violations	No violations recorded.
<b>Stalls</b>	Does not Exist
<b>Walls</b>	Inspected
Condition	2 - Between Good and Fair
Deficiency	PLASTER: CRACKS/SPALLING
Deficiency Location/Instance	In Room 102
Deficiency Quantity	10
Quantity Uom	S.F.
Potential Action	REPLACE
Urgency of Action	PRIORITY 3
Purpose of Action	LEVEL 2
Deficiency Photo1

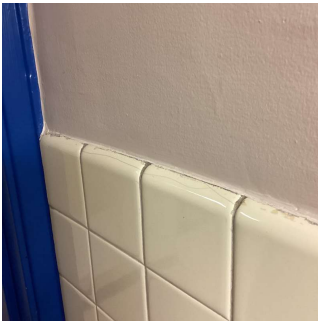
In Room 102
Violations	No violations recorded.
Deficiency	CERAMIC TILE: BROKEN/ MISSING
Deficiency Location/Instance	In Rooms 102, 202
Deficiency Quantity	20
Quantity Uom	S.F.
Potential Action	REPLACE
Urgency of Action	PRIORITY 3
Purpose of Action	LEVEL 2

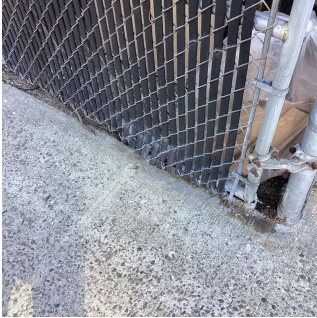
Violations	Rear of Building No violations recorded.
Deficiency	CHAIN LINK: DAMAGED/DETERIORATED
Deficiency Location/Instance	37th Street
Deficiency Quantity	150
Quantity Uom	S.F.
Potential Action	REPLACE
Urgency of Action	PRIORITY 3
Purpose of Action	LEVEL 2
Deficiency Photo1

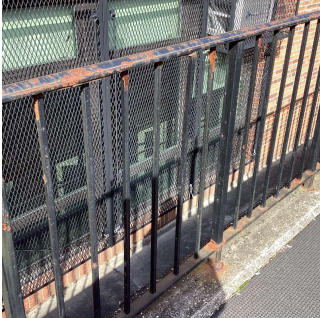
Question	Response
<b>SITE</b>	
<b>PLAYGROUNDS</b>	
<b>Fence</b>	
Condition	3 - Fair
Deficiency	WROUGHT IRON: DAMAGED/DETERIORATED
Deficiency Location/Instance	West Side
Deficiency Quantity	80
Quantity Uom	S.F.
Potential Action	REPLACE
Urgency of Action	PRIORITY 3
Purpose of Action	LEVEL 2
Deficiency Photo1

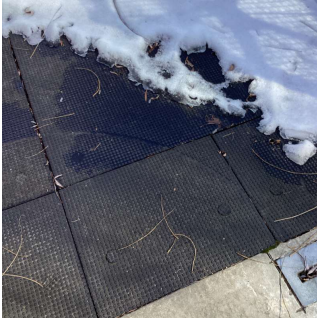
Question	Response
<b>SITE</b>	
<b>PLAYGROUNDS</b>	
<b>Safety Surfacing</b>	
Deficiency Location/Instance	Near Entrance Gate
Deficiency Quantity	10
Quantity Uom	S.F.
Potential Action	REPLACE
Urgency of Action	PRIORITY 3
Purpose of Action	LEVEL 2
Deficiency Photo1
