FEMA DR-GA-1033

INTERAGENCY HAZARD MITIGATION TEAM

FLOODING IN GEORGIA FROM TROPICAL STORM ALBERTO

PREPARED BY THE
BUILDING AND DAM
PERFORMANCE ASSESSMENT TEAM

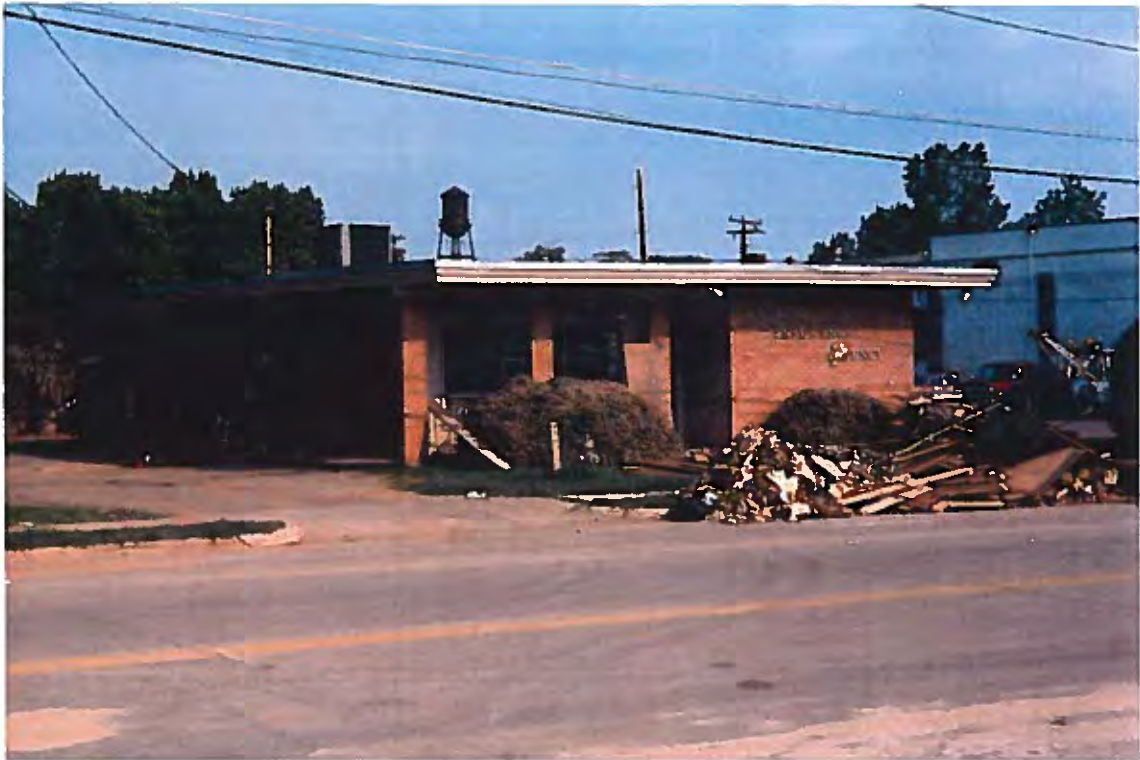
4. Cole insurance office next to Flint River. Loss of interior walls and furnishings.

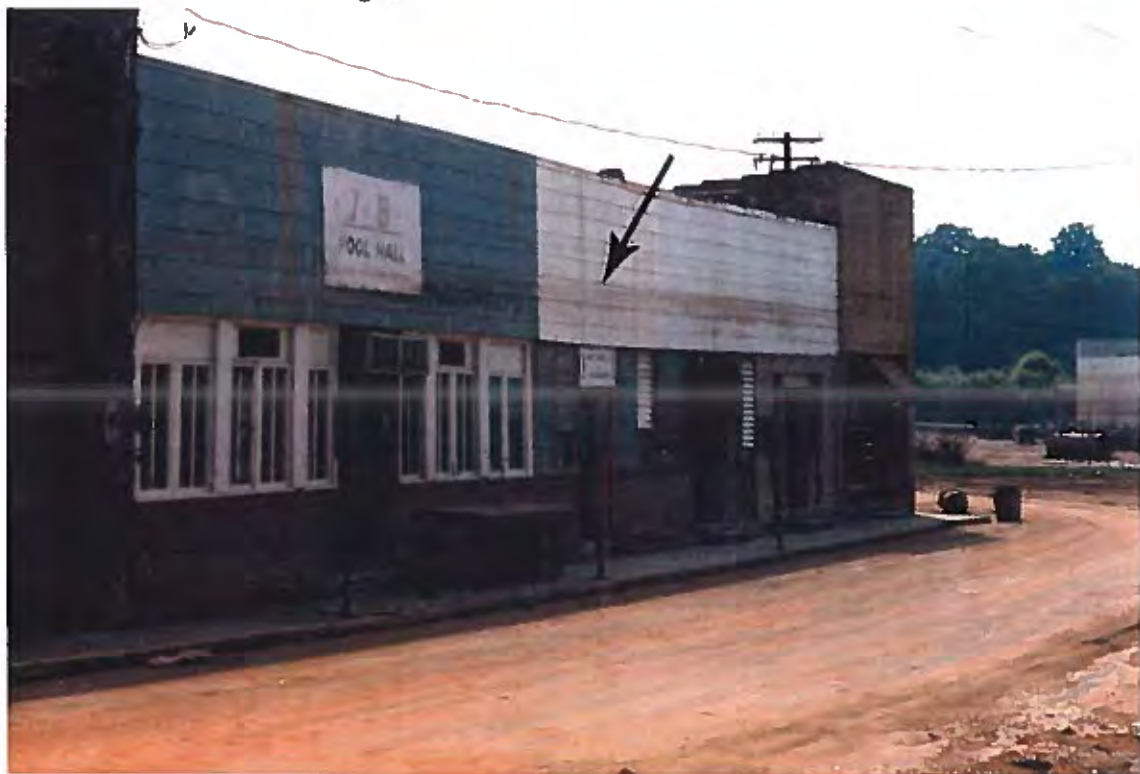
5. 1946 structure with original exterior brick walls. Interior updated with pre-engineered steel columns. High water mark indicated by arrow.

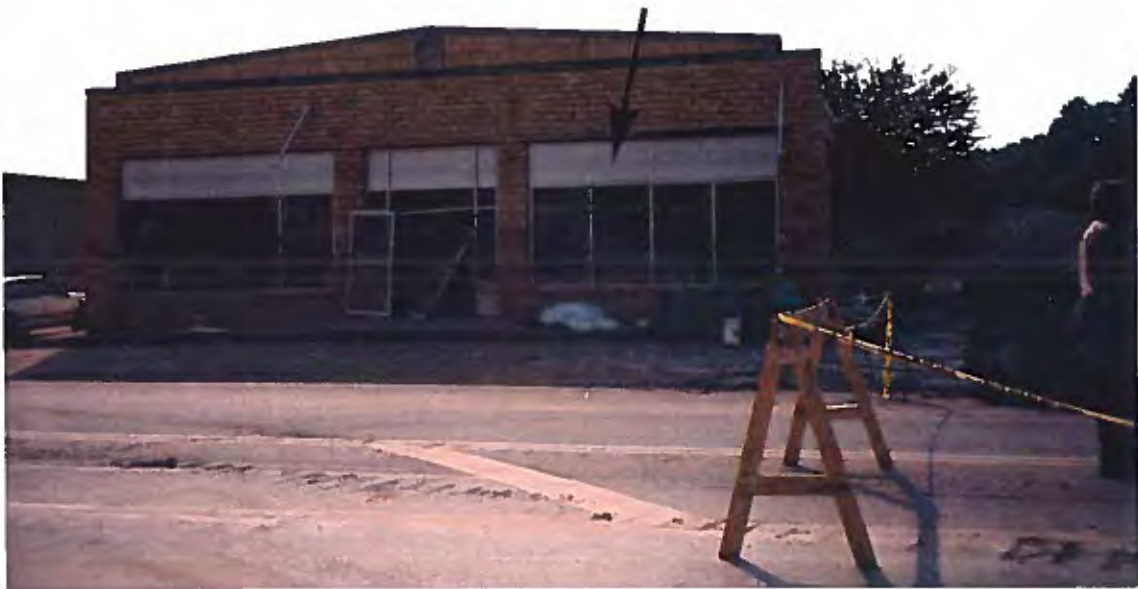
6. View down side street. High water mark indicated by arrow.

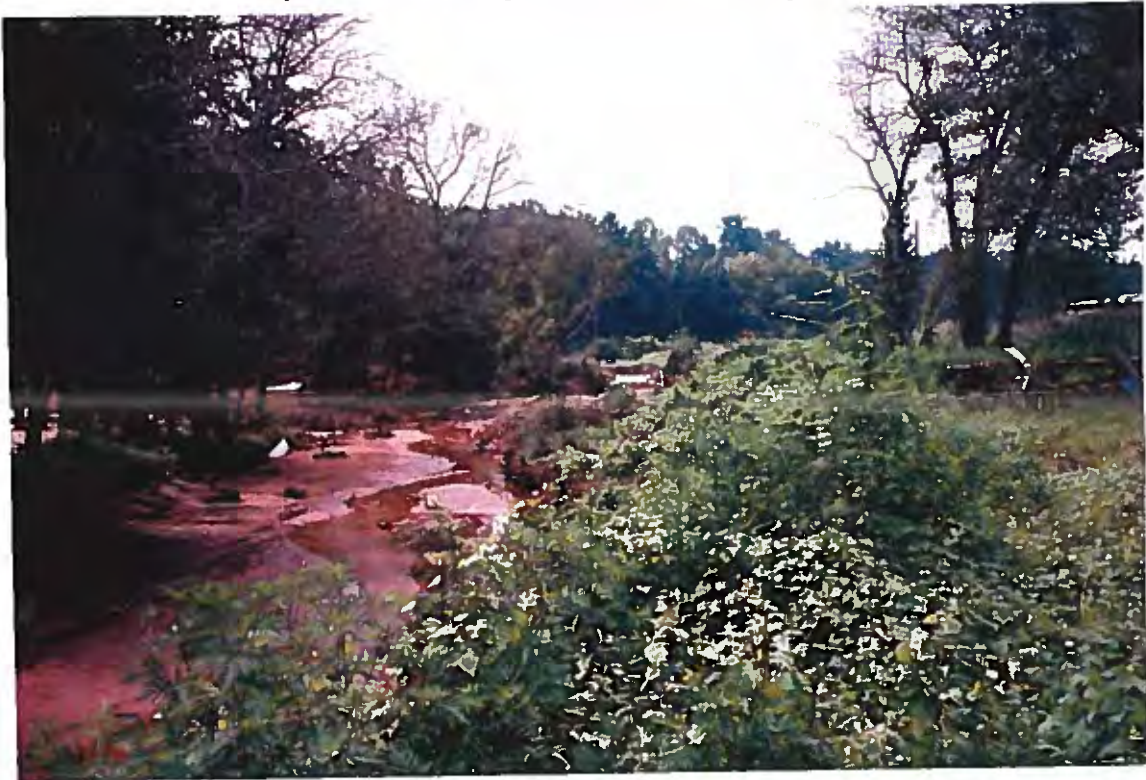
2. Looking down tributary of Town Creek from railroad tracks.
House in photo 1 above located just to the left of creek.

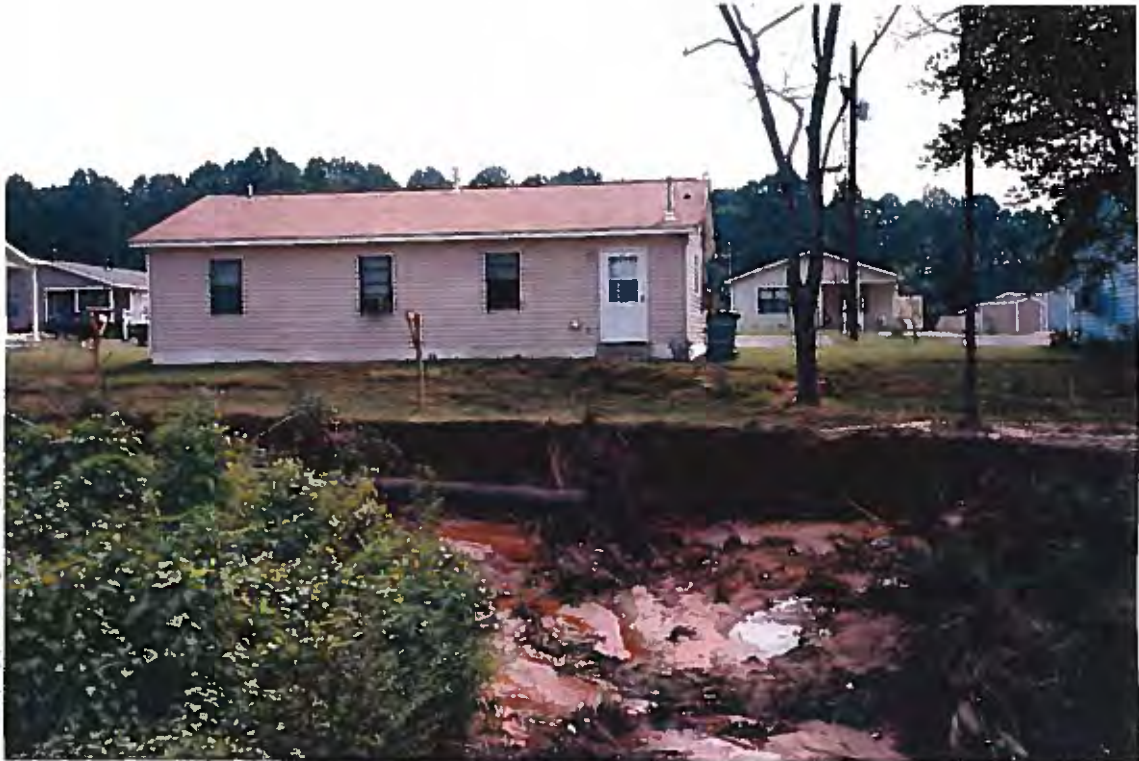
3. Eroded banks along tributary. Proximity of house to creek channel shows danger of siting too close to a waterway.

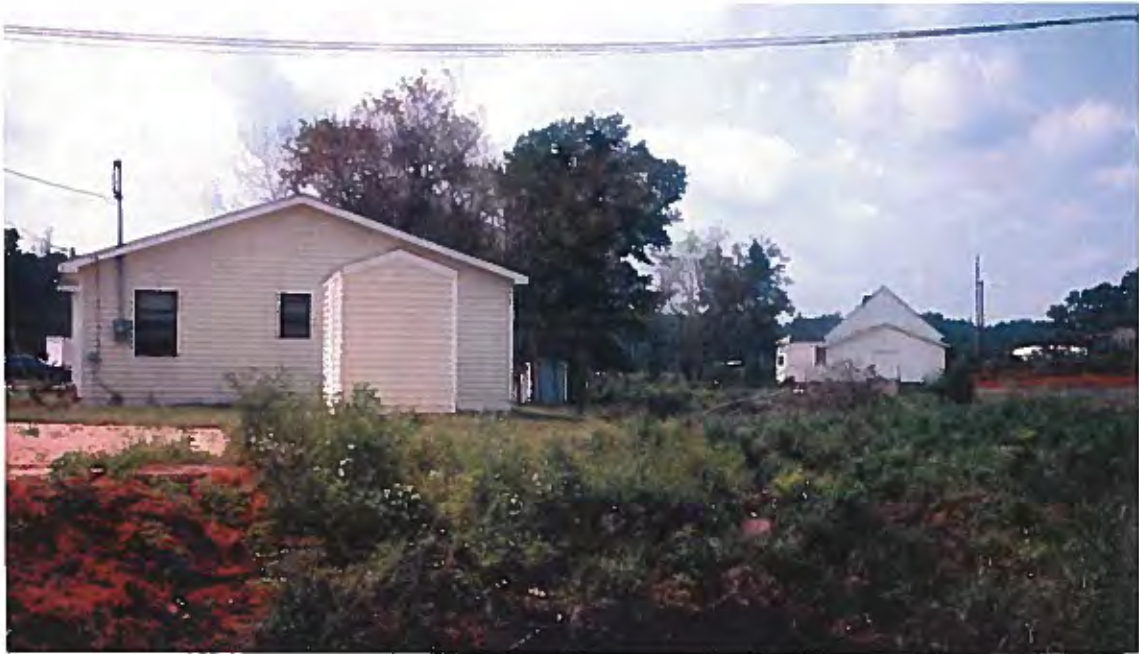
4. Looking downstream from existing storm drain pipe. Discharge from pipe is directed at stream bank; stream meanders to right then turns left and parallels houses. Possible mitigation opportunity exists: channel improvement or proper siting of structures.

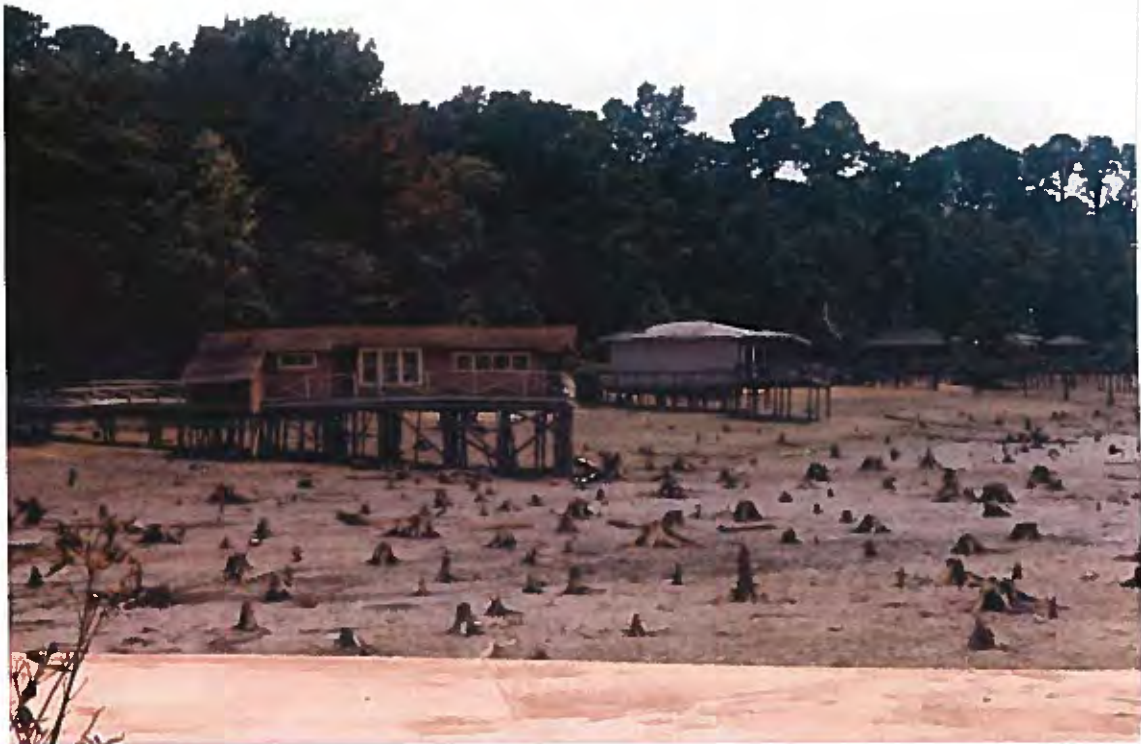
5. View of house on pilings. House damaged by floodwaters that rose high enough to float the structure.

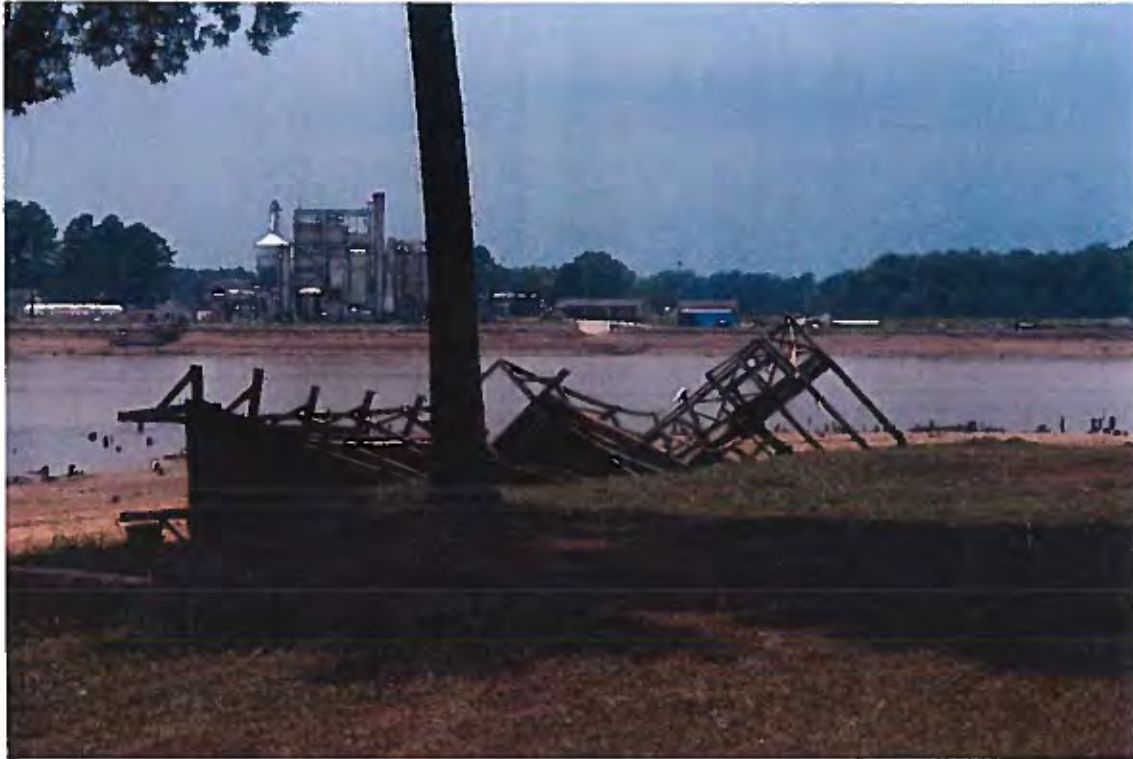
6. View of fishing pier overturned at Walker house on Lakeshore Drive. Possibly floated by rising floodwaters and toppled by the flow of water rushing downstream.

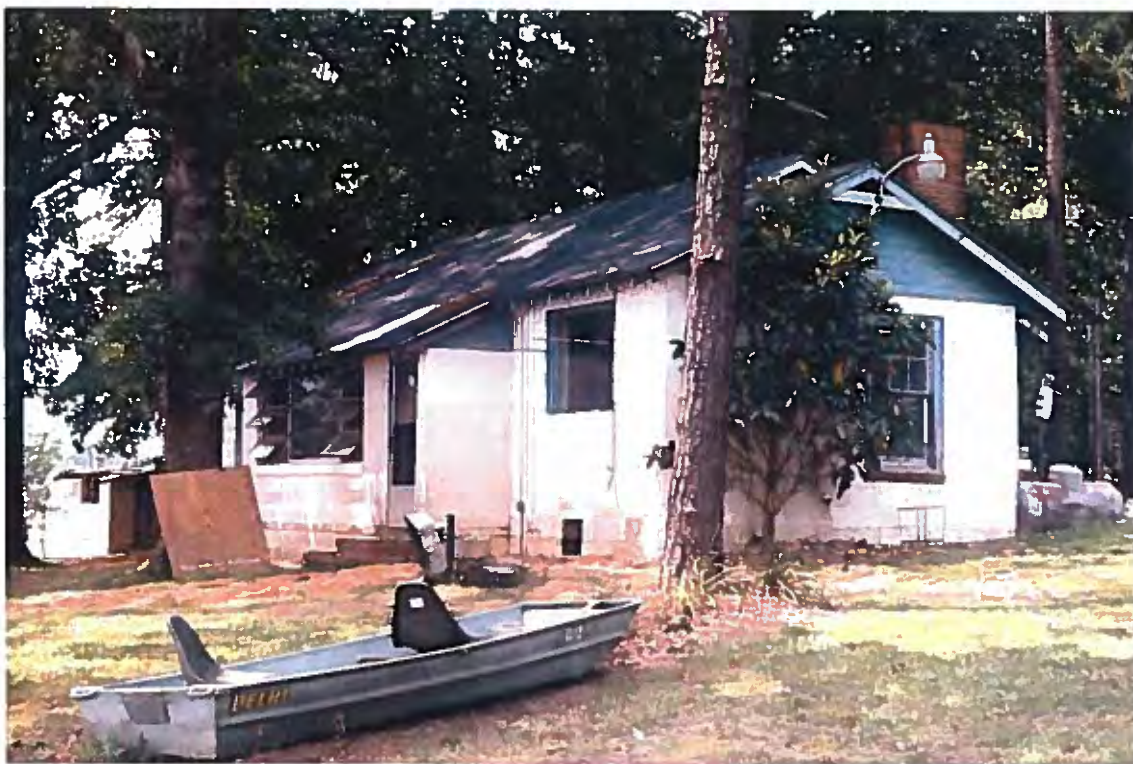
7. Walker House. Water rose above the eaves.

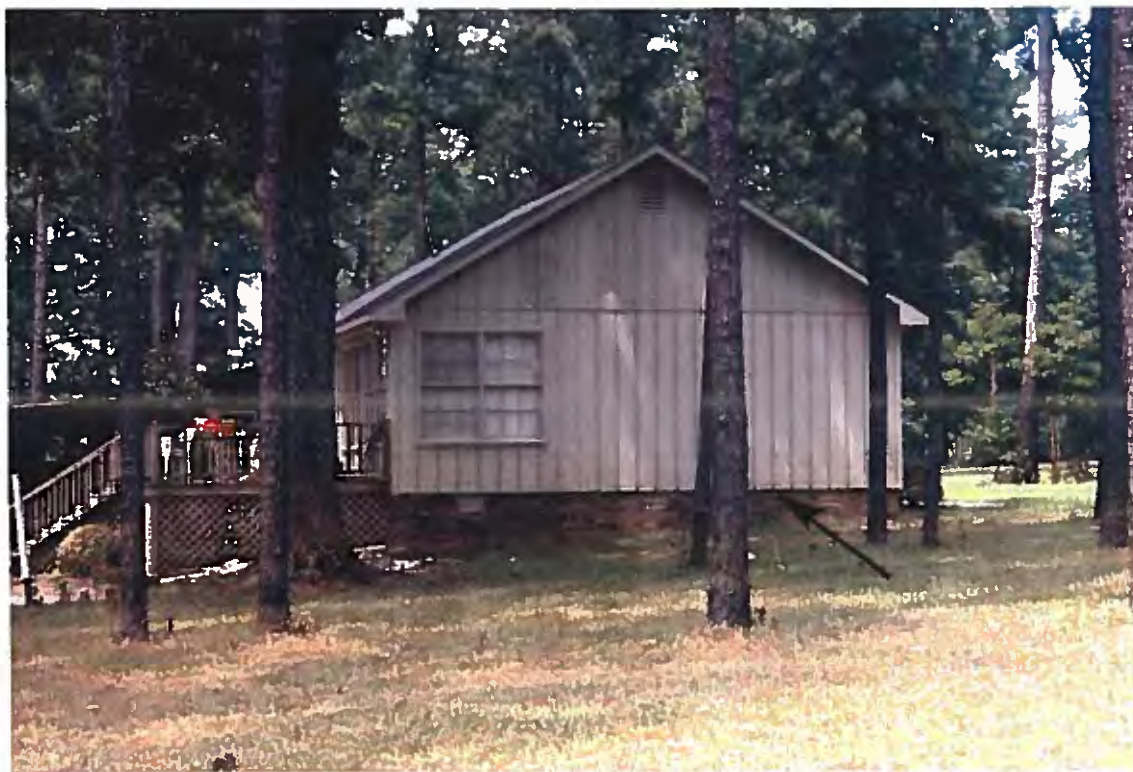
8. View of elevated house. Water mark below first floor level indicated by arrow.

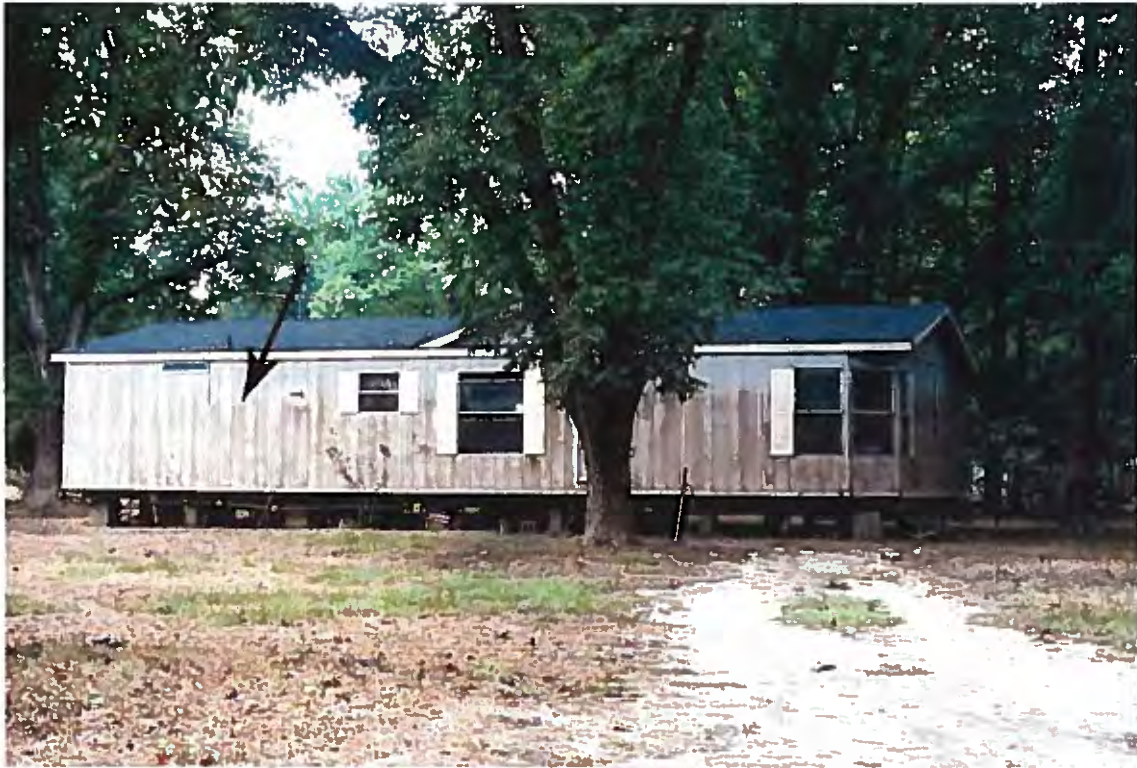
1. Flooded mobile home at intersection of W. Springdale and N. Springdale. High water mark indicated by arrow.

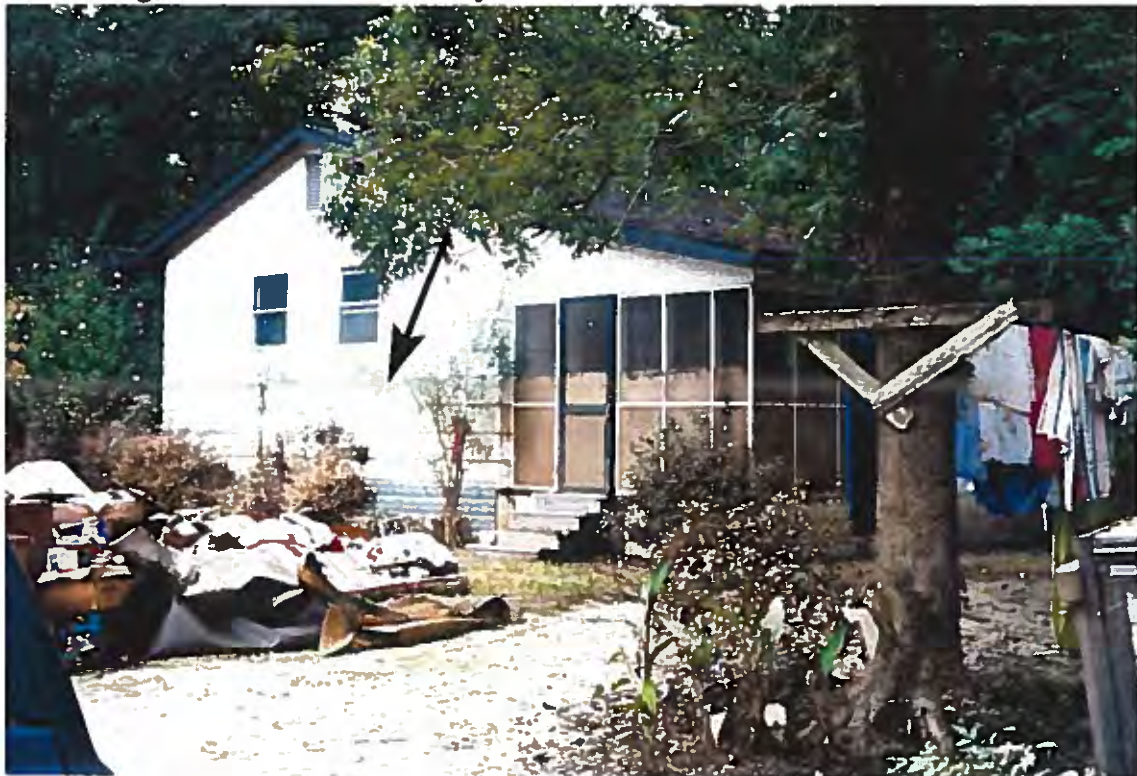
2. House on E. Parks Avenue. High water mark indicated by arrow.

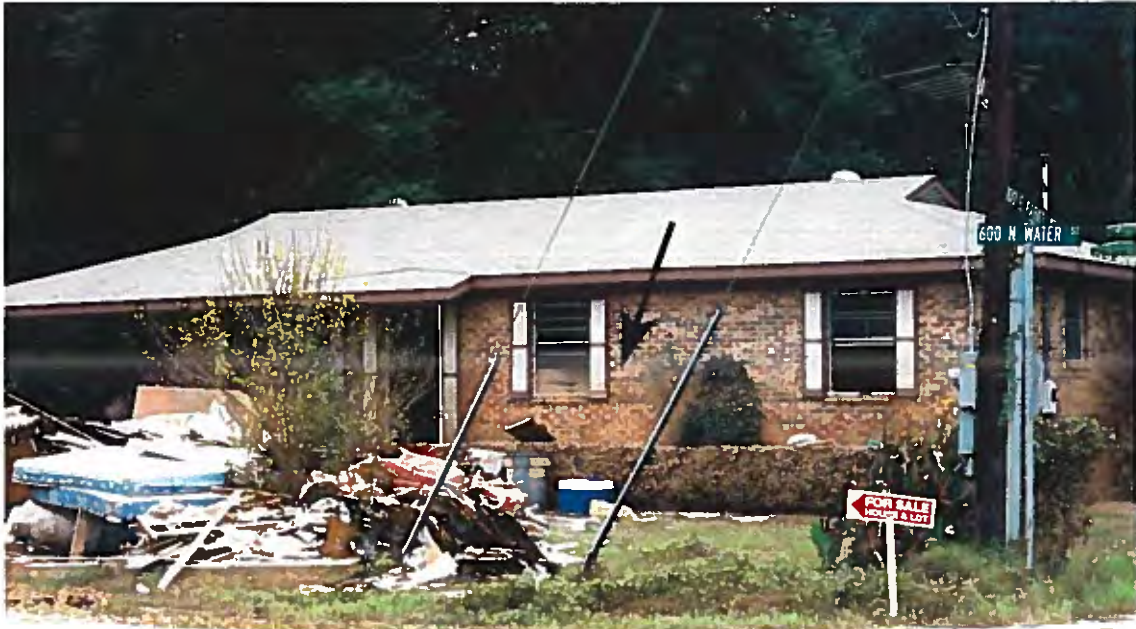
4. House at E. Parks and Water Street. High water mark indicated by arrow.

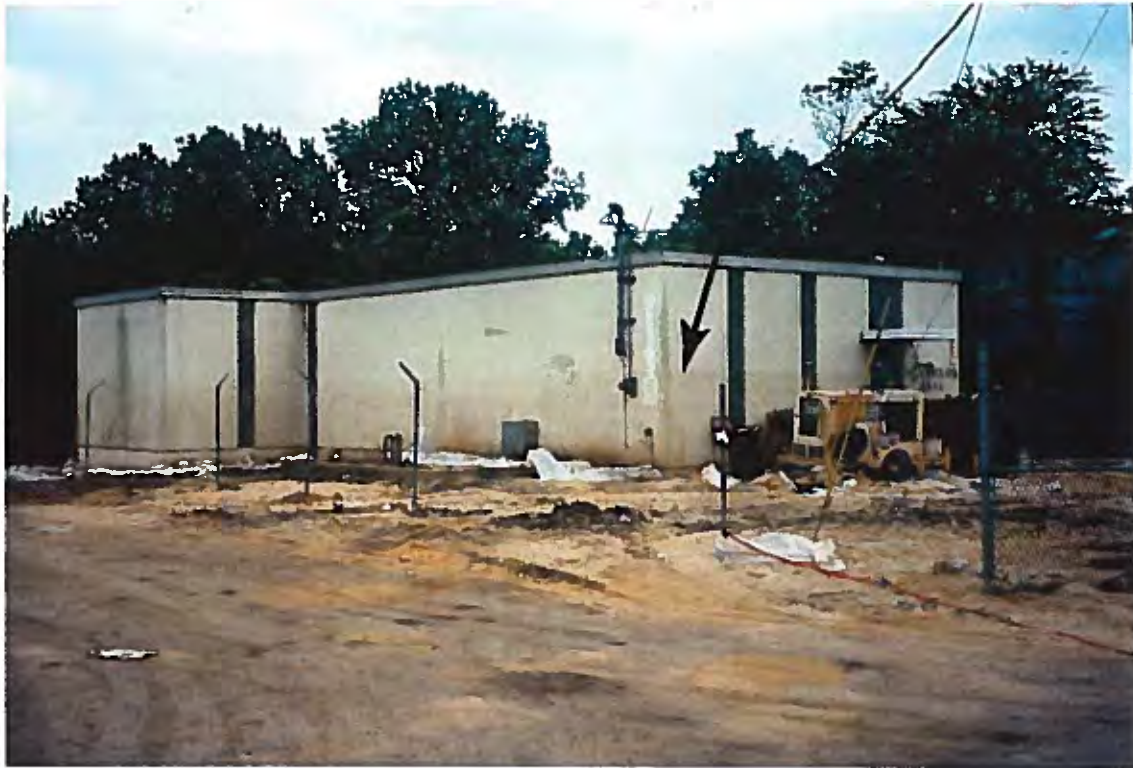
5. Southern Bell Facility at E. Phipps and Water Street. High water mark indicated by arrow.

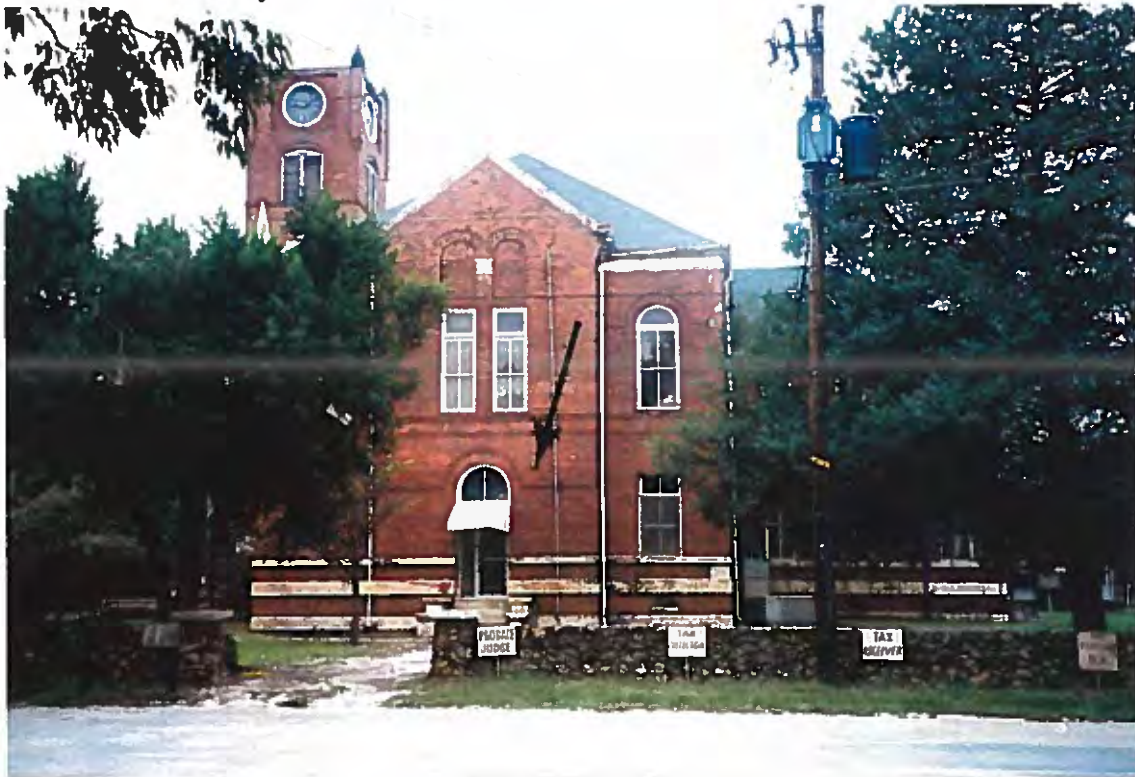
6. Courthouse. High water mark indicated by arrow.

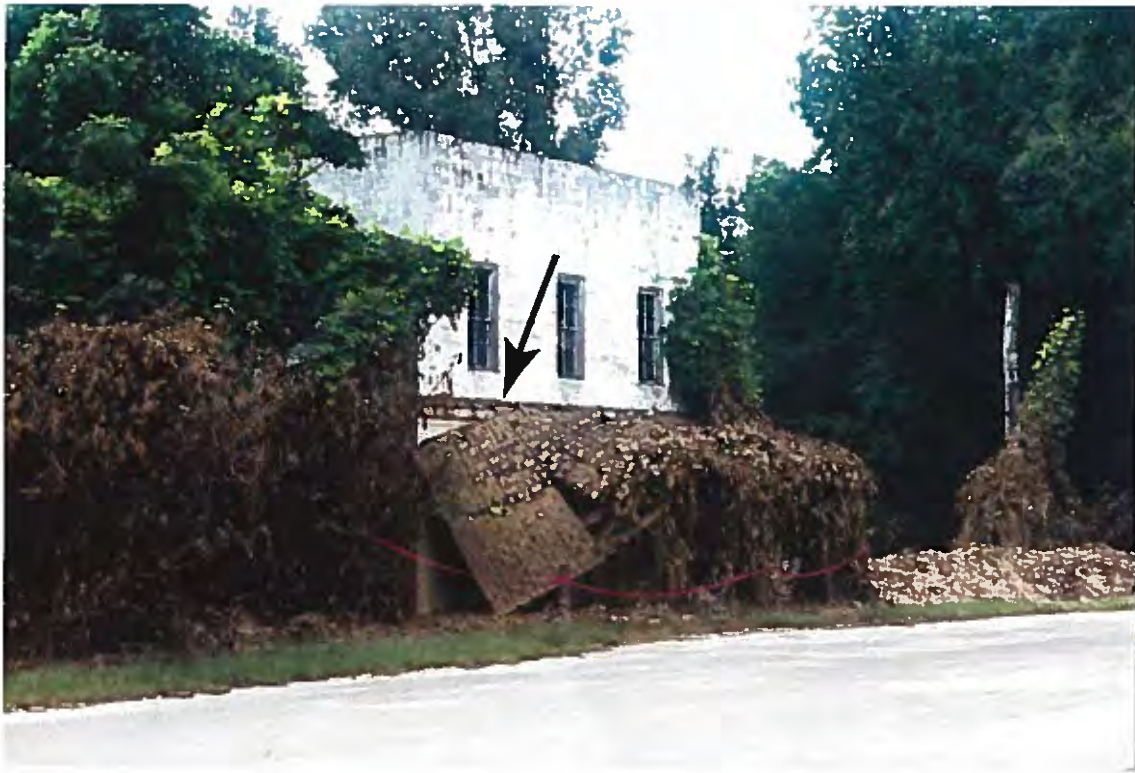
9. Abandoned commercial building at Hall and S. Water Street. High water mark indicated by arrow.

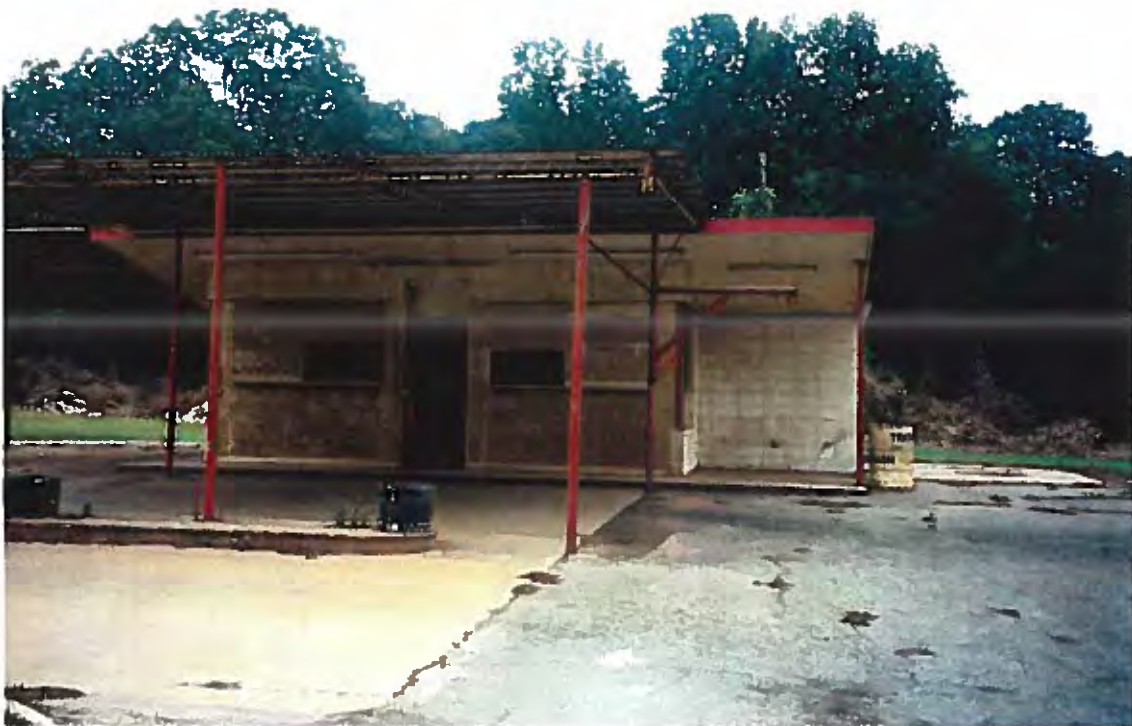
10. Abandoned commercial building on Main Street was completely inundated.

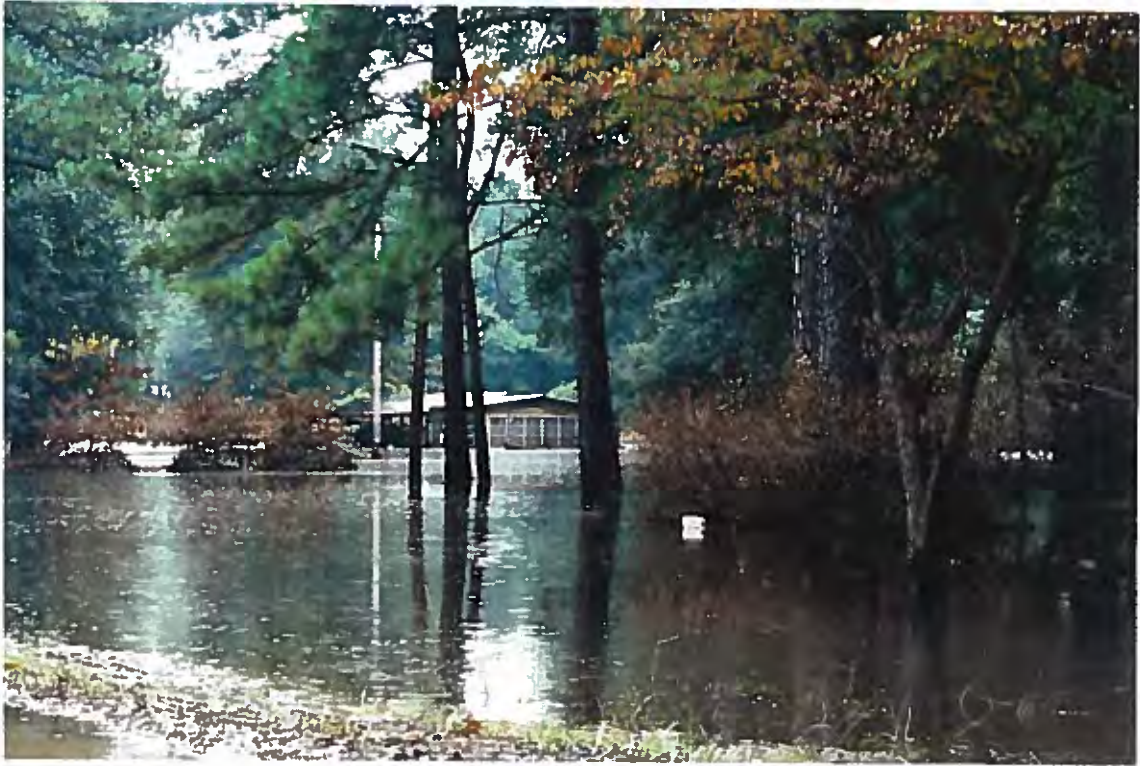
14. House on Clear Water Street still flooded.

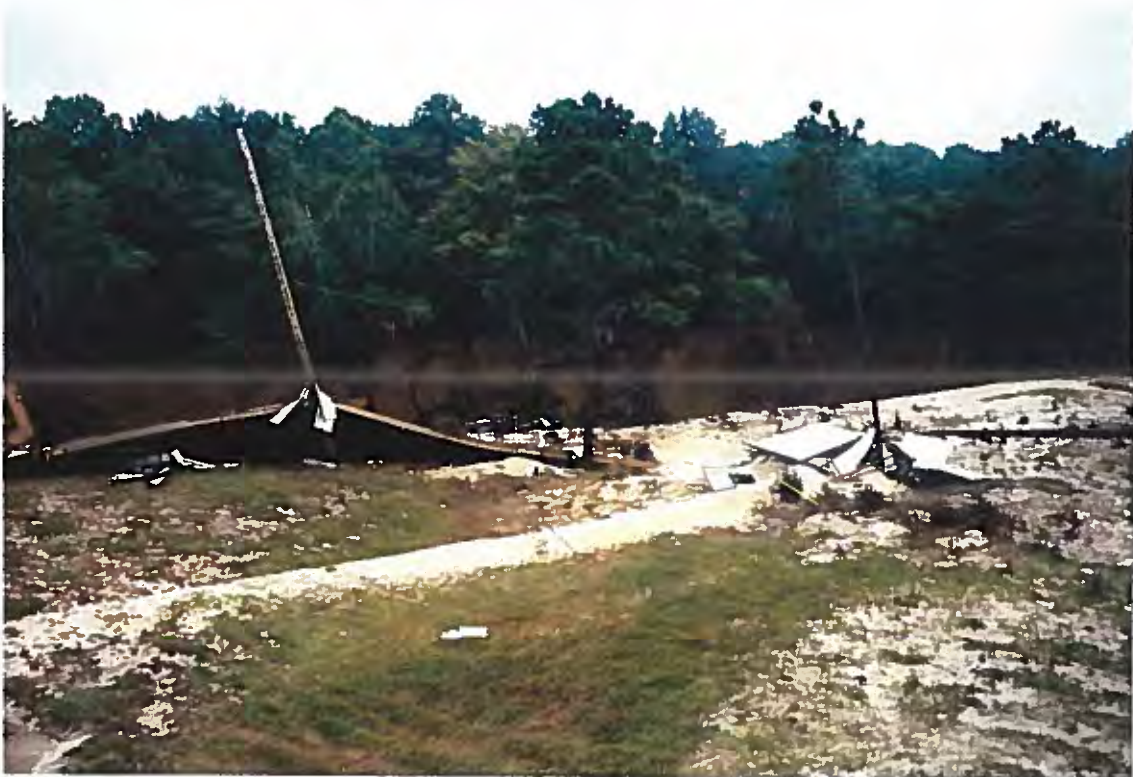
15. Remains of Rivertrace Restaurant along bank of Flint River at State Route 37 Bridge

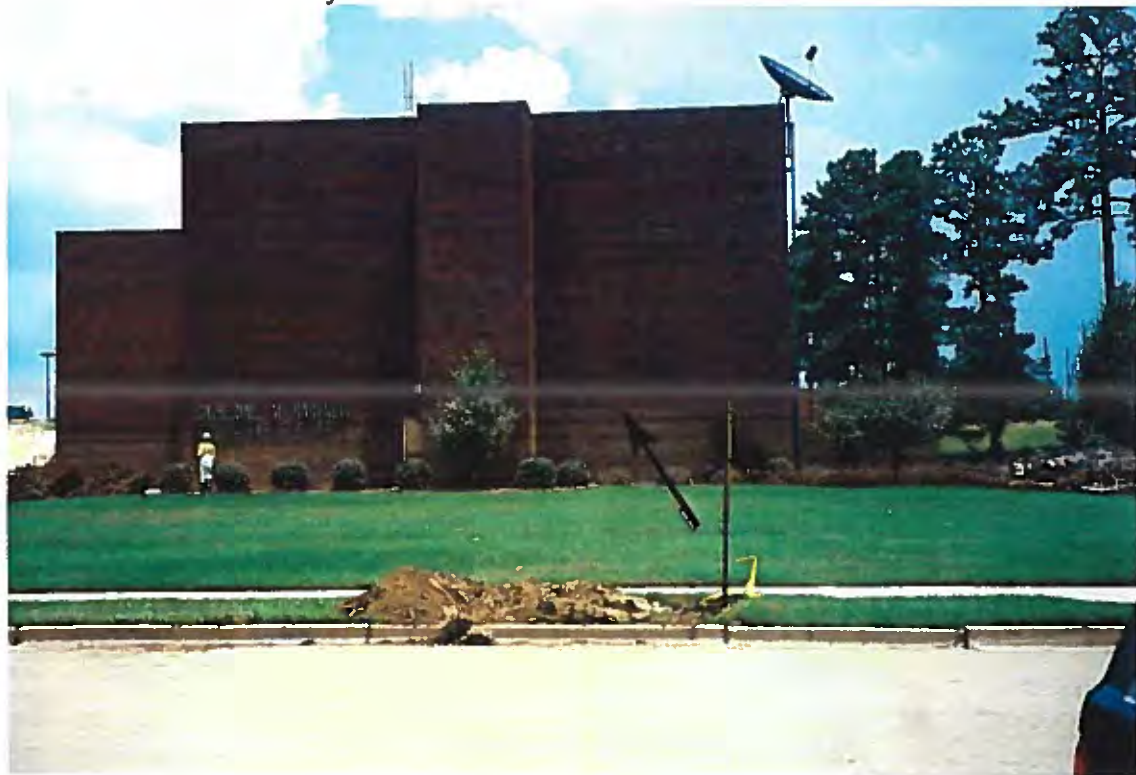
2. Hartnett Criminal Justice Building. High water mark indicated by arrow.

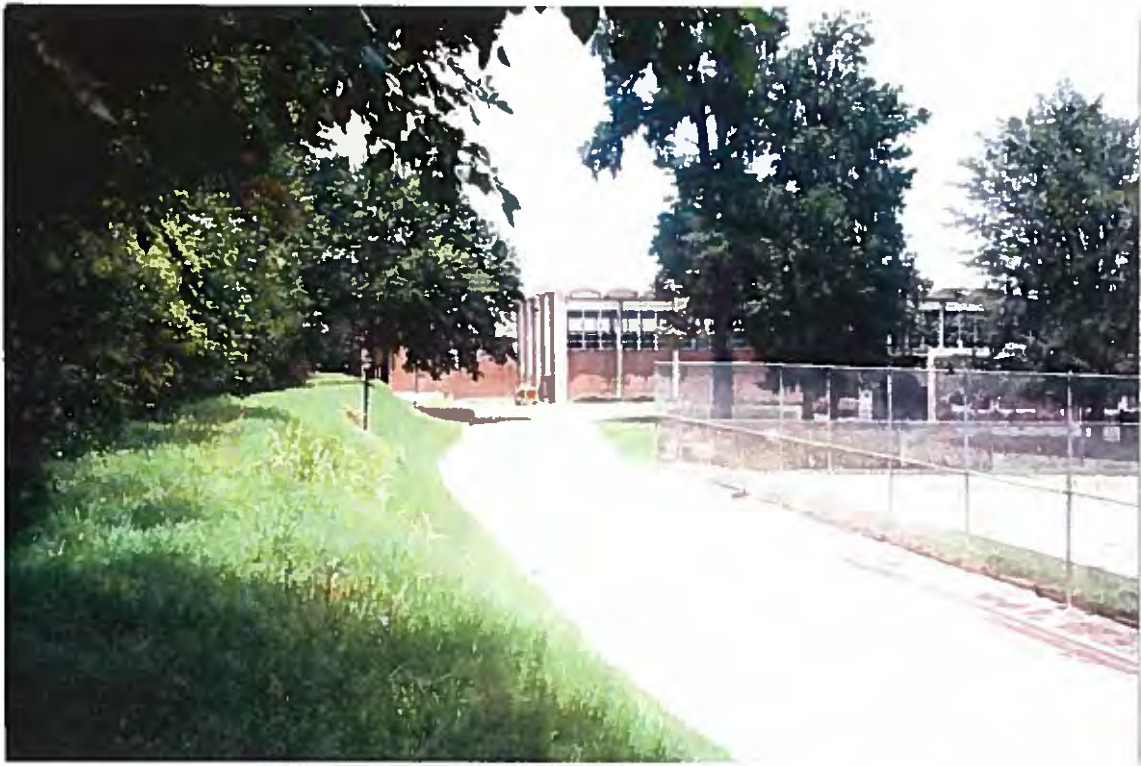
3. Looking toward gymnasium. Levee at left.

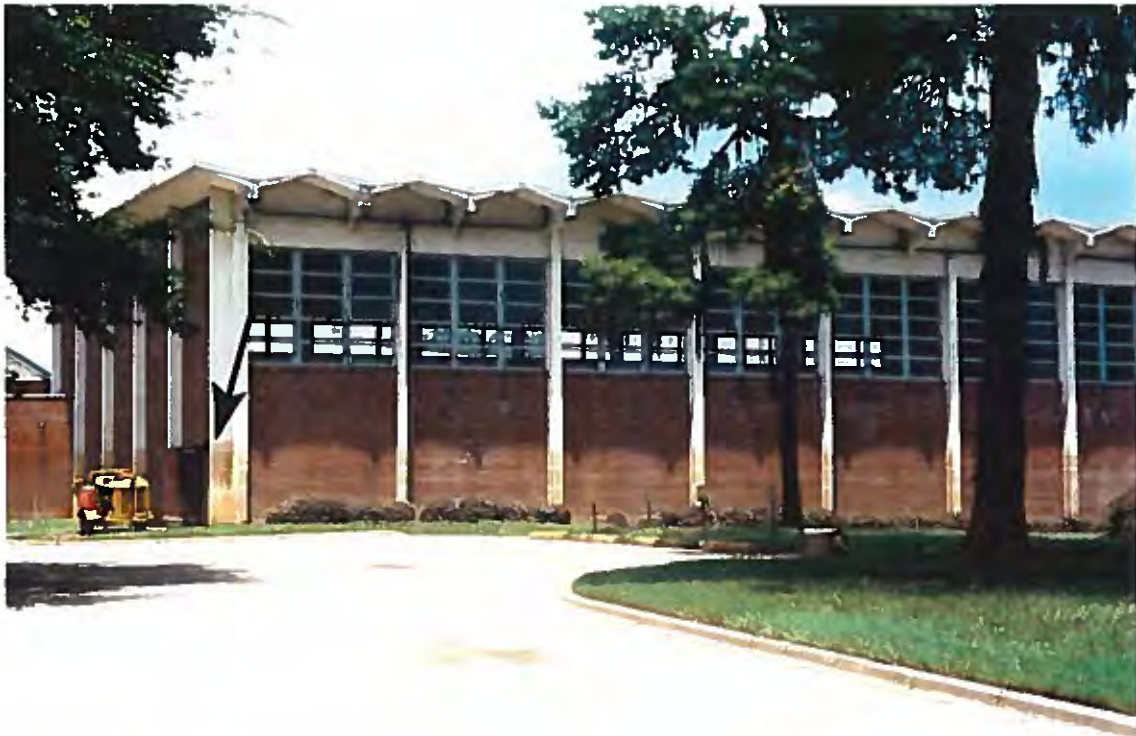
5. Sanford Hall gymnasium and pool. High water mark indicated by arrow.

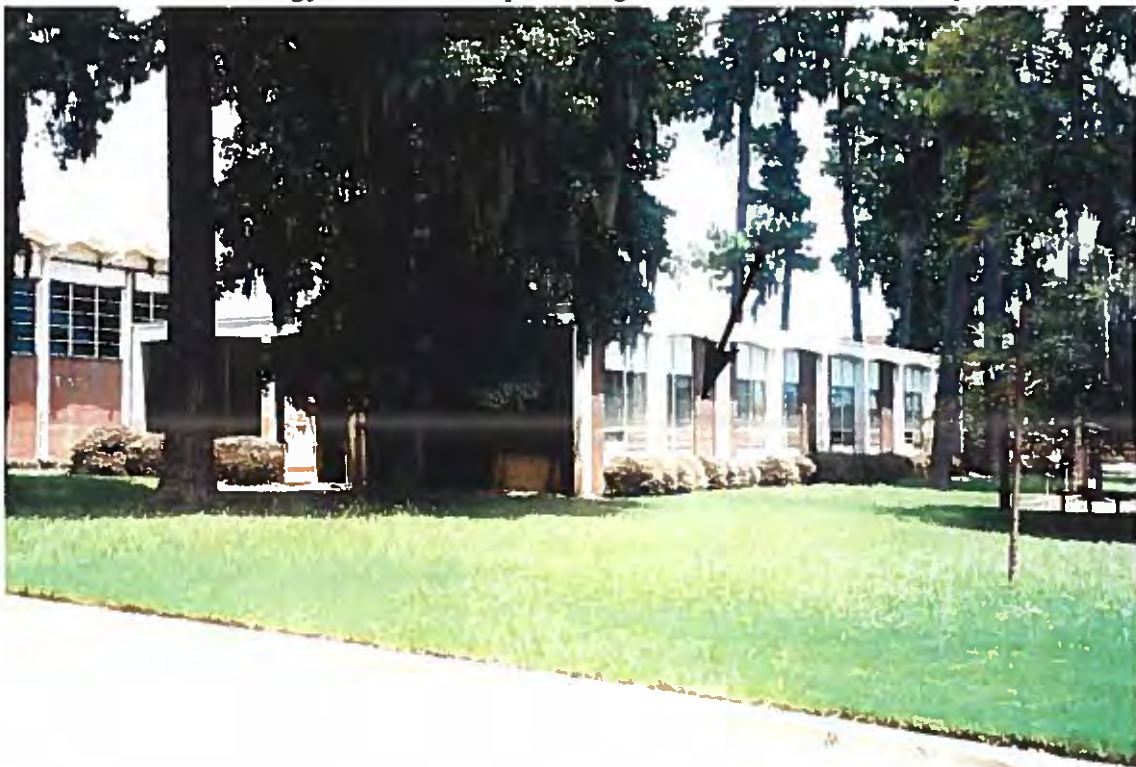
6. Hattie Malone Infirmary. High water mark indicated by arrow.

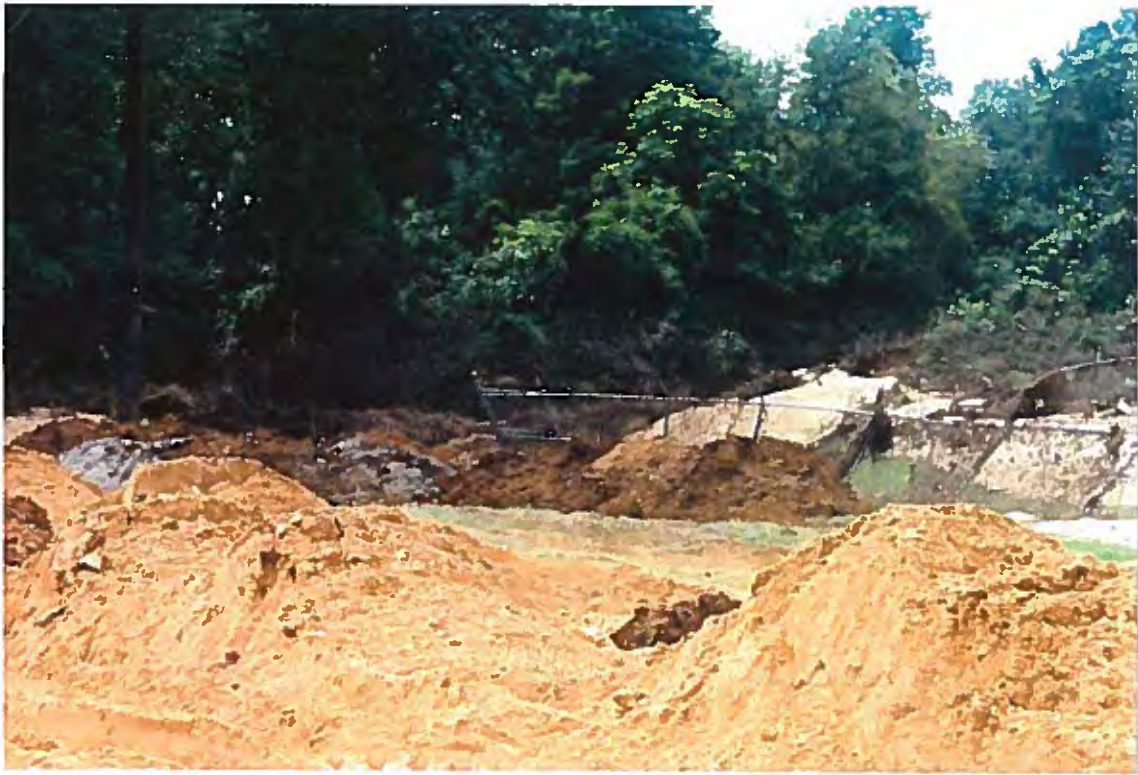
11. Breach in levee near end of recreation field.

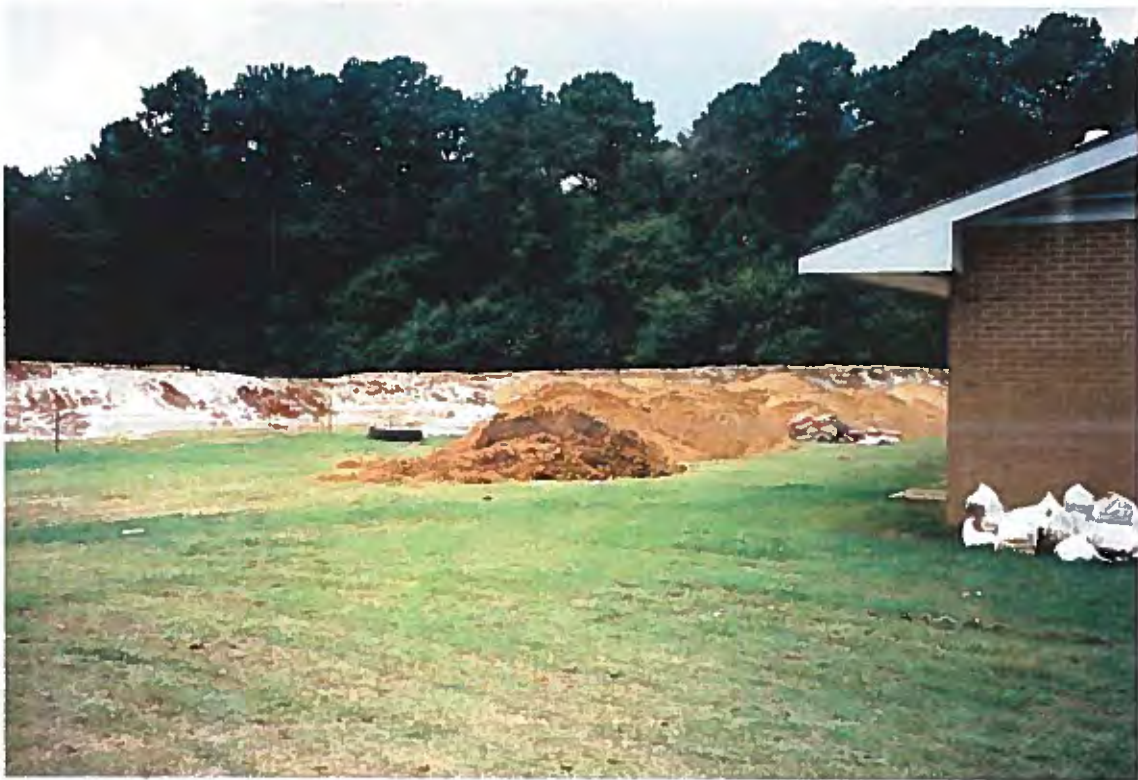
12. Temporary emergency levee at lower end of recreation field.

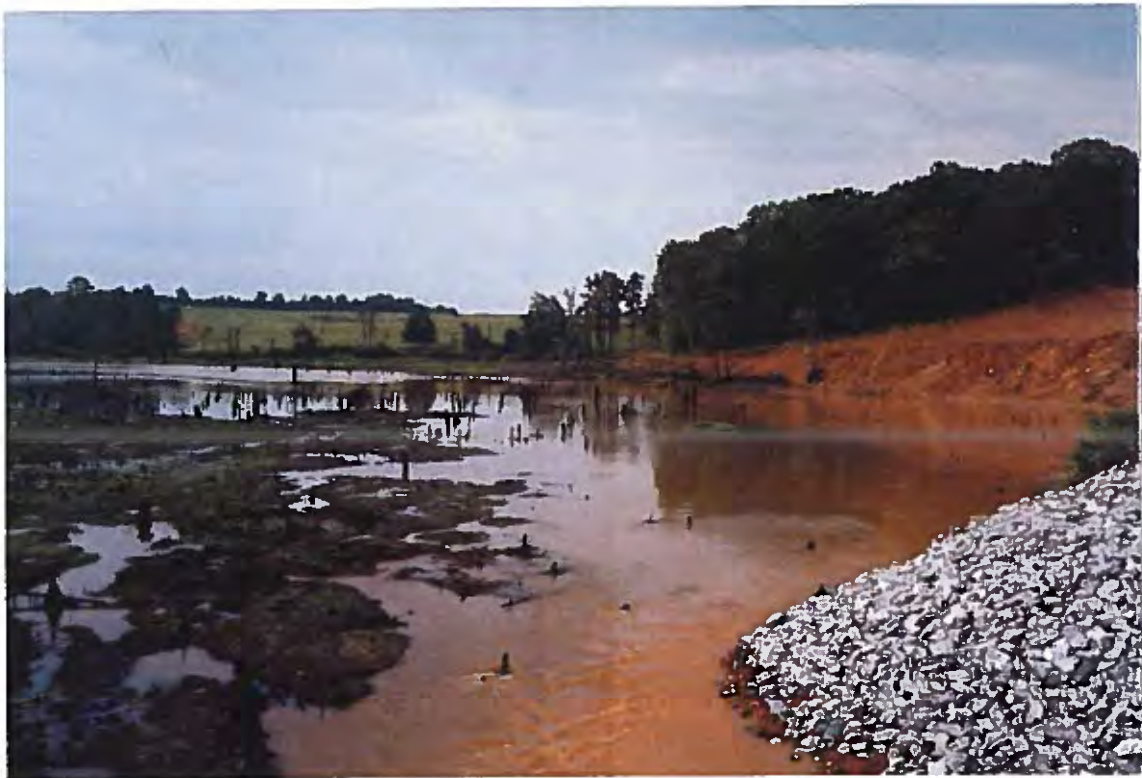
2. Lake area after loss of water
