FEMA DR-GA-1033

INTERAGENCY HAZARD MITIGATION TEAM

FLOODING IN GEORGIA FROM TROPICAL STORM ALBERTO

PREPARED BY THE
BUILDING AND DAM
PERFORMANCE ASSESSMENT TEAM

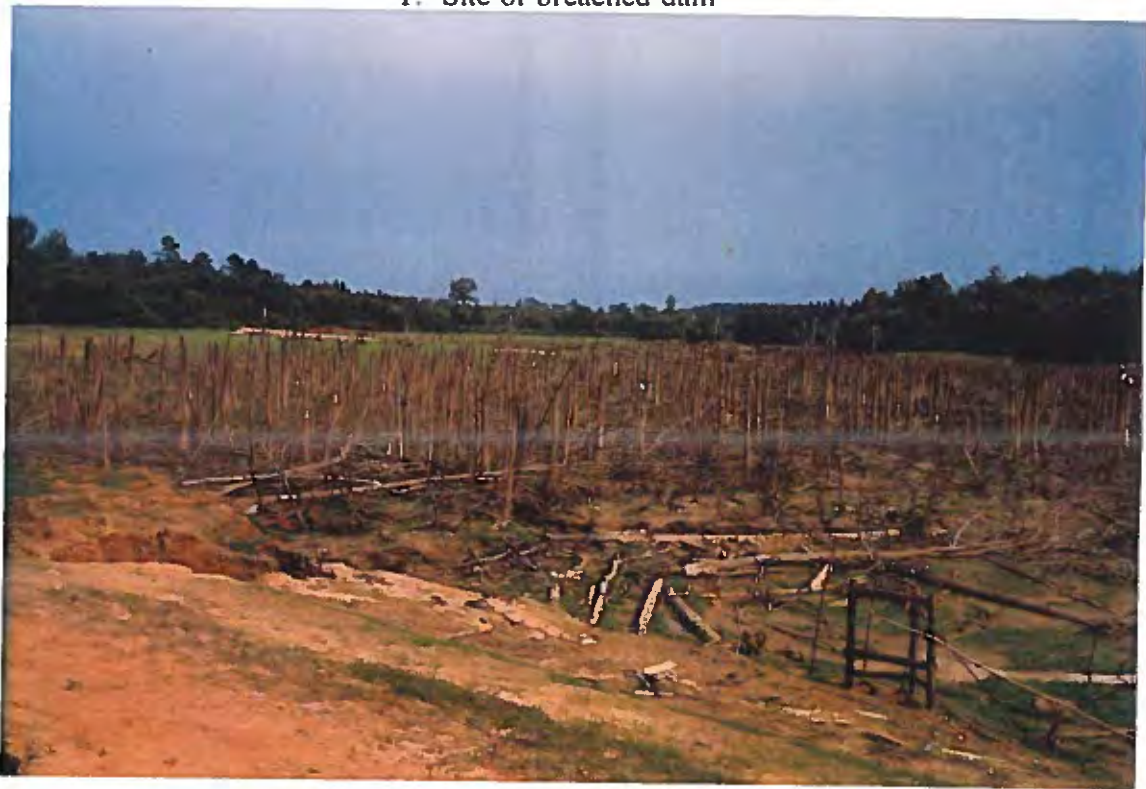
2. Lake area after loss of water

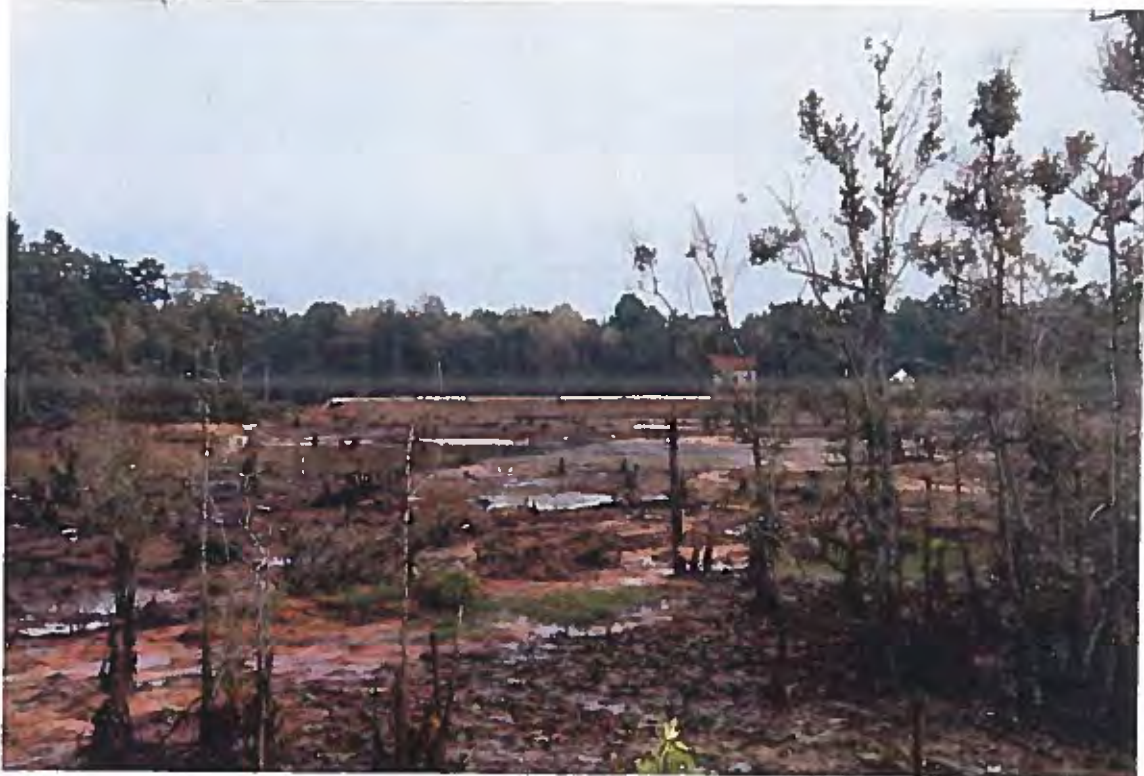
2. Lake area after loss of water

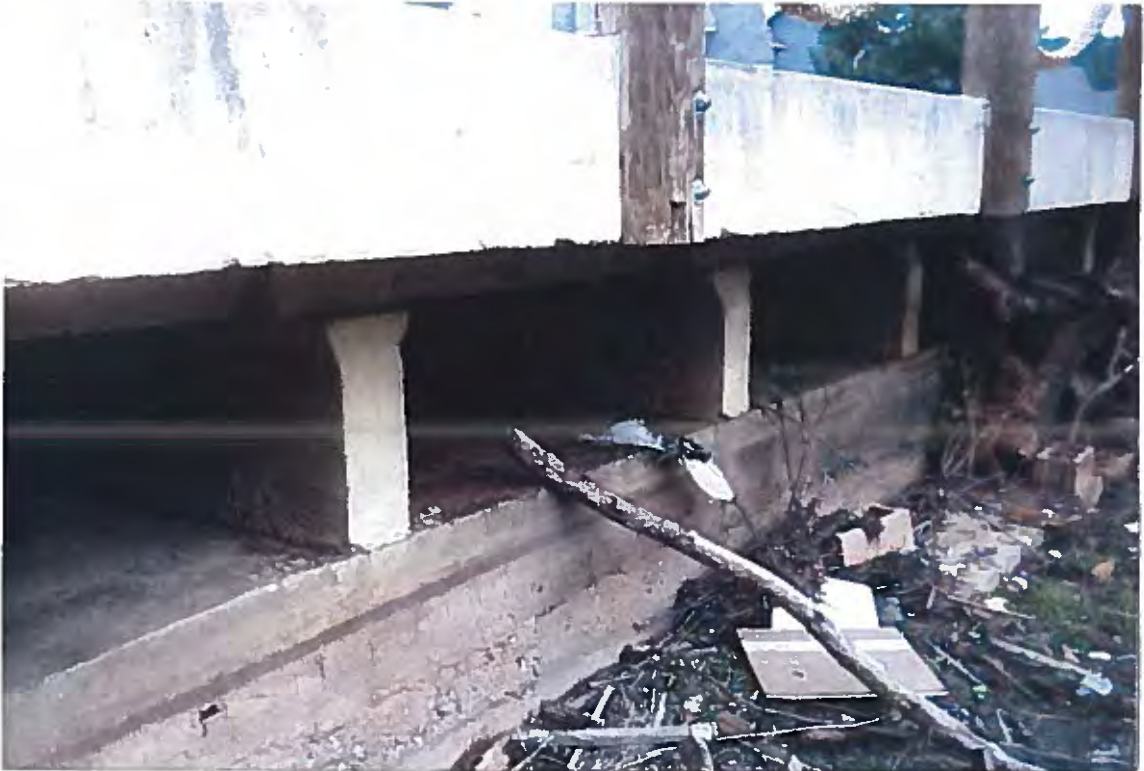
2. Closeup of control structure showing clogged openings

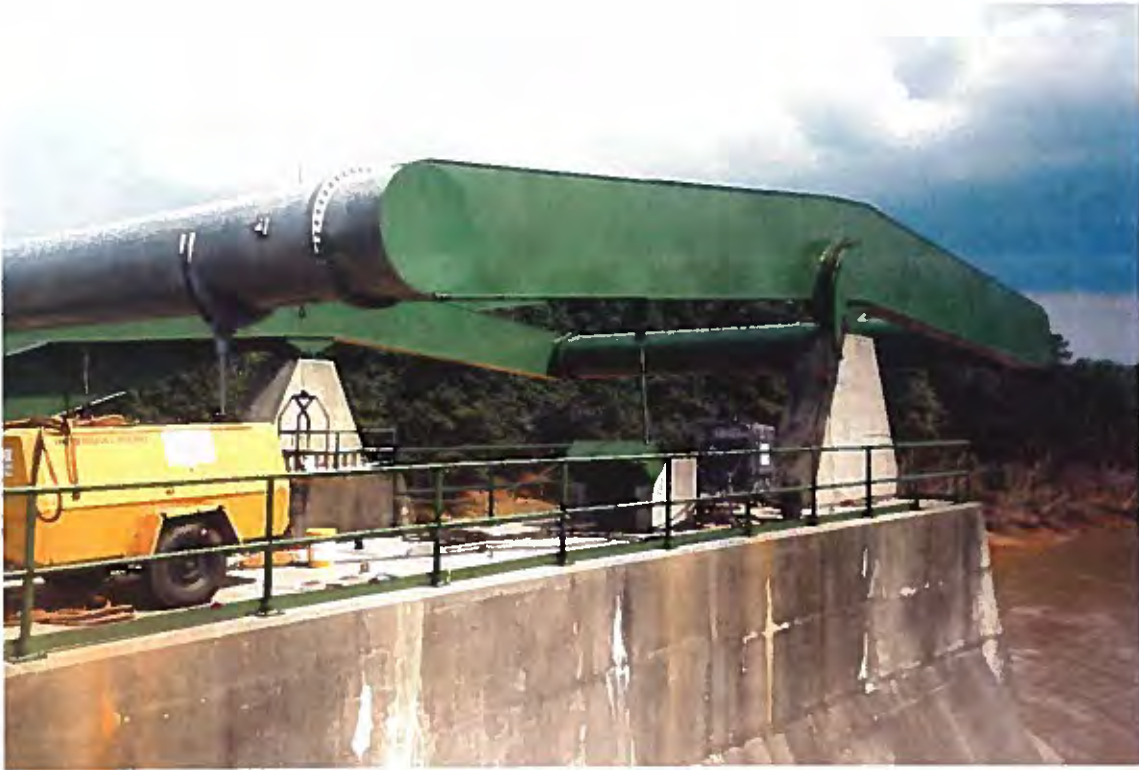
2. Gate counterweight

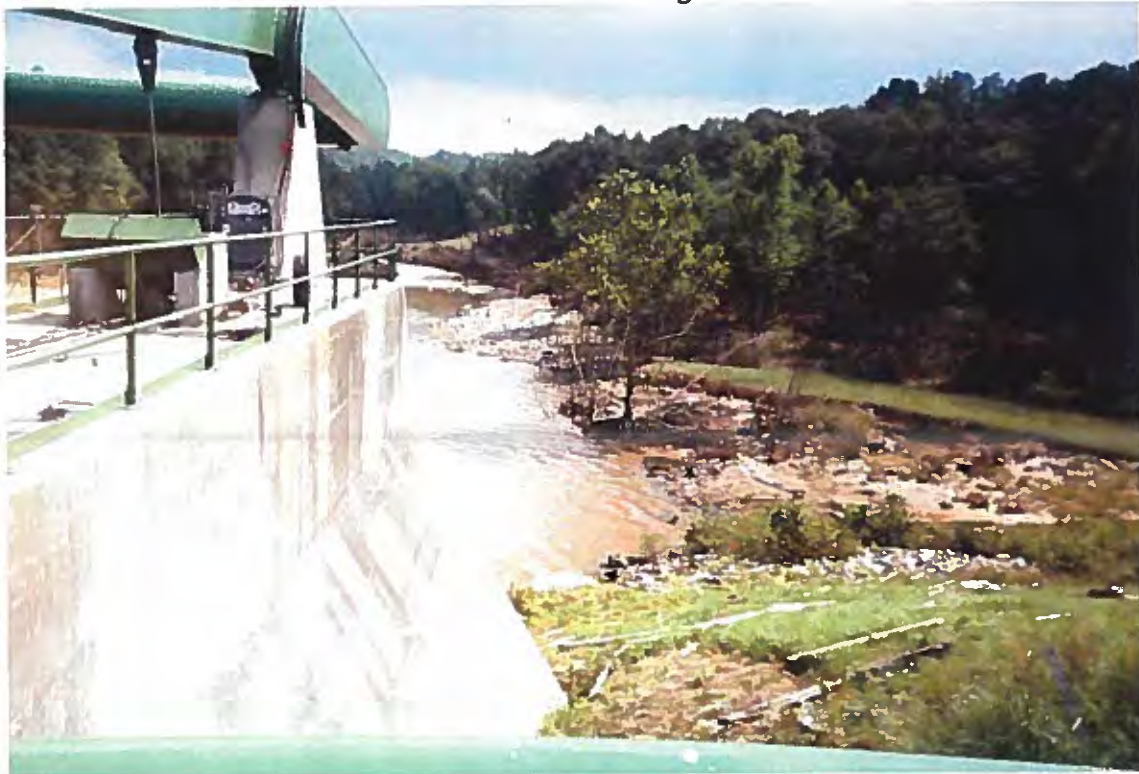
3. Downstream erosion

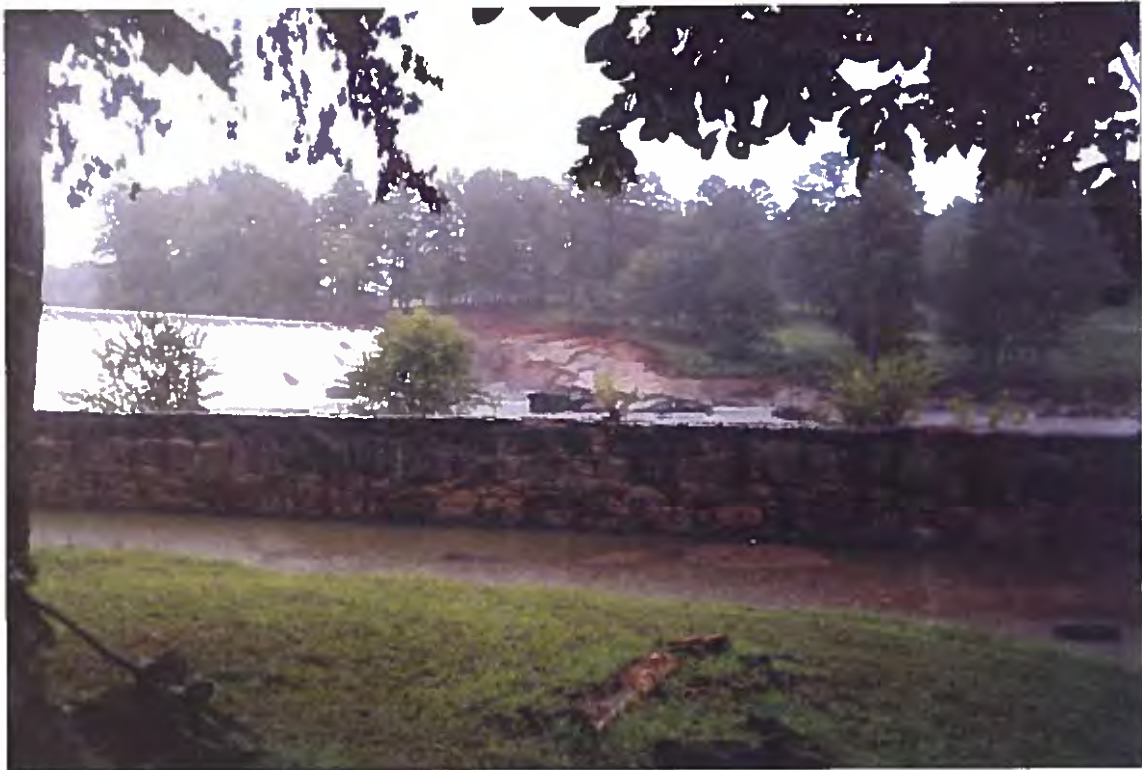
2. Erosion at dam abutment

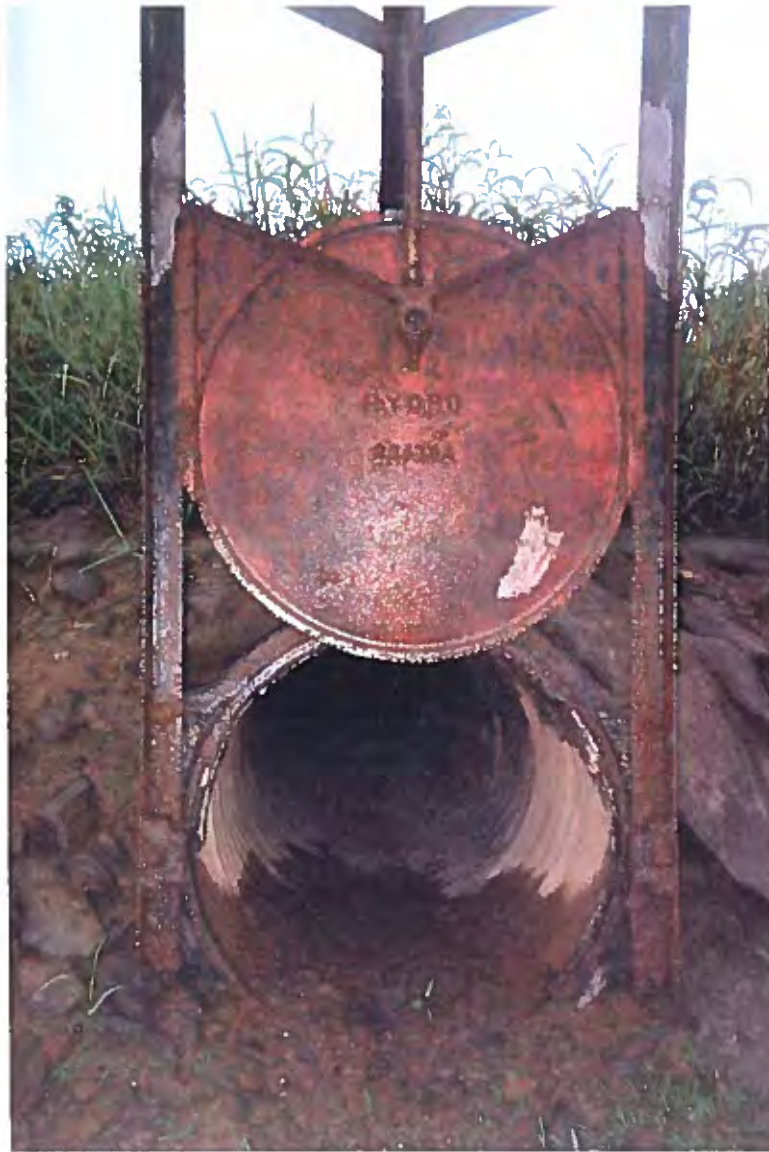
3. Undersized outlet
