INVESTIGATION OF THE CAUSE OF QUAIL CREEK DIKE FAILURE

Report of Independent Review Team

March 7, 1989

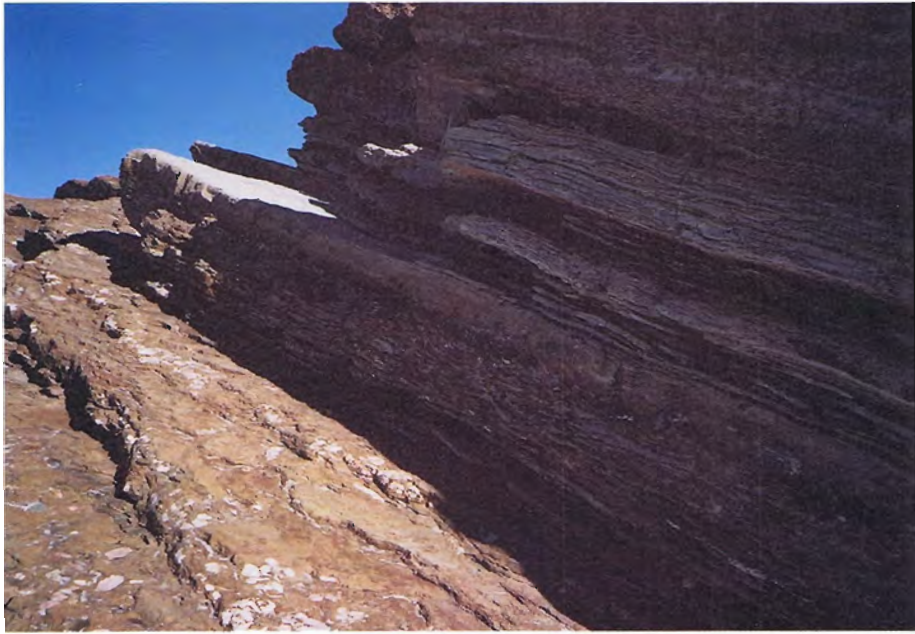
26. View of bedding showing variability of erodibility within a rock unit.
