TENNESSEE VALLEY AUTHORITY

SUBJECT: REPORT ON FAILURE OF WHEELER LOCK

REPORT ON FAILURE OF WHEELER LOCK

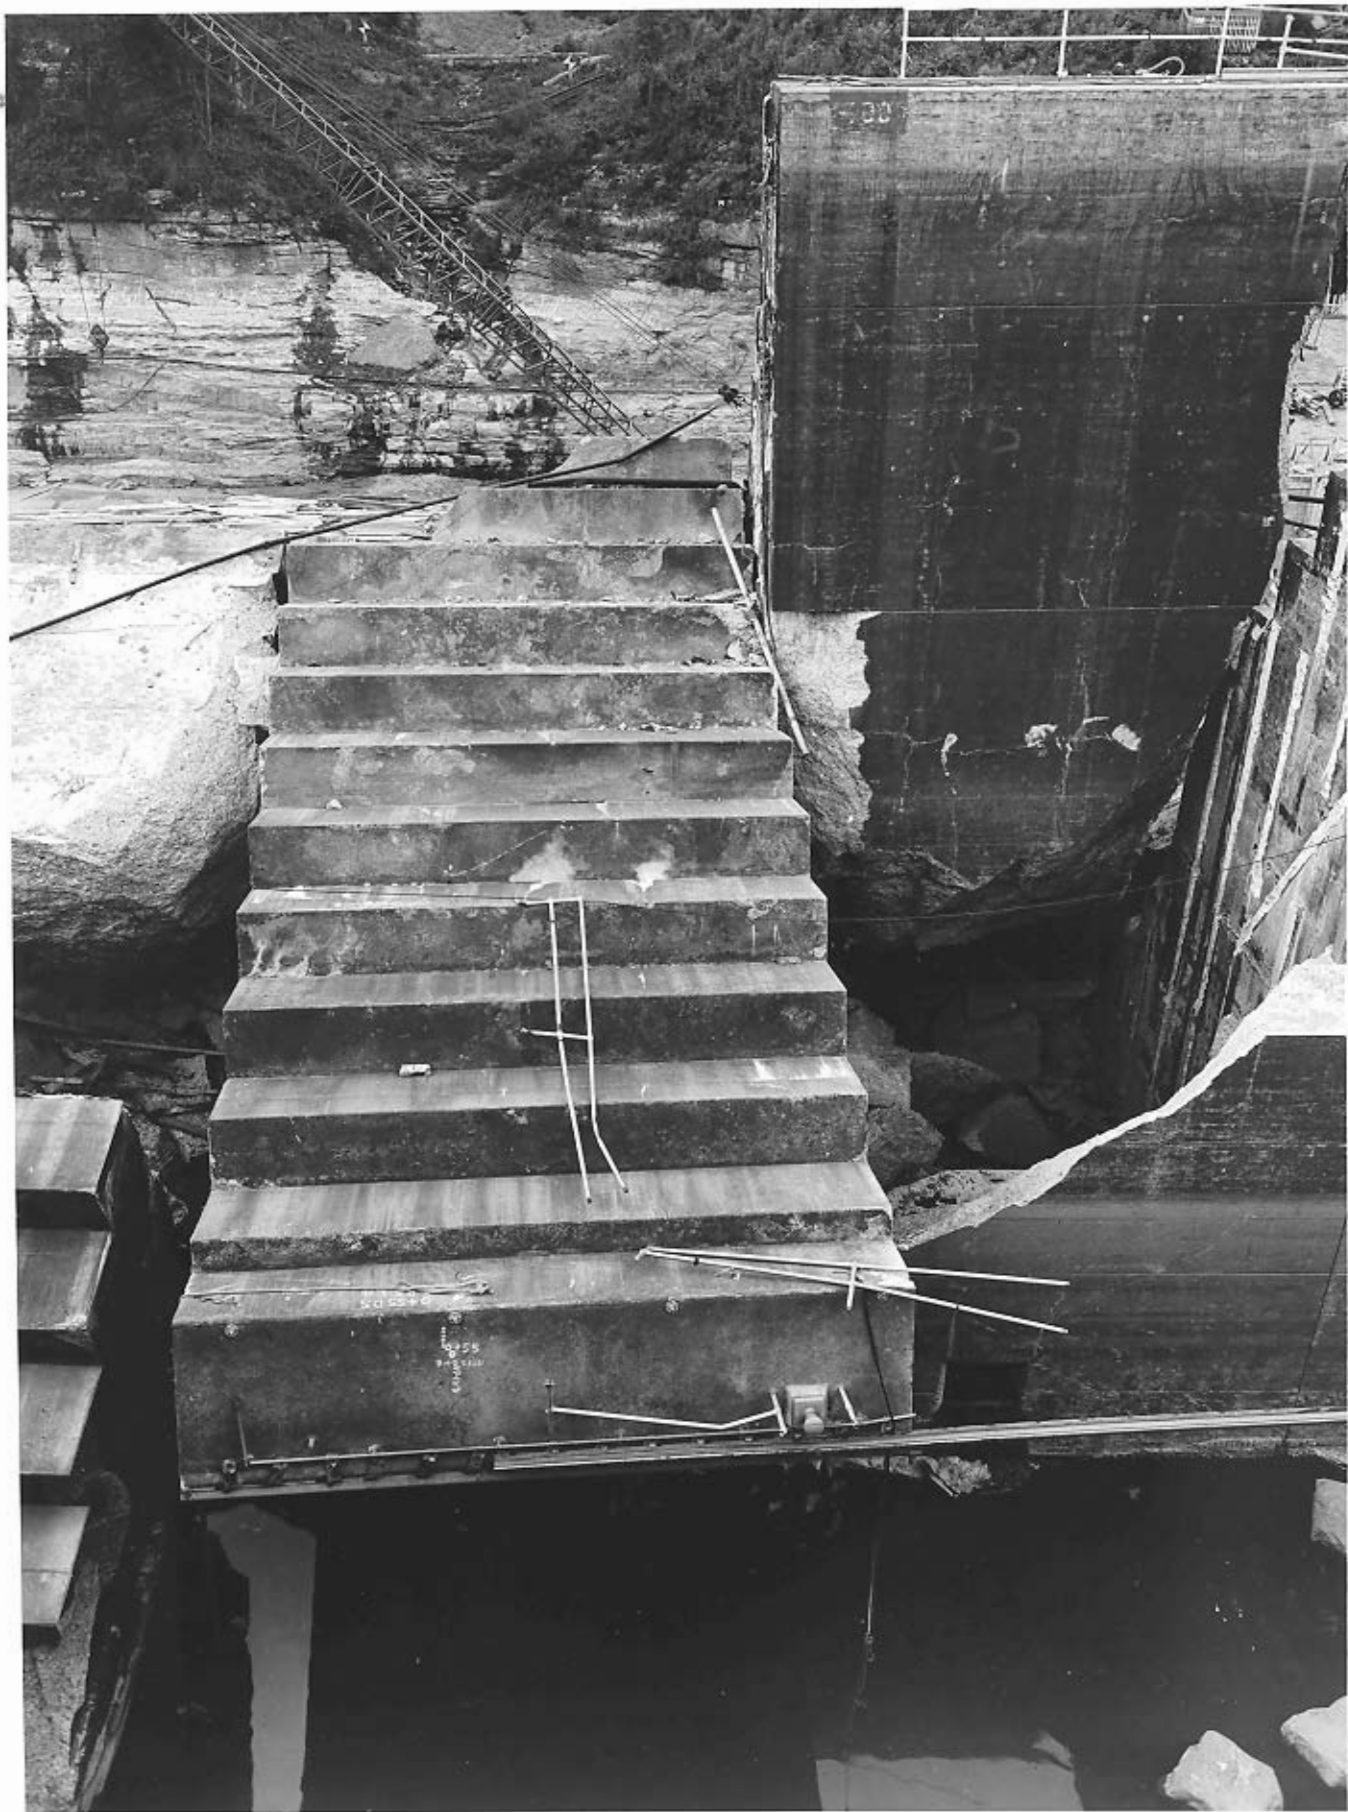
Auxiliary lock, blocks 4, 3, and 2.

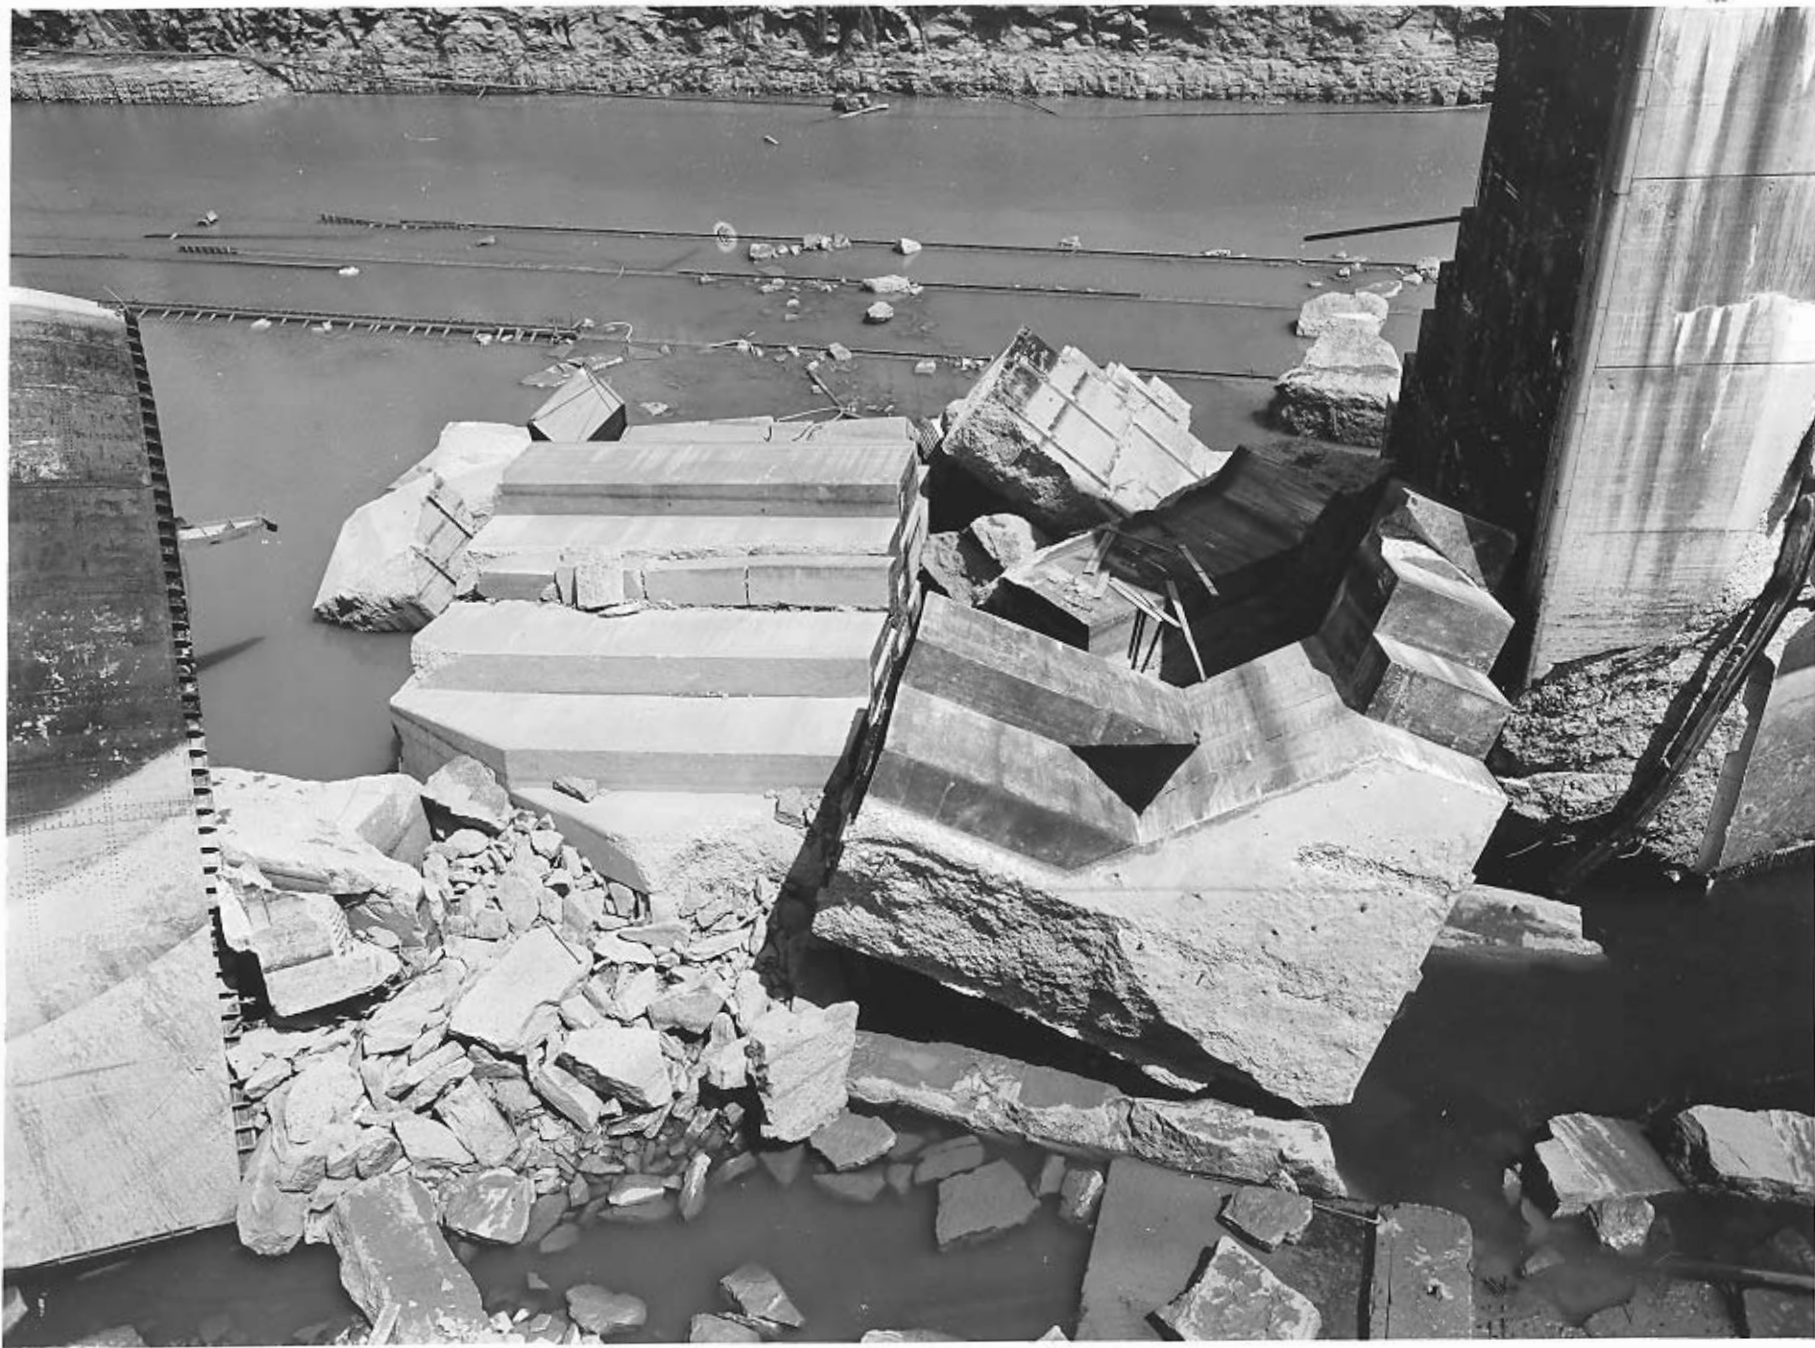
Auxiliary lock blocks 14, 13, and 12.

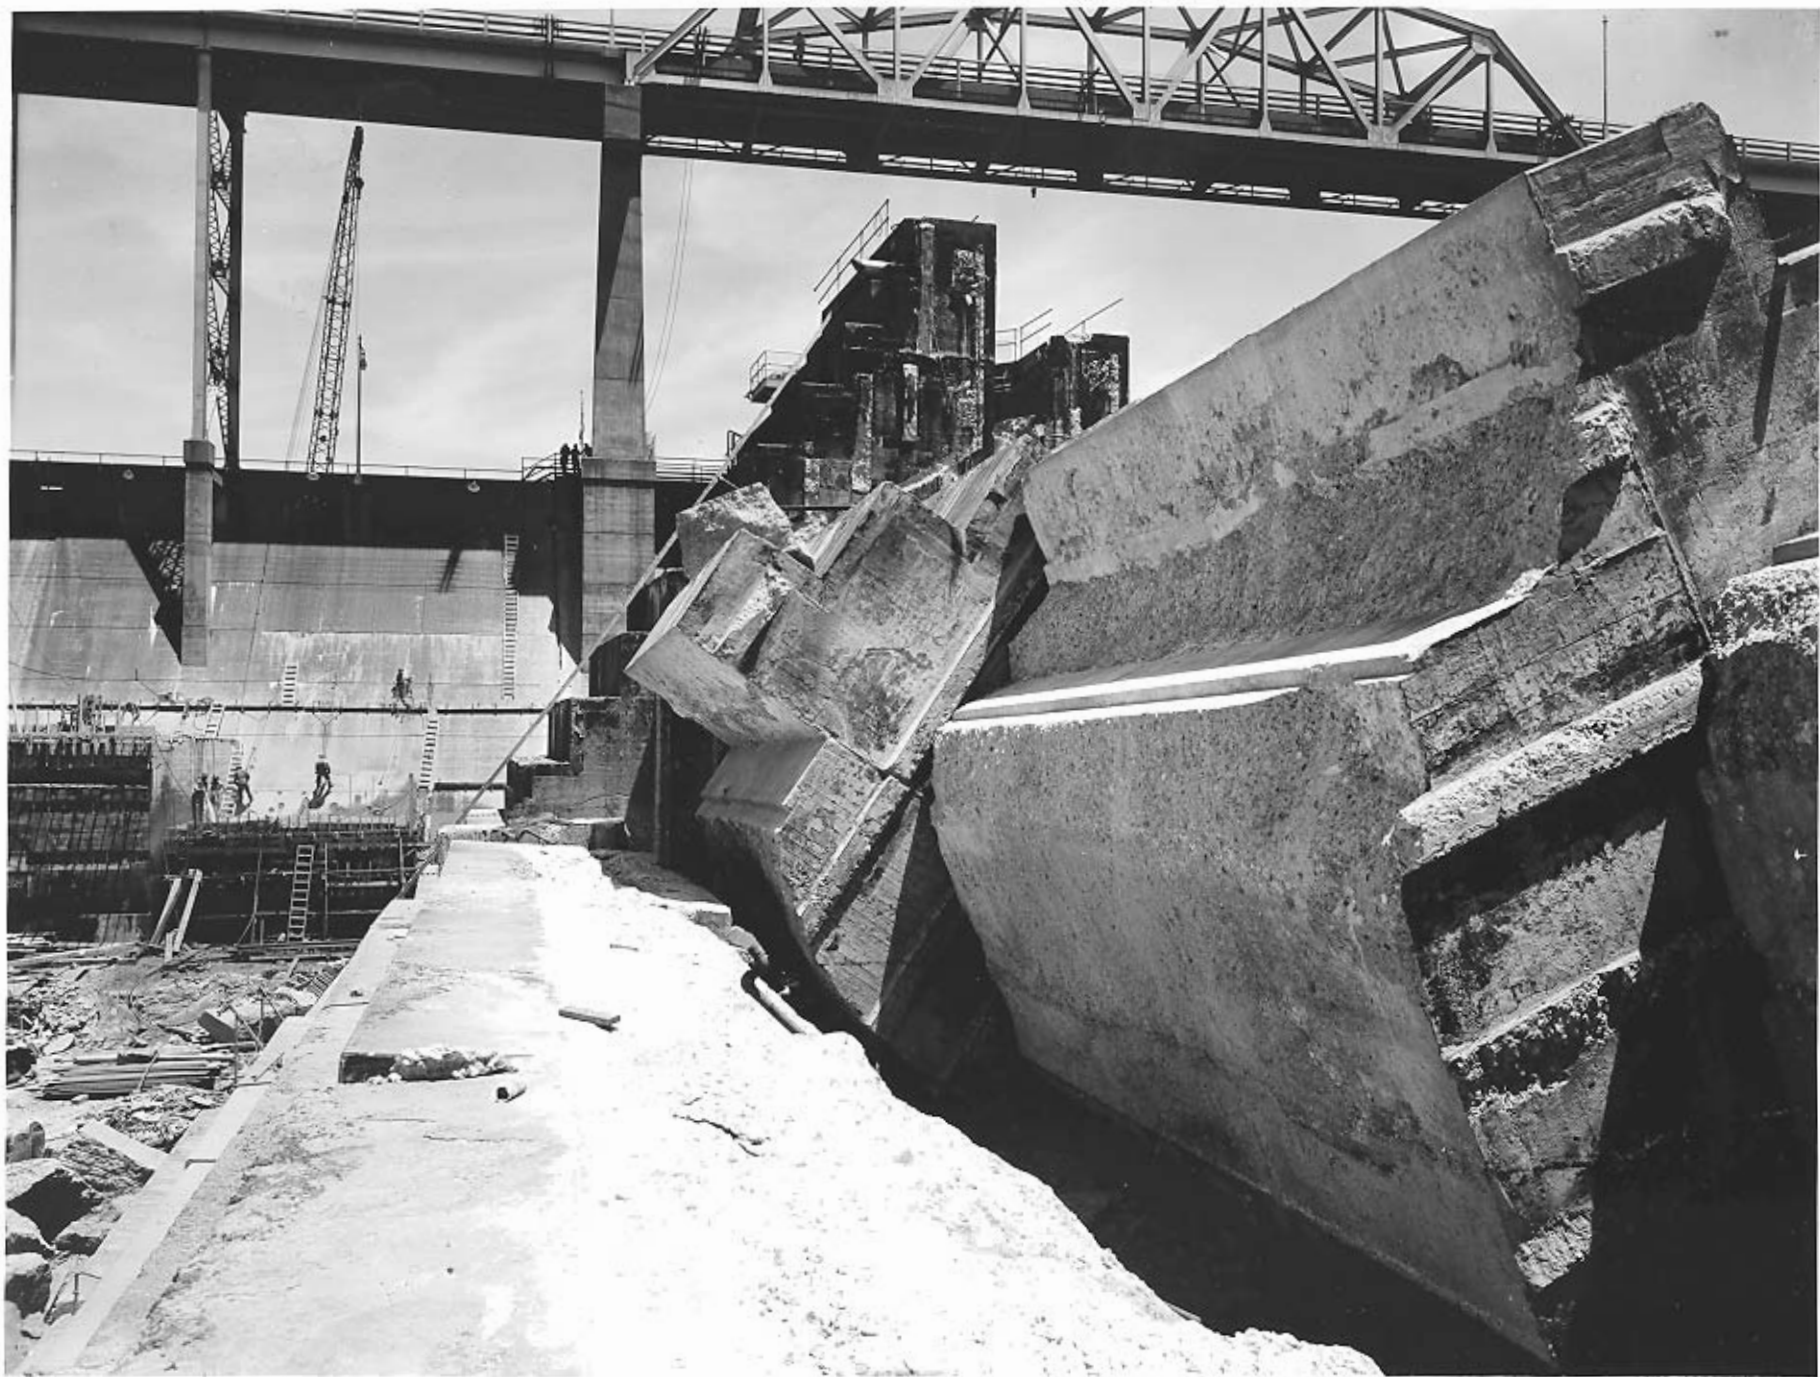
Auxiliary lock, lock upstream at blocks 2, 3, and 4.

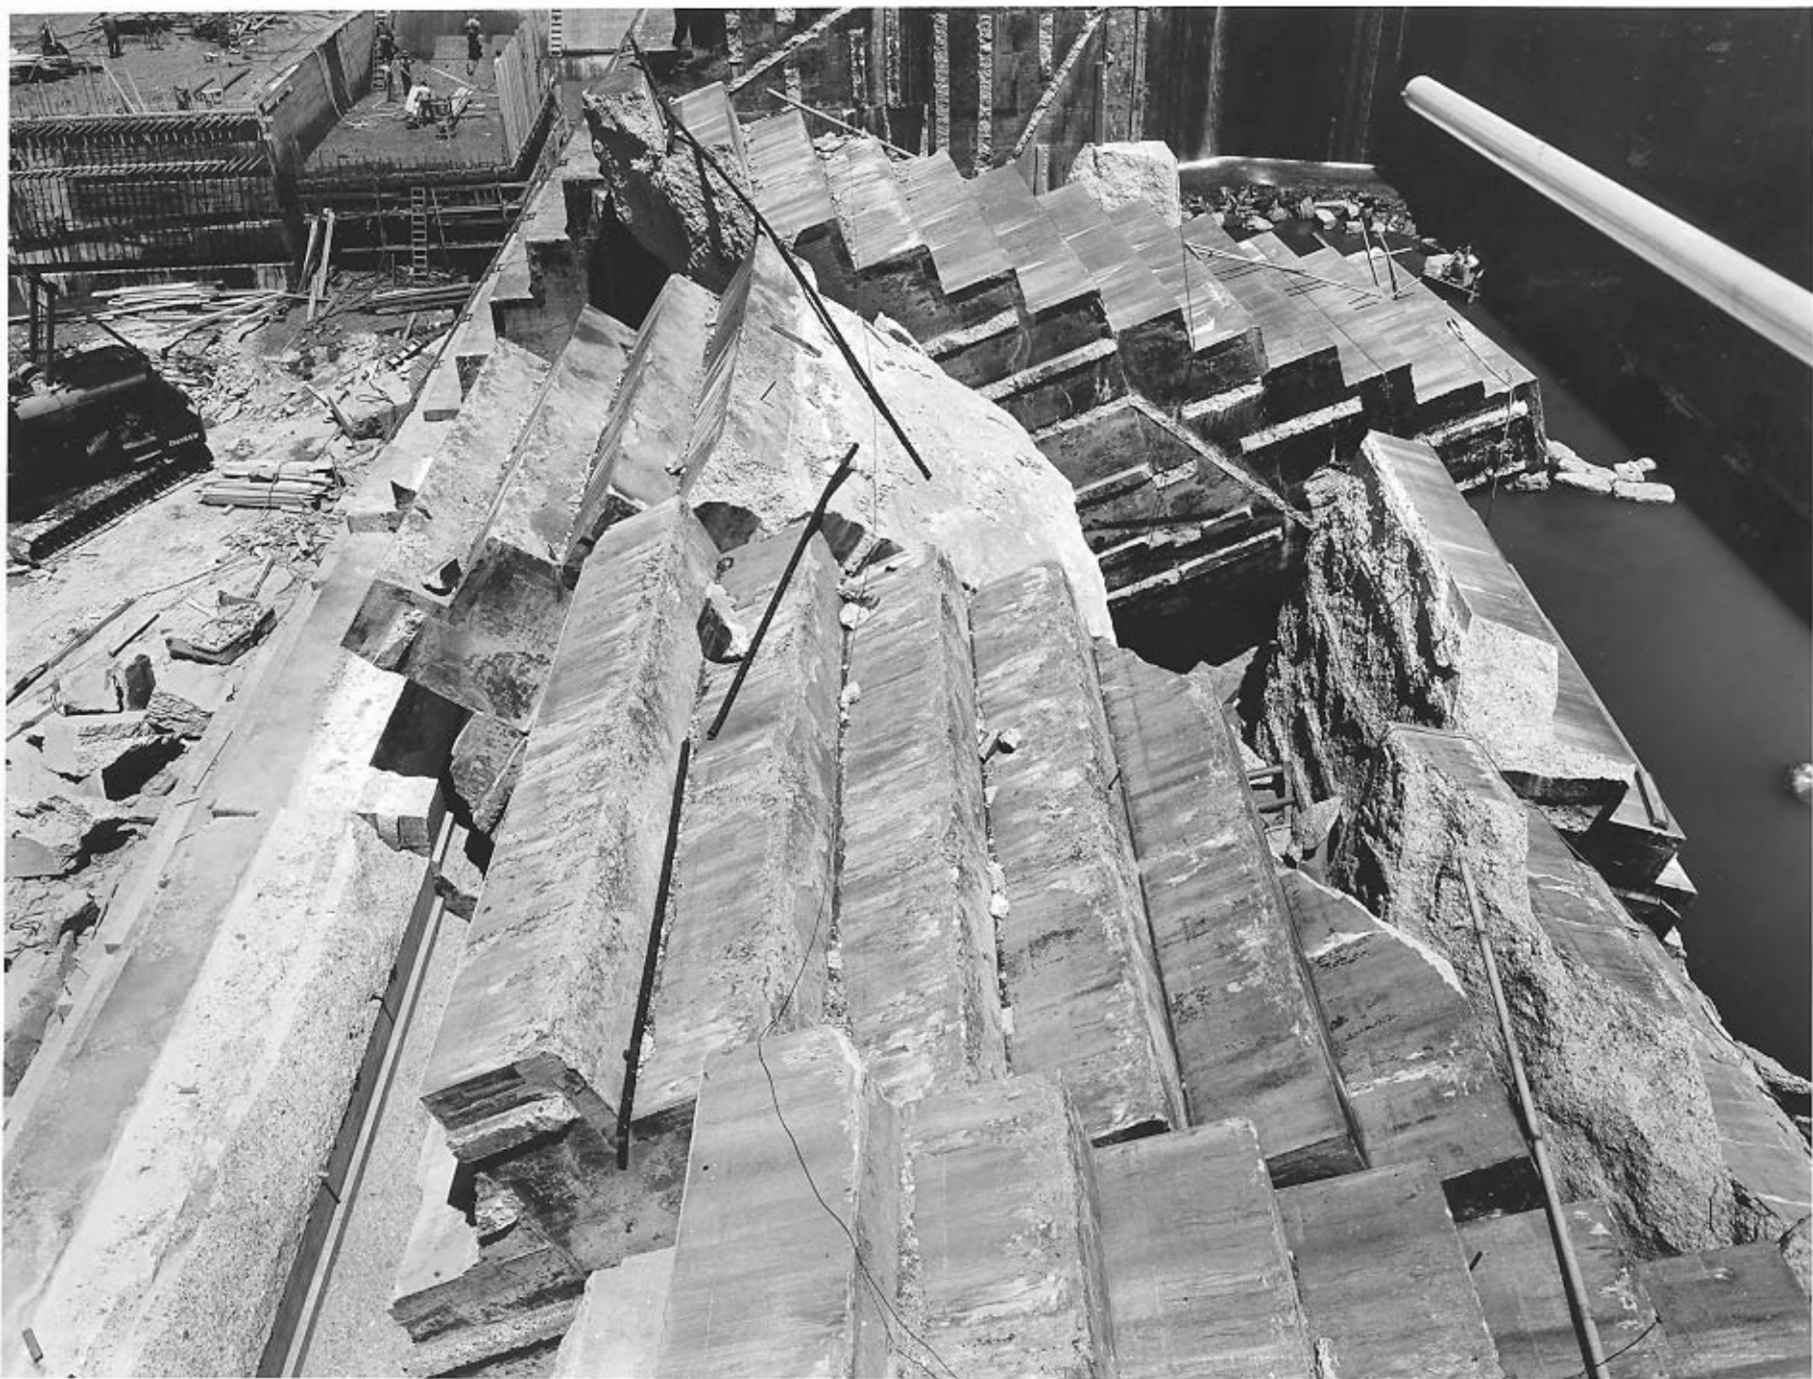
Auxiliary lock, blocks 3, 4, and 5.

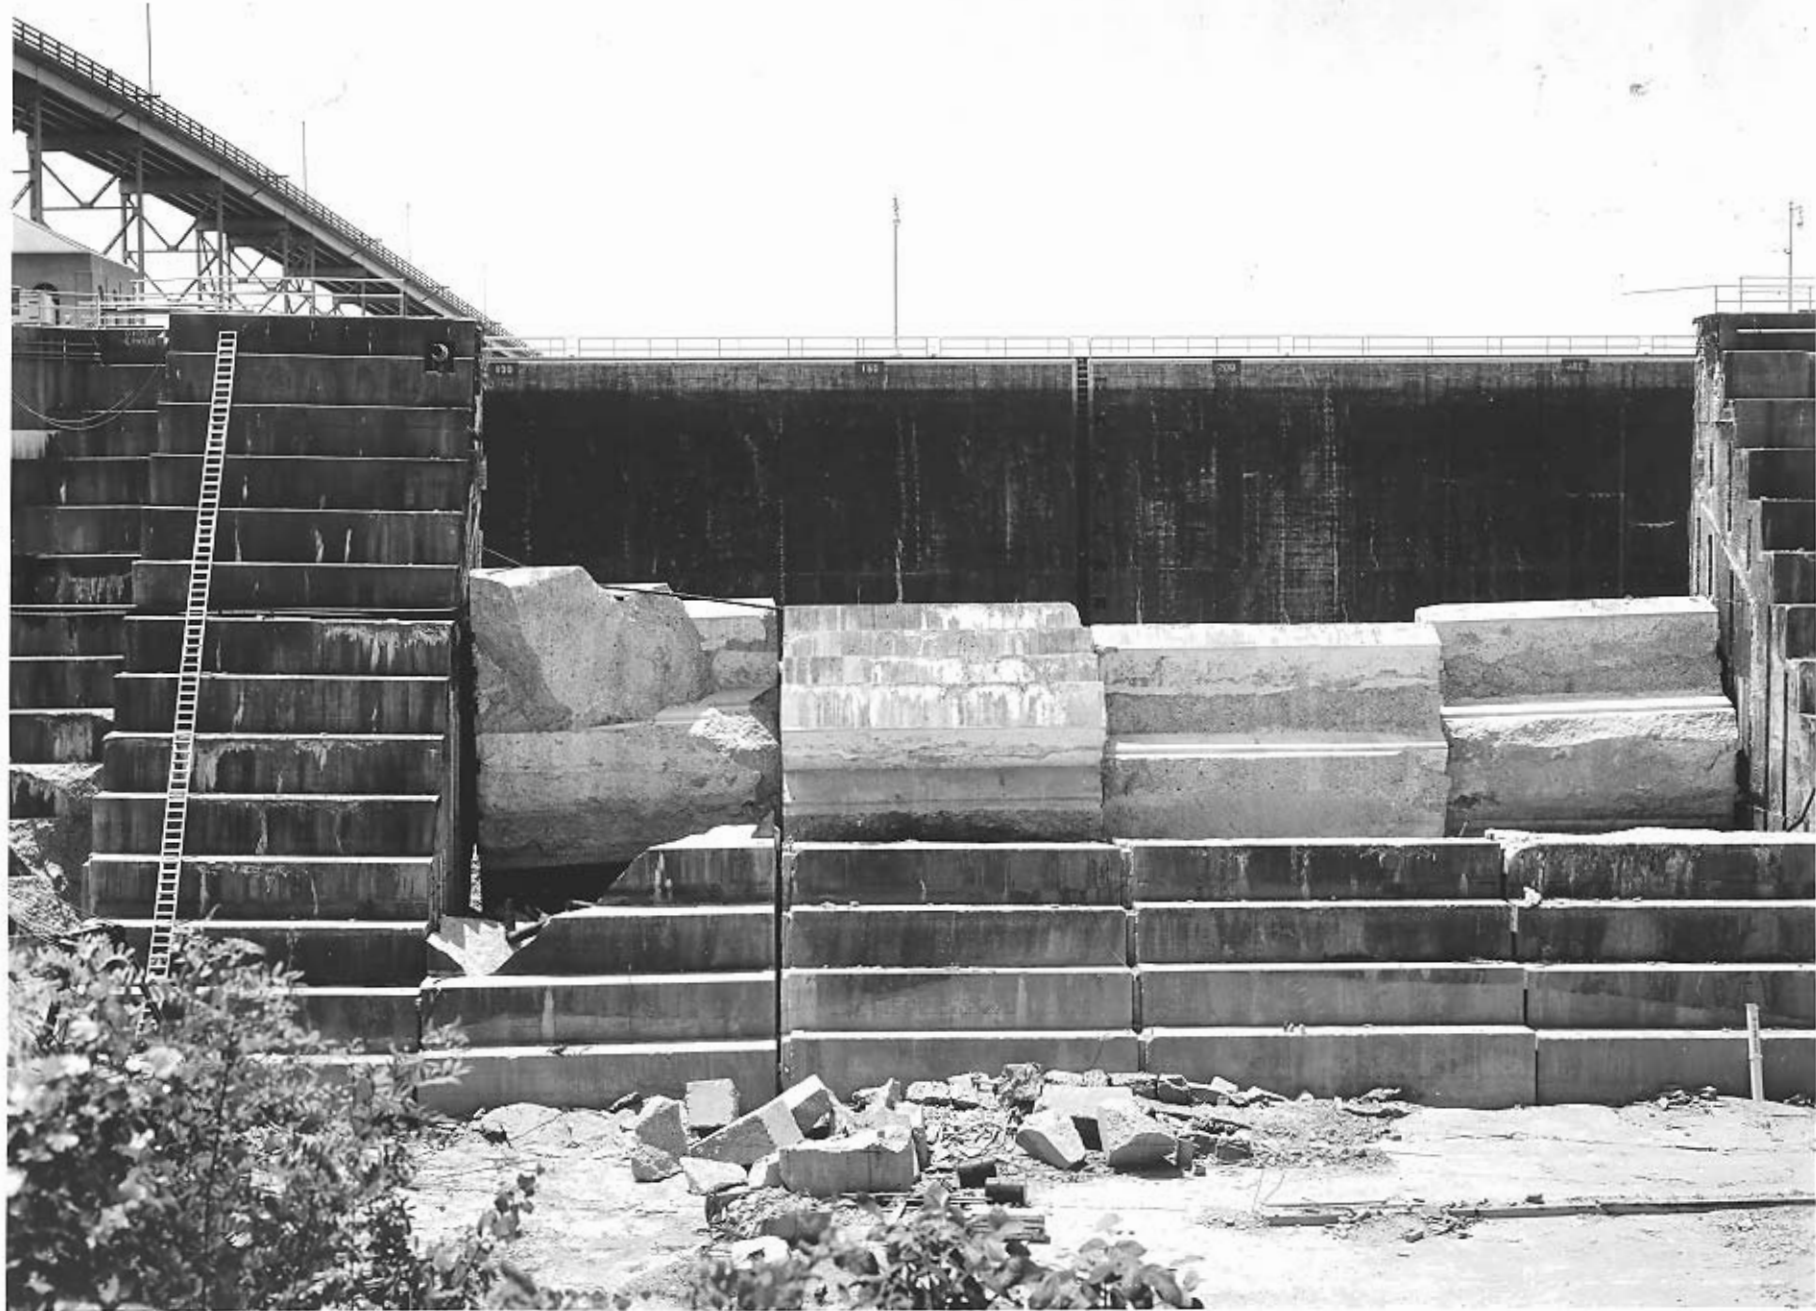
Auxiliary lock, blocks 2 through 6.

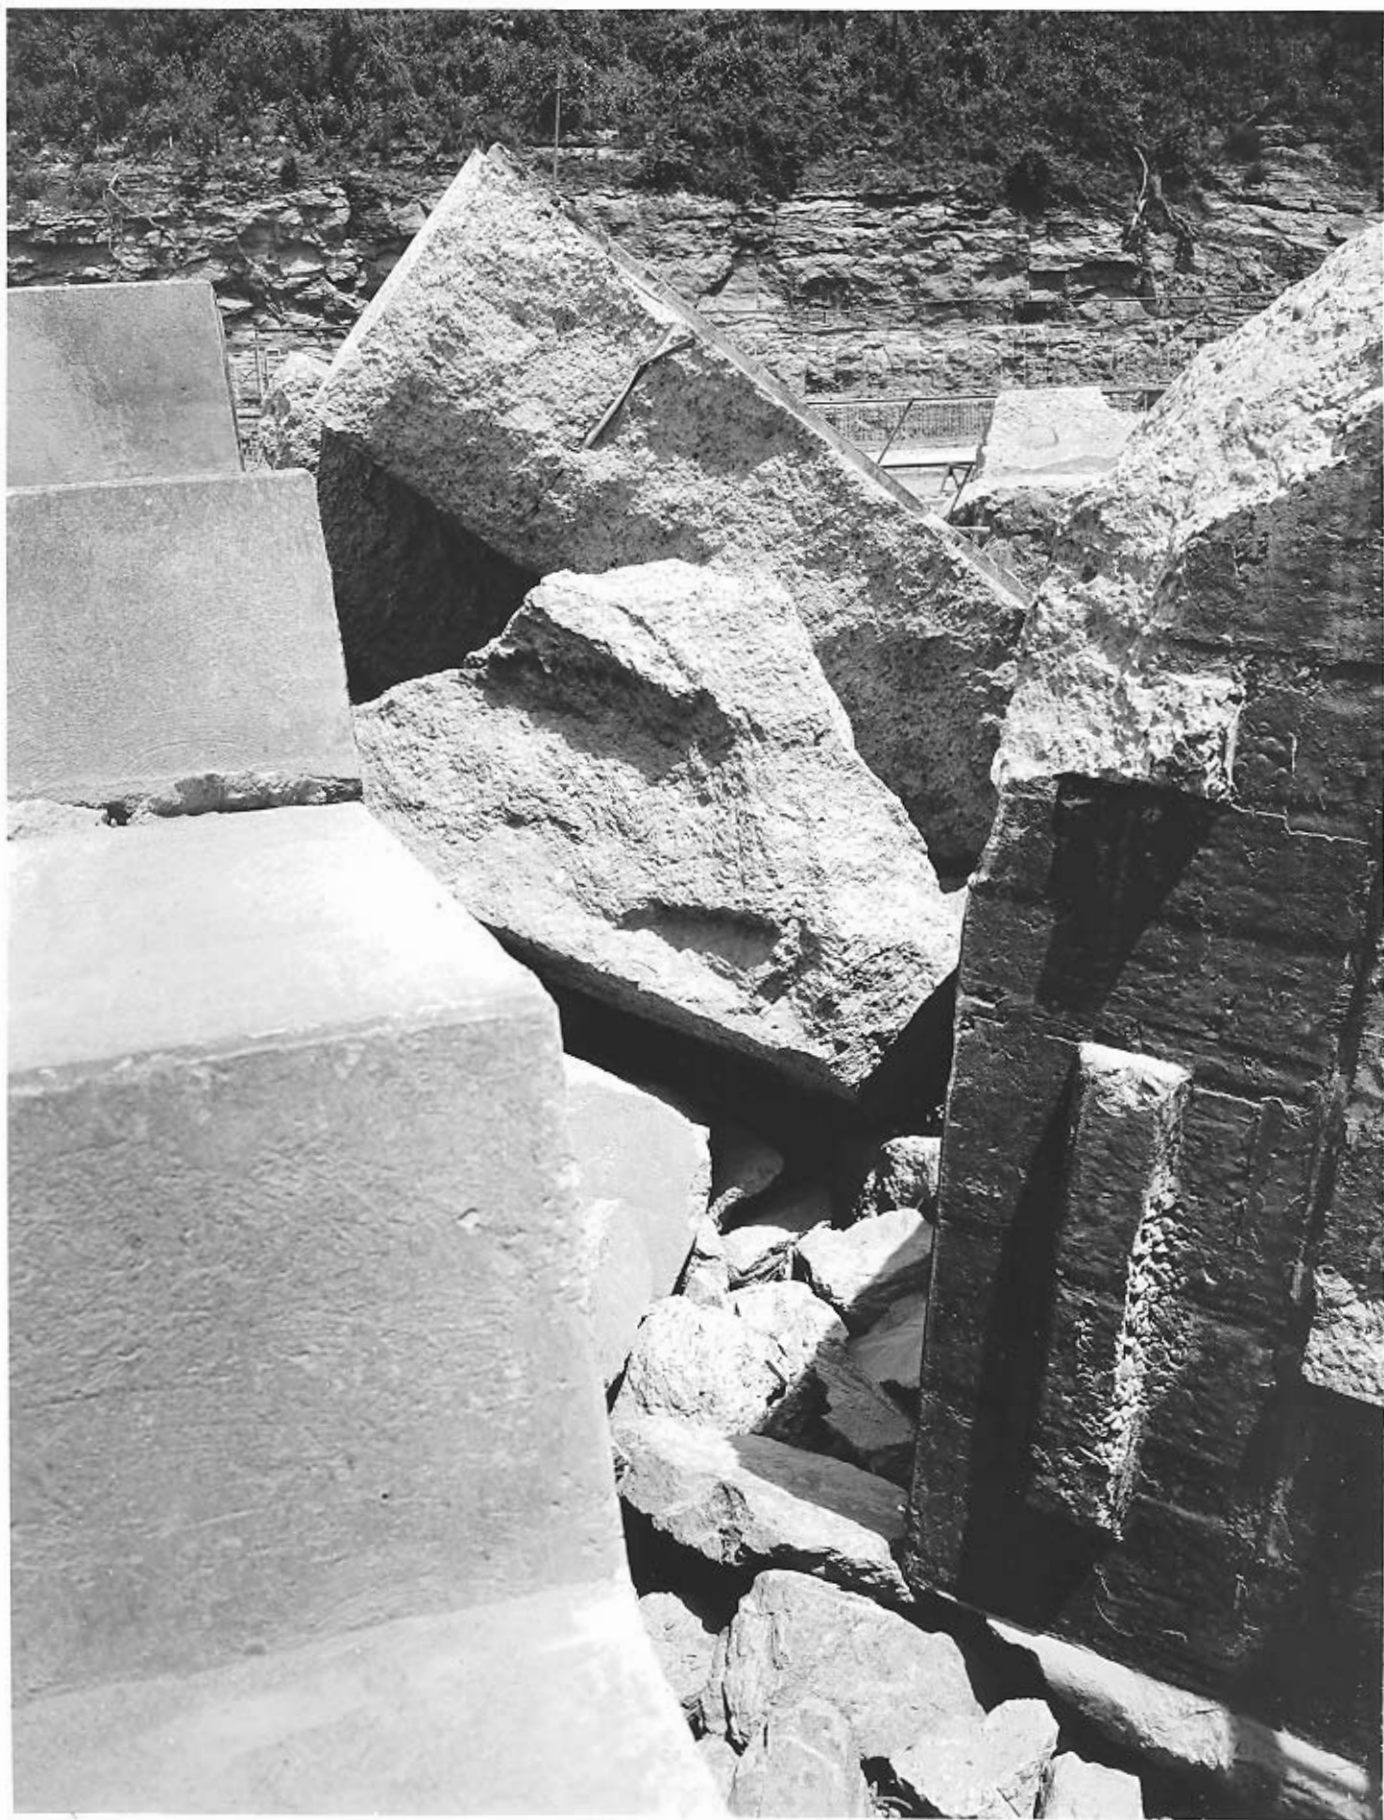
Auxiliary lock, concrete fragments downstream from block 12.

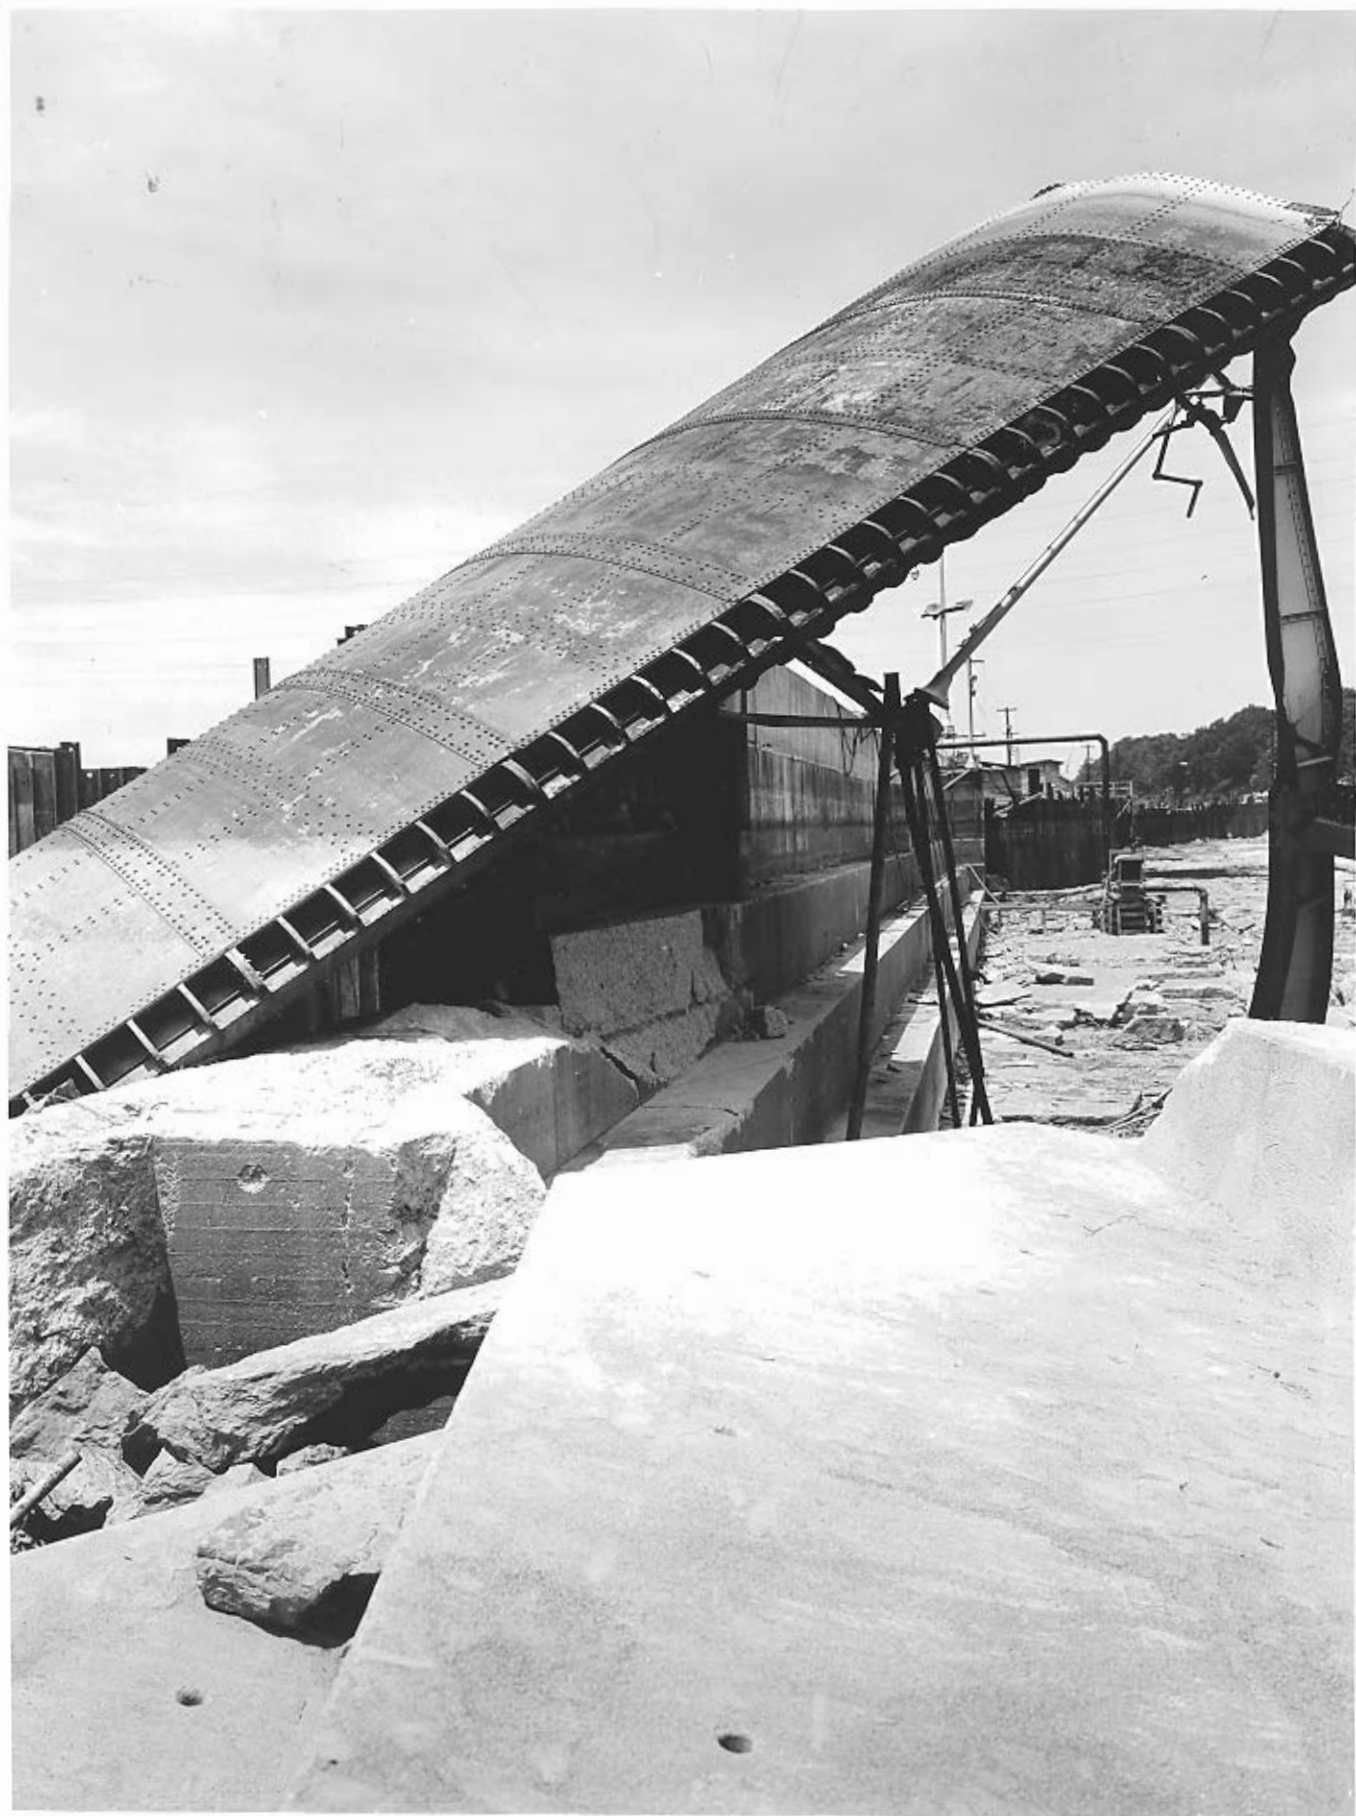
Auxiliary lock, gate leaf and guide wall (looking downstream).

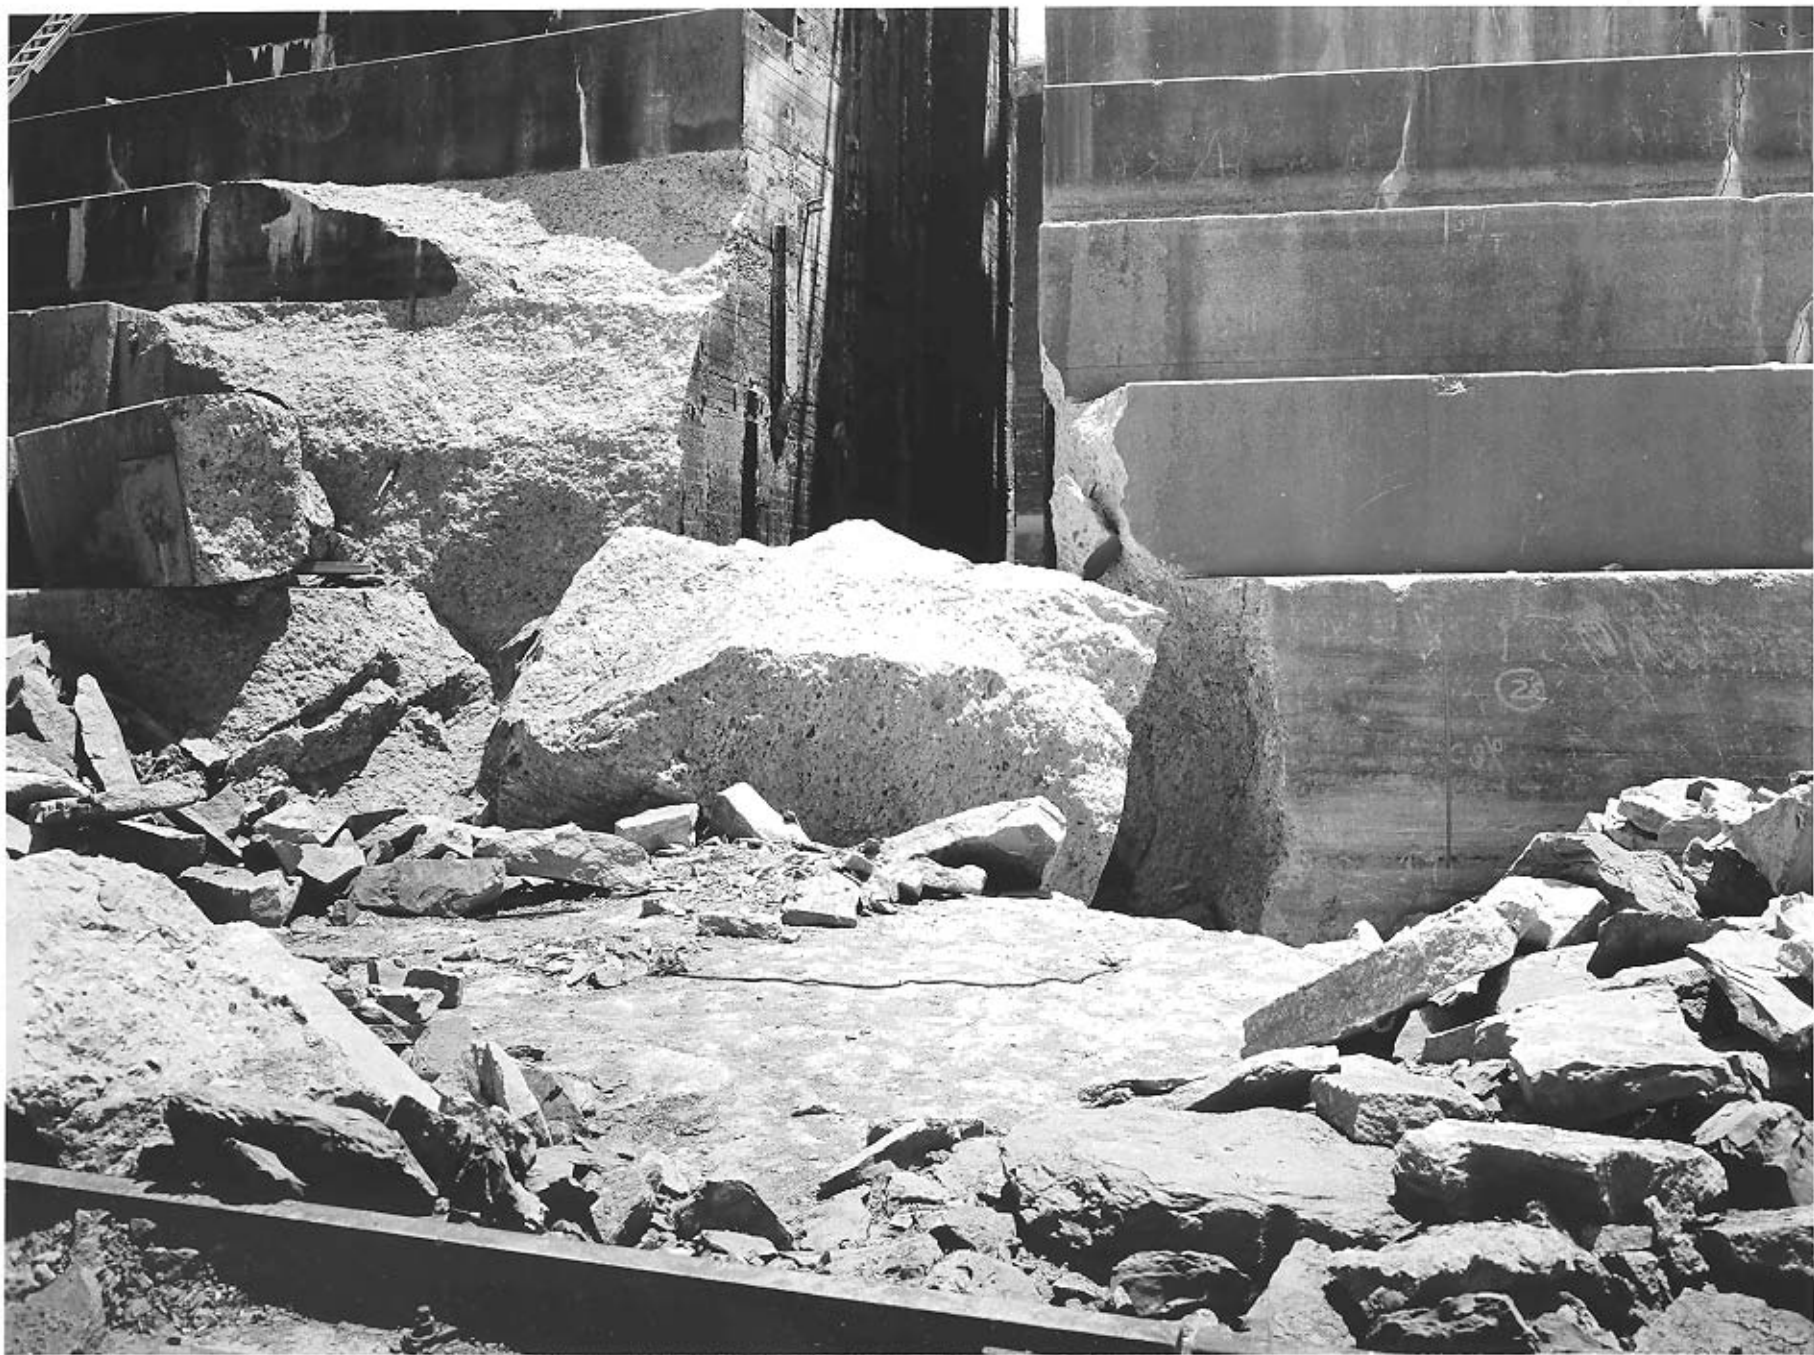
Auxiliary lock, blocks 11 and 12, north side.

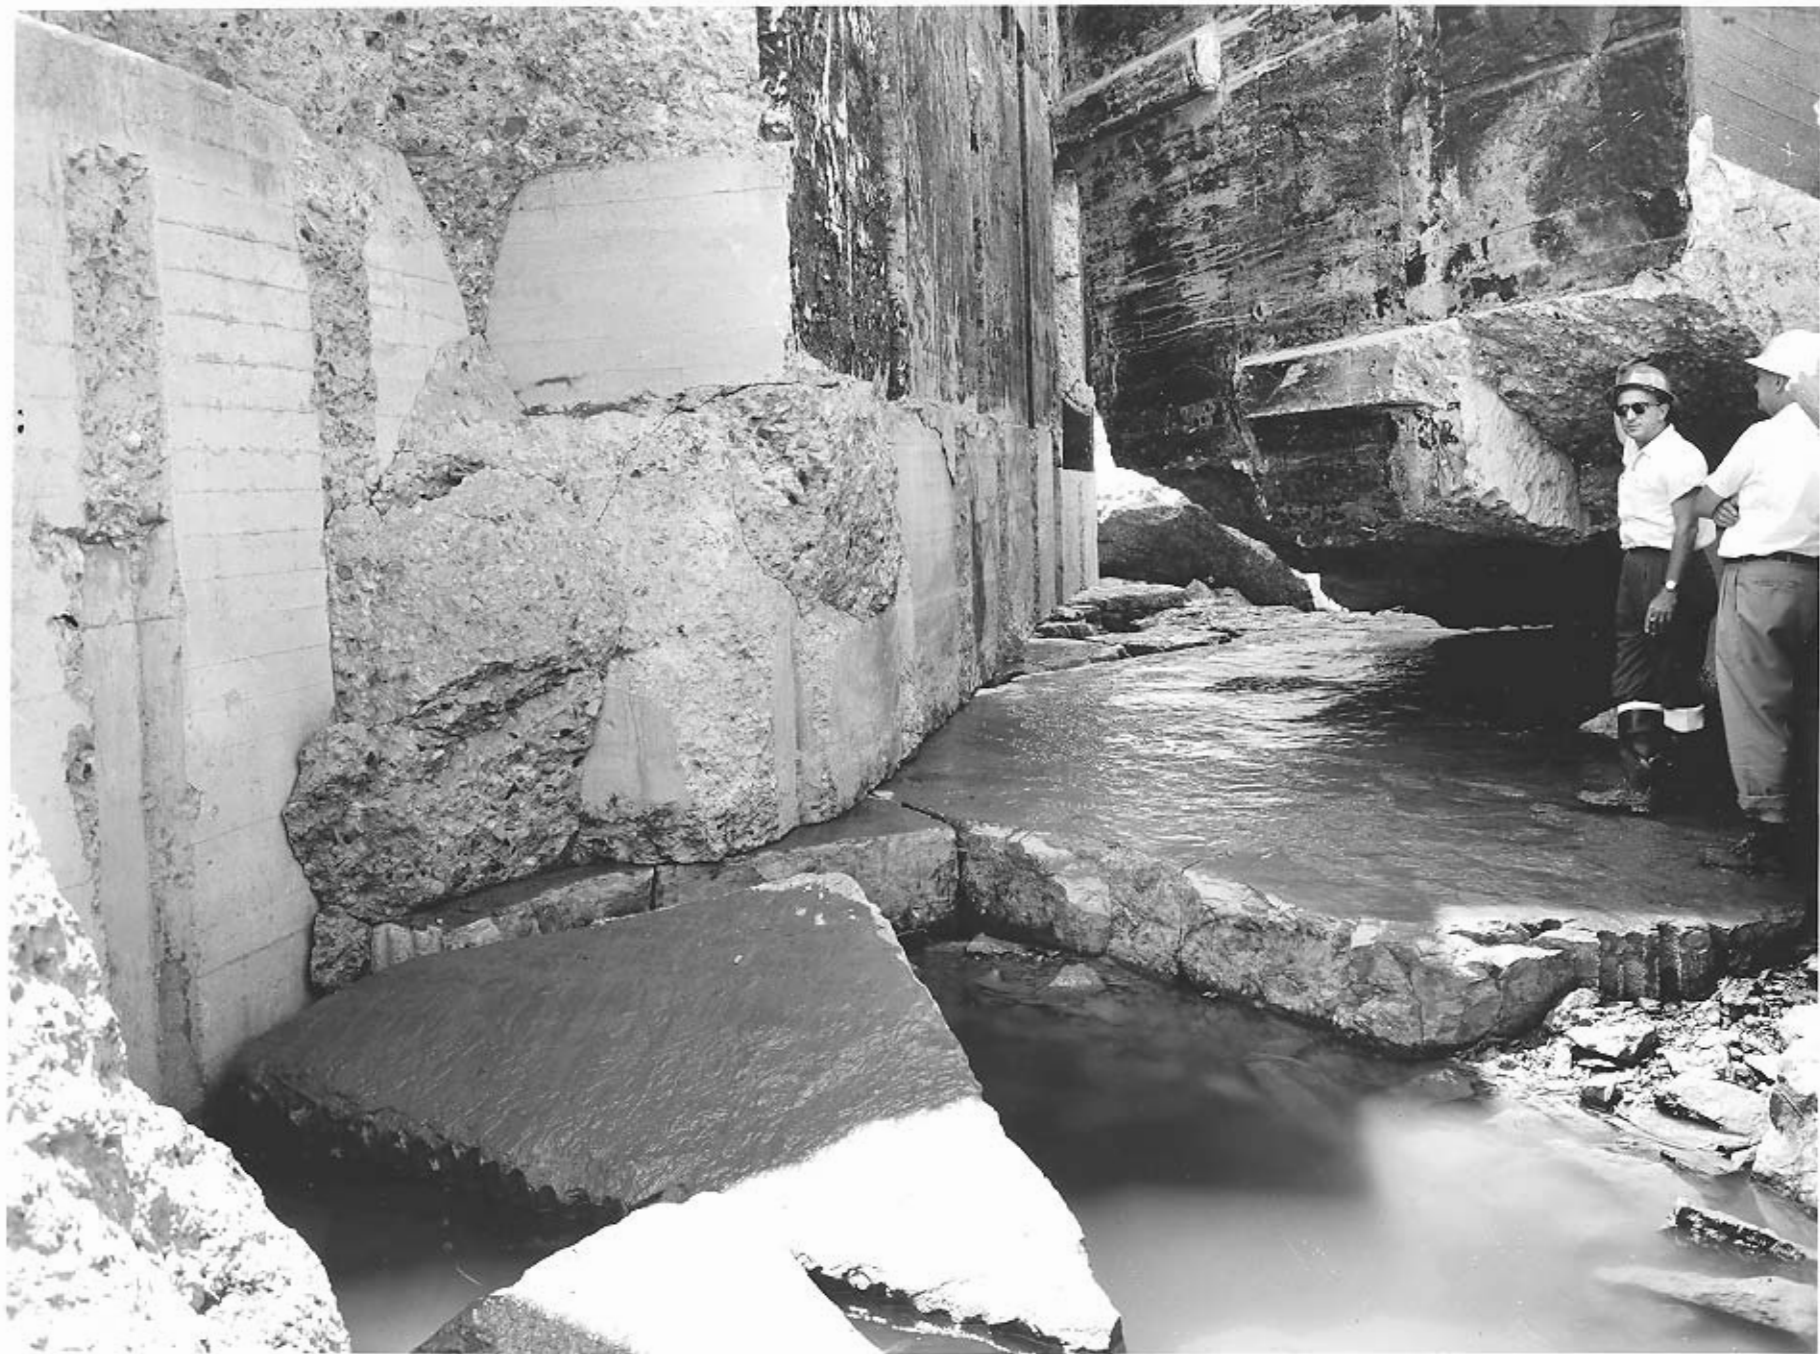
Auxiliary lock bottom of block 12 (downstream side).
