TENNESSEE VALLEY AUTHORITY

SUBJECT: REPORT ON FAILURE OF WHEELER LOCK

REPORT ON FAILURE OF WHEELER LOCK

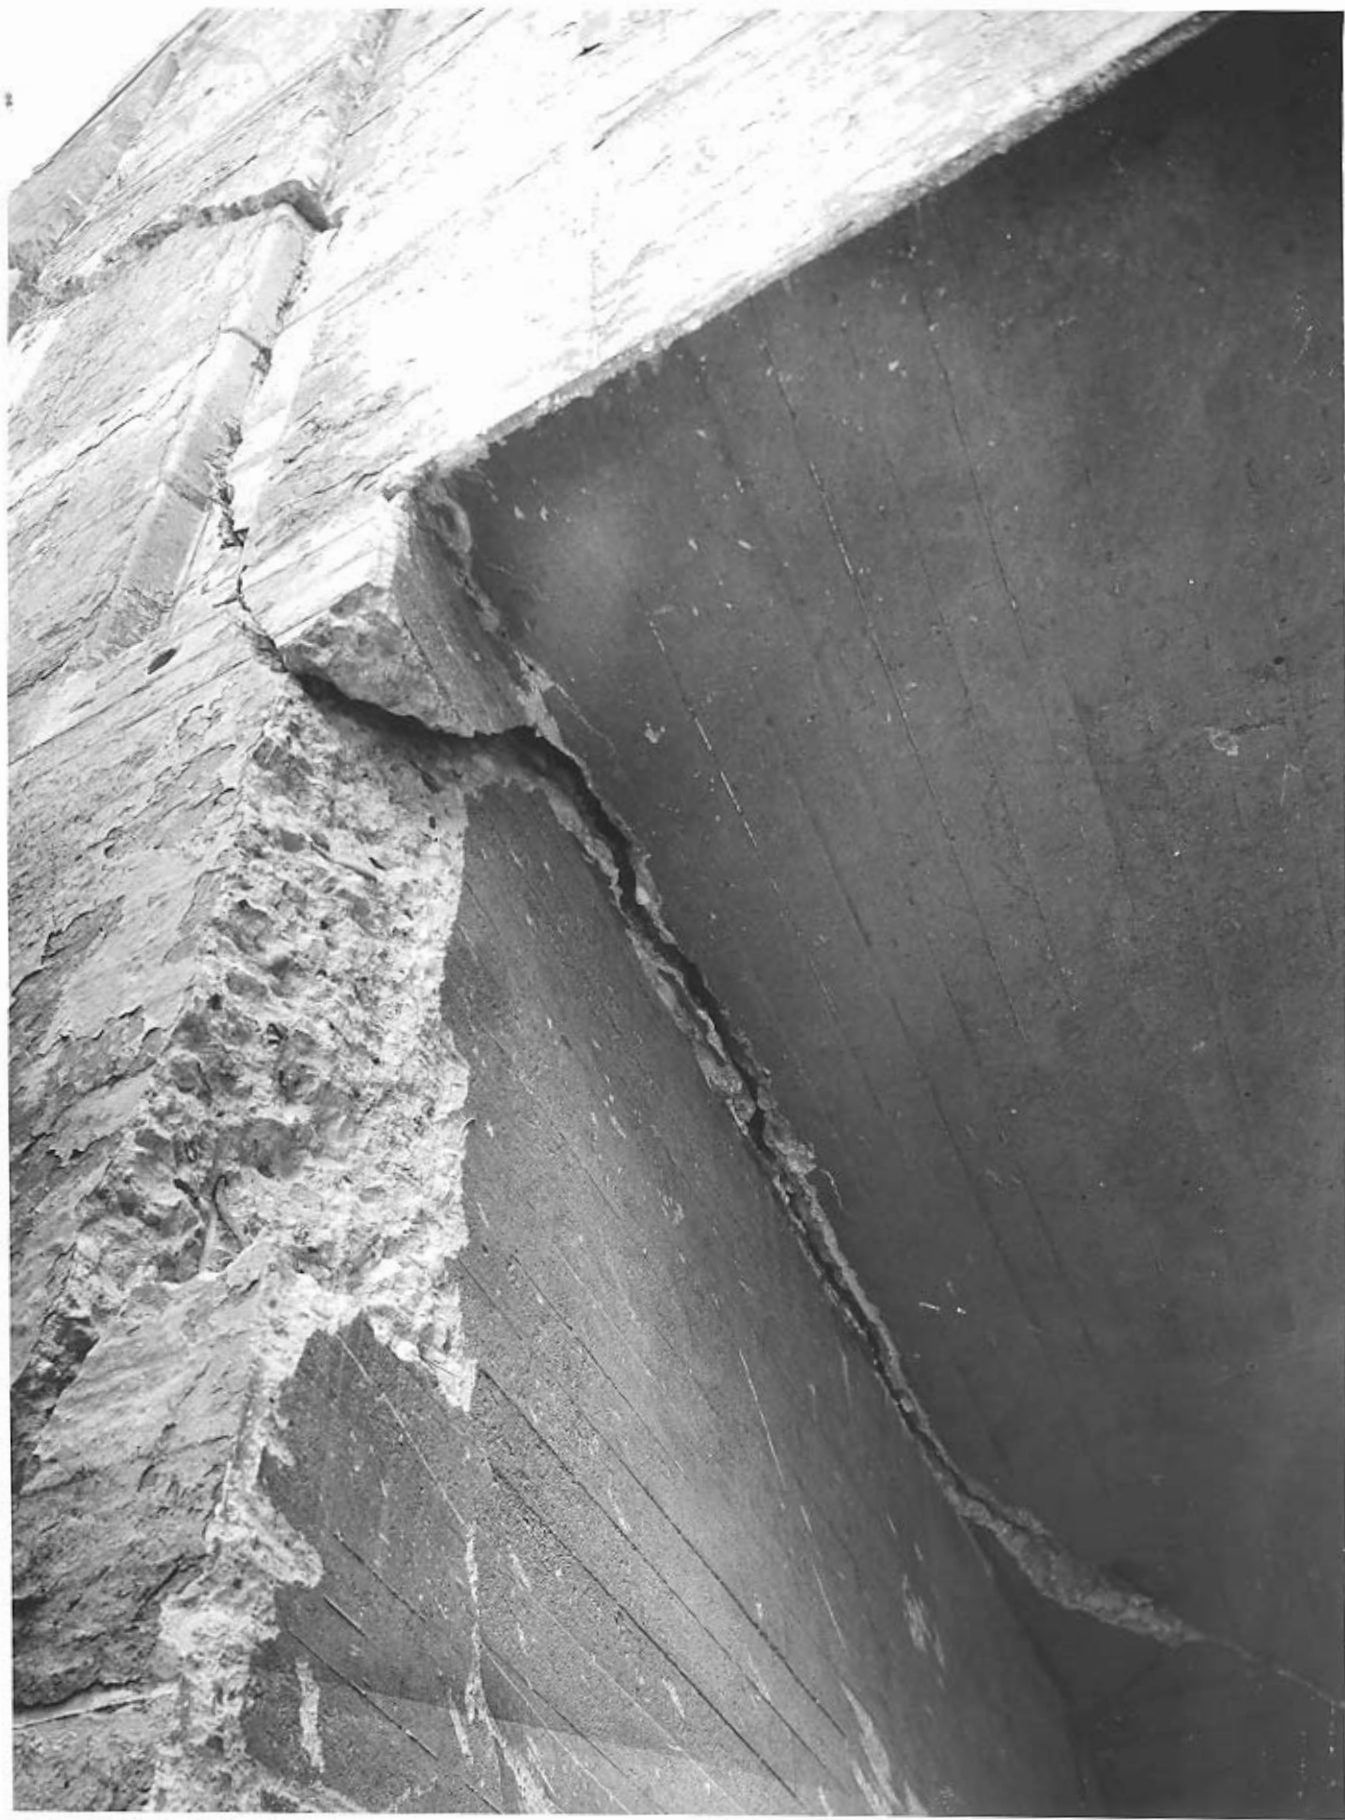
Auxiliary lock downstream face and culvert in block 12.

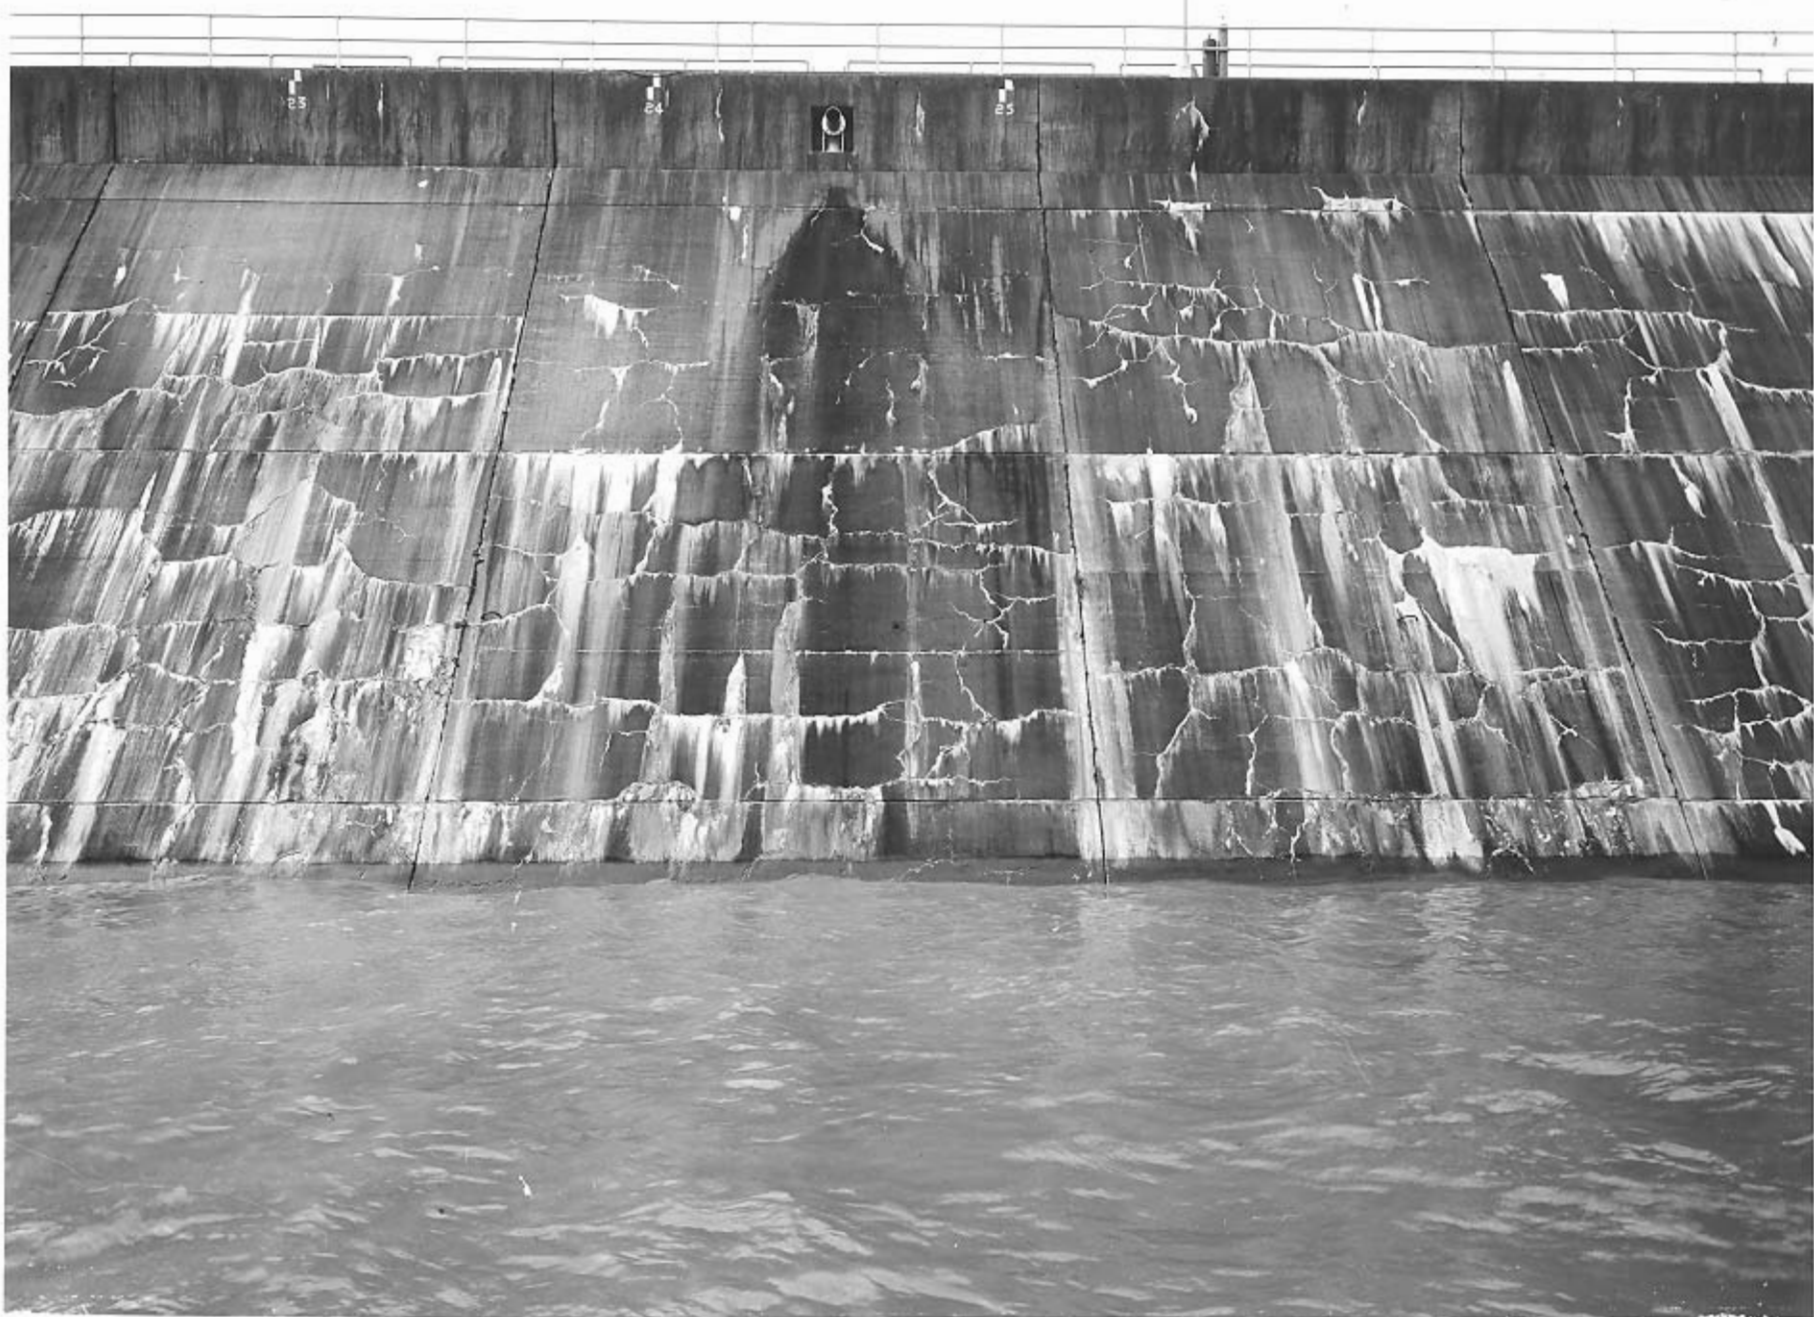
Auxiliary lock river wall blocks 55, 56, 57, and 58.

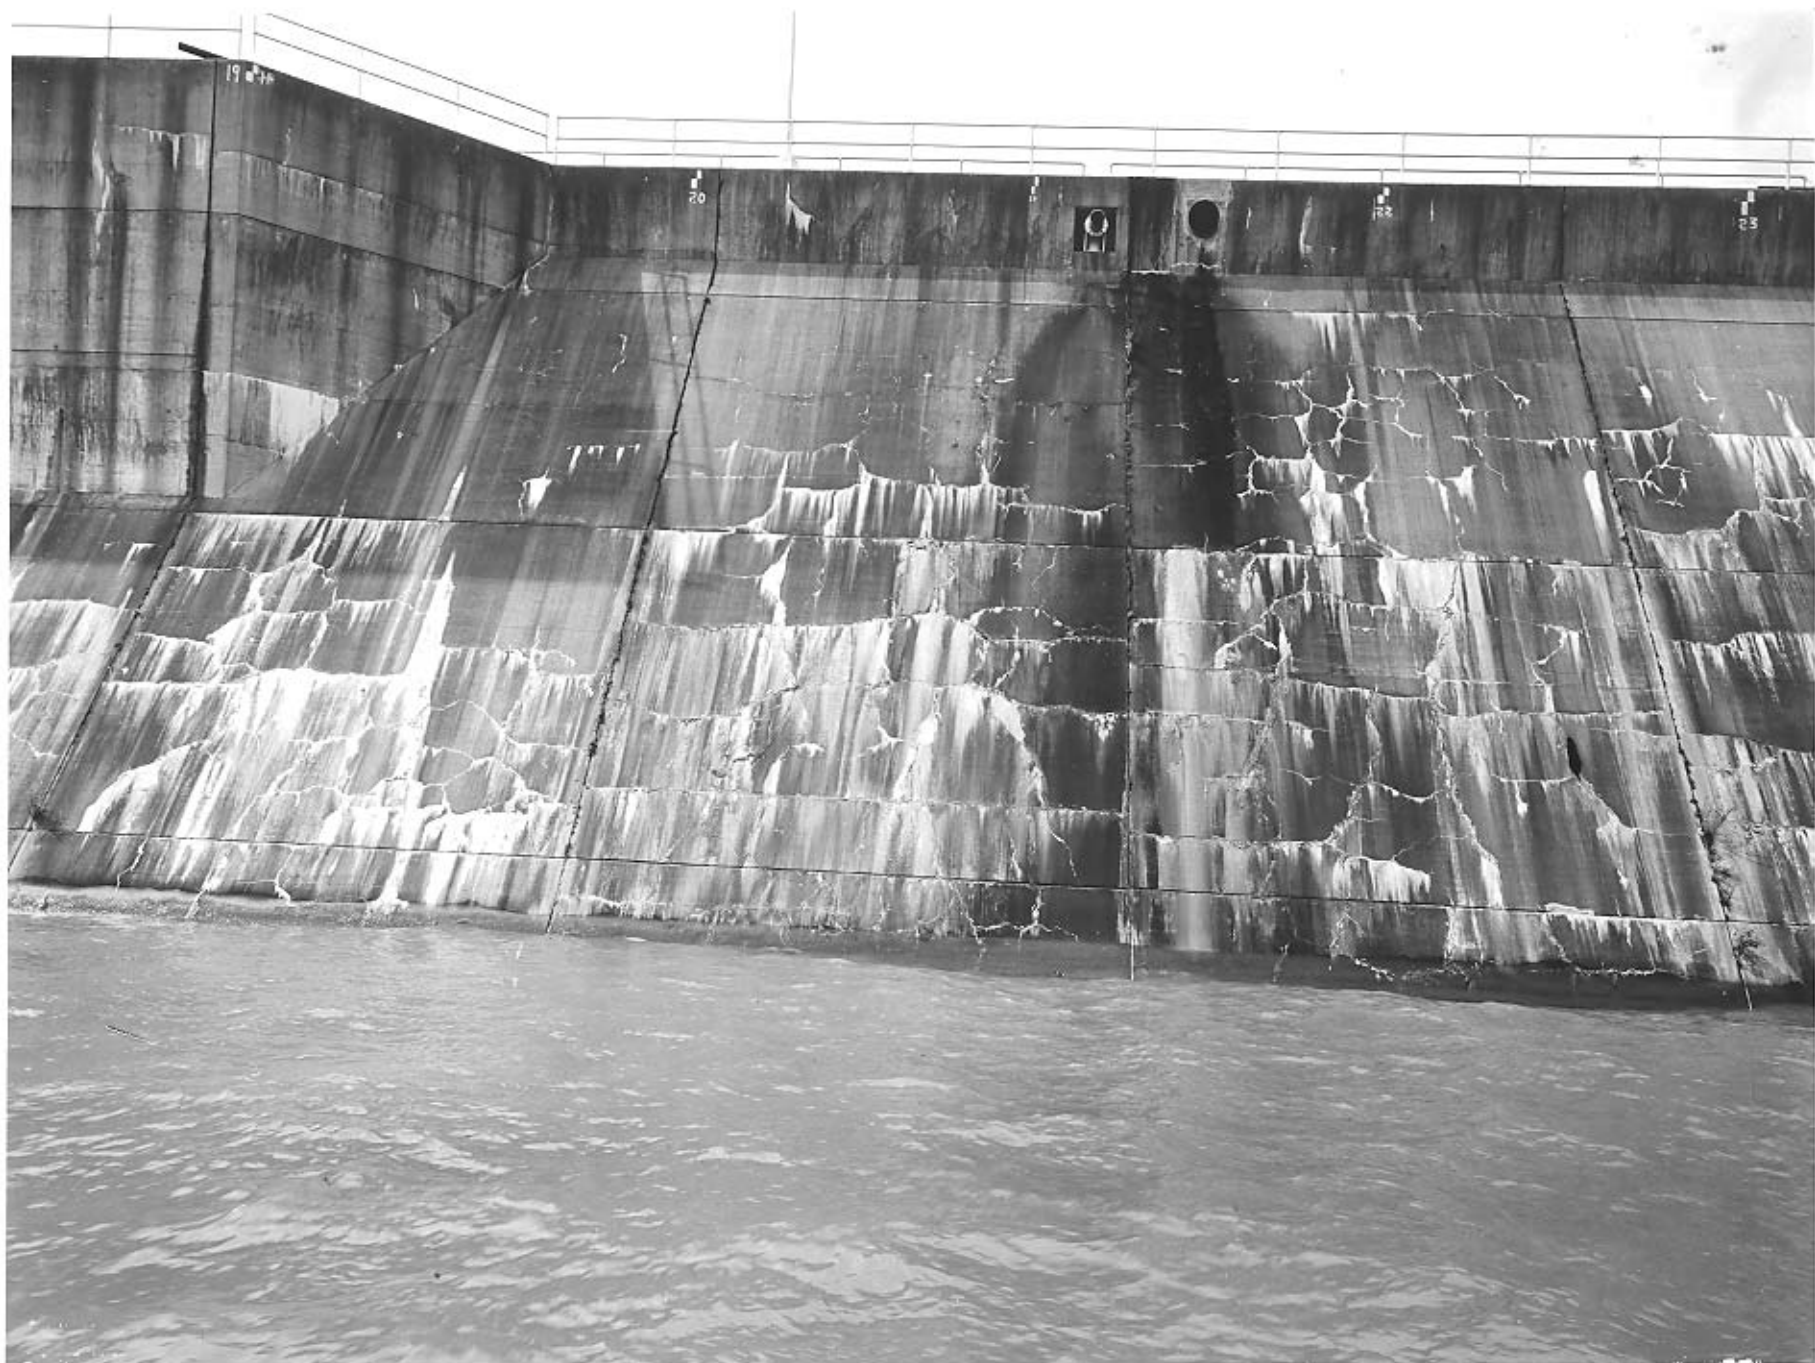
Auxiliary lock river wall blocks 58, 59, 60, 61, and 62.

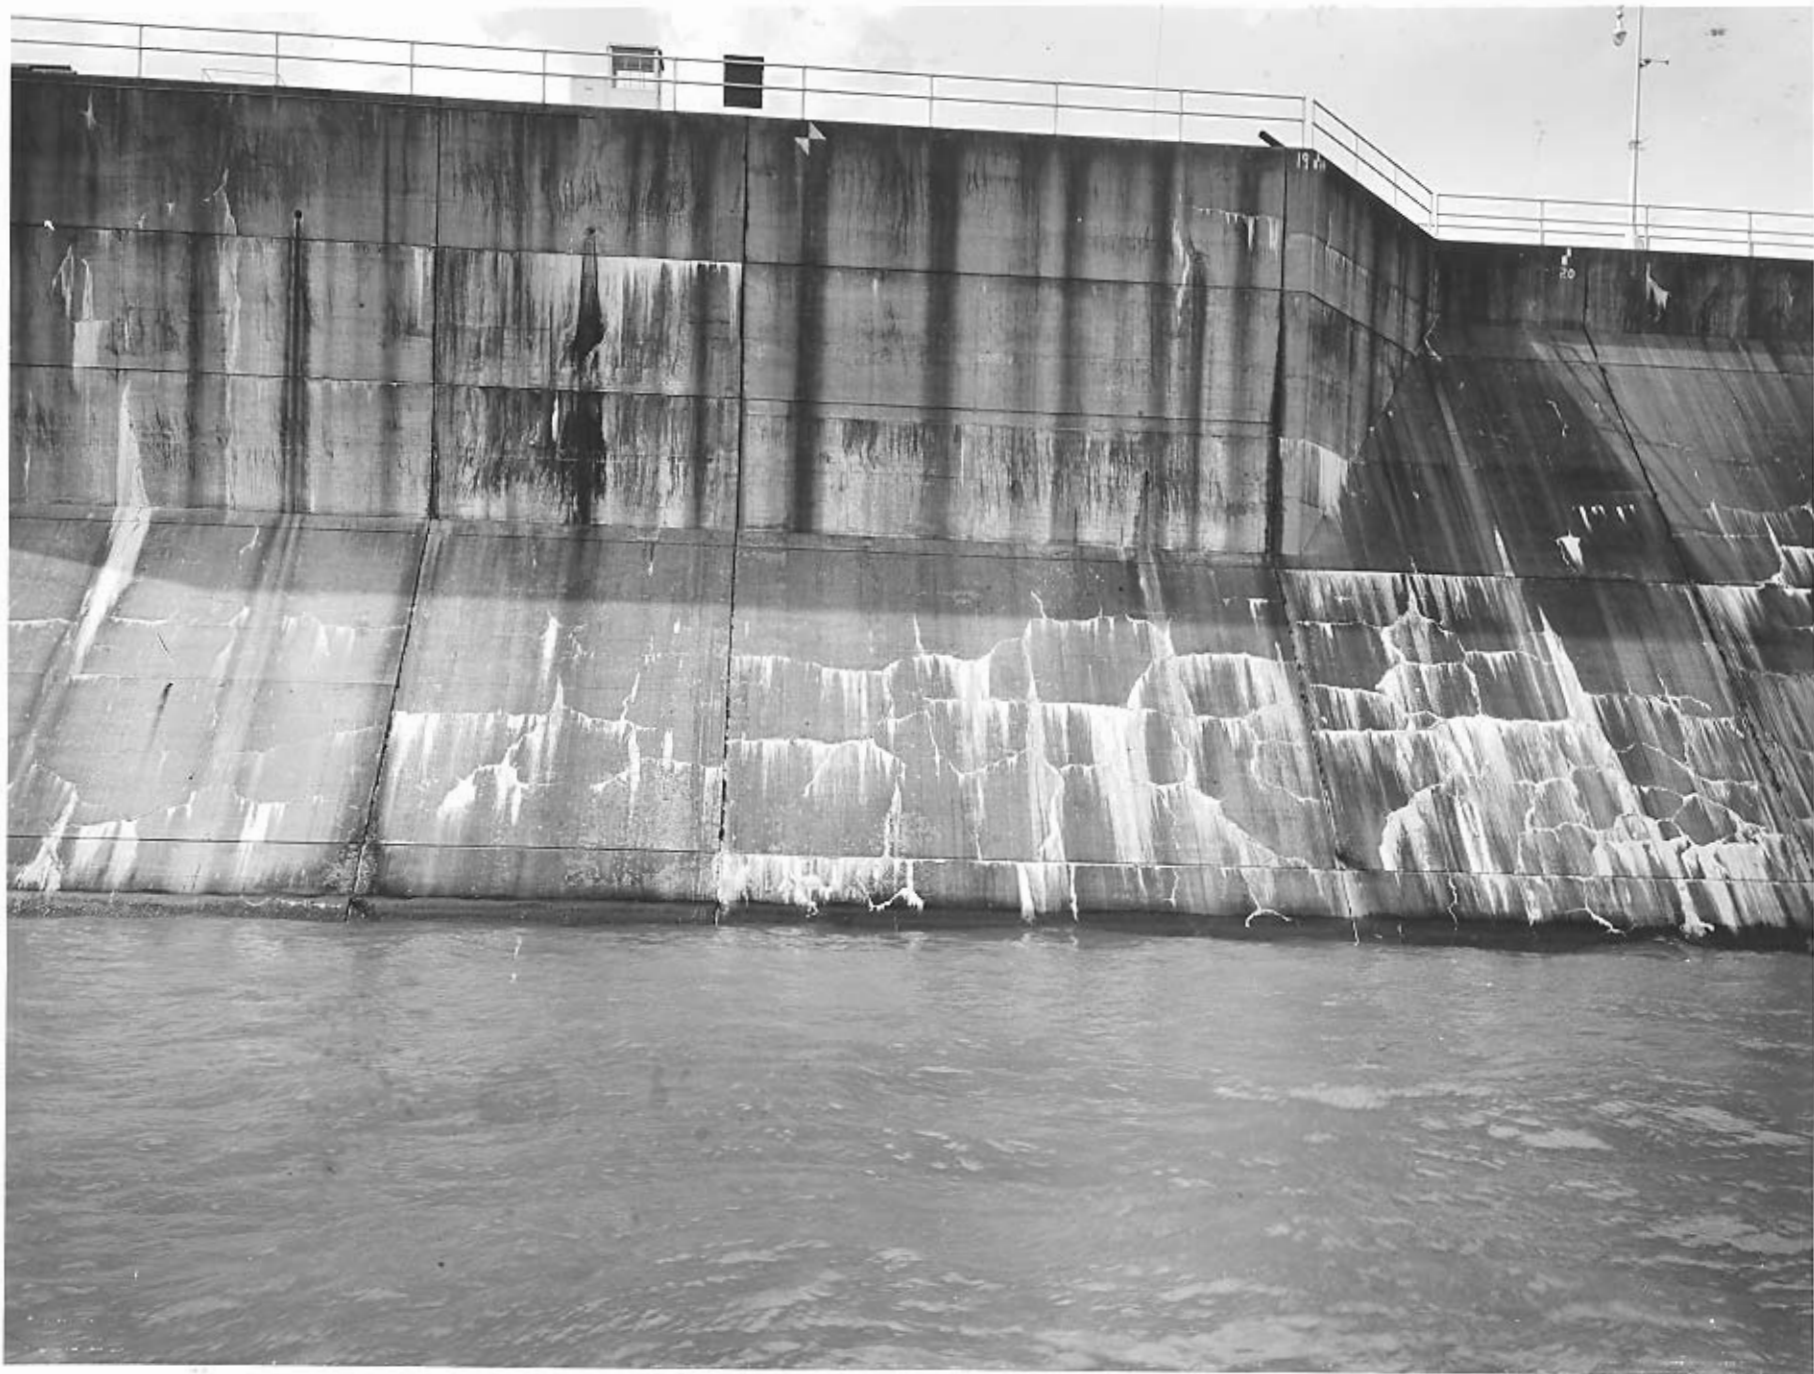
Auxiliary lock river wall blocks 60, 61, 62, 63, and 64.

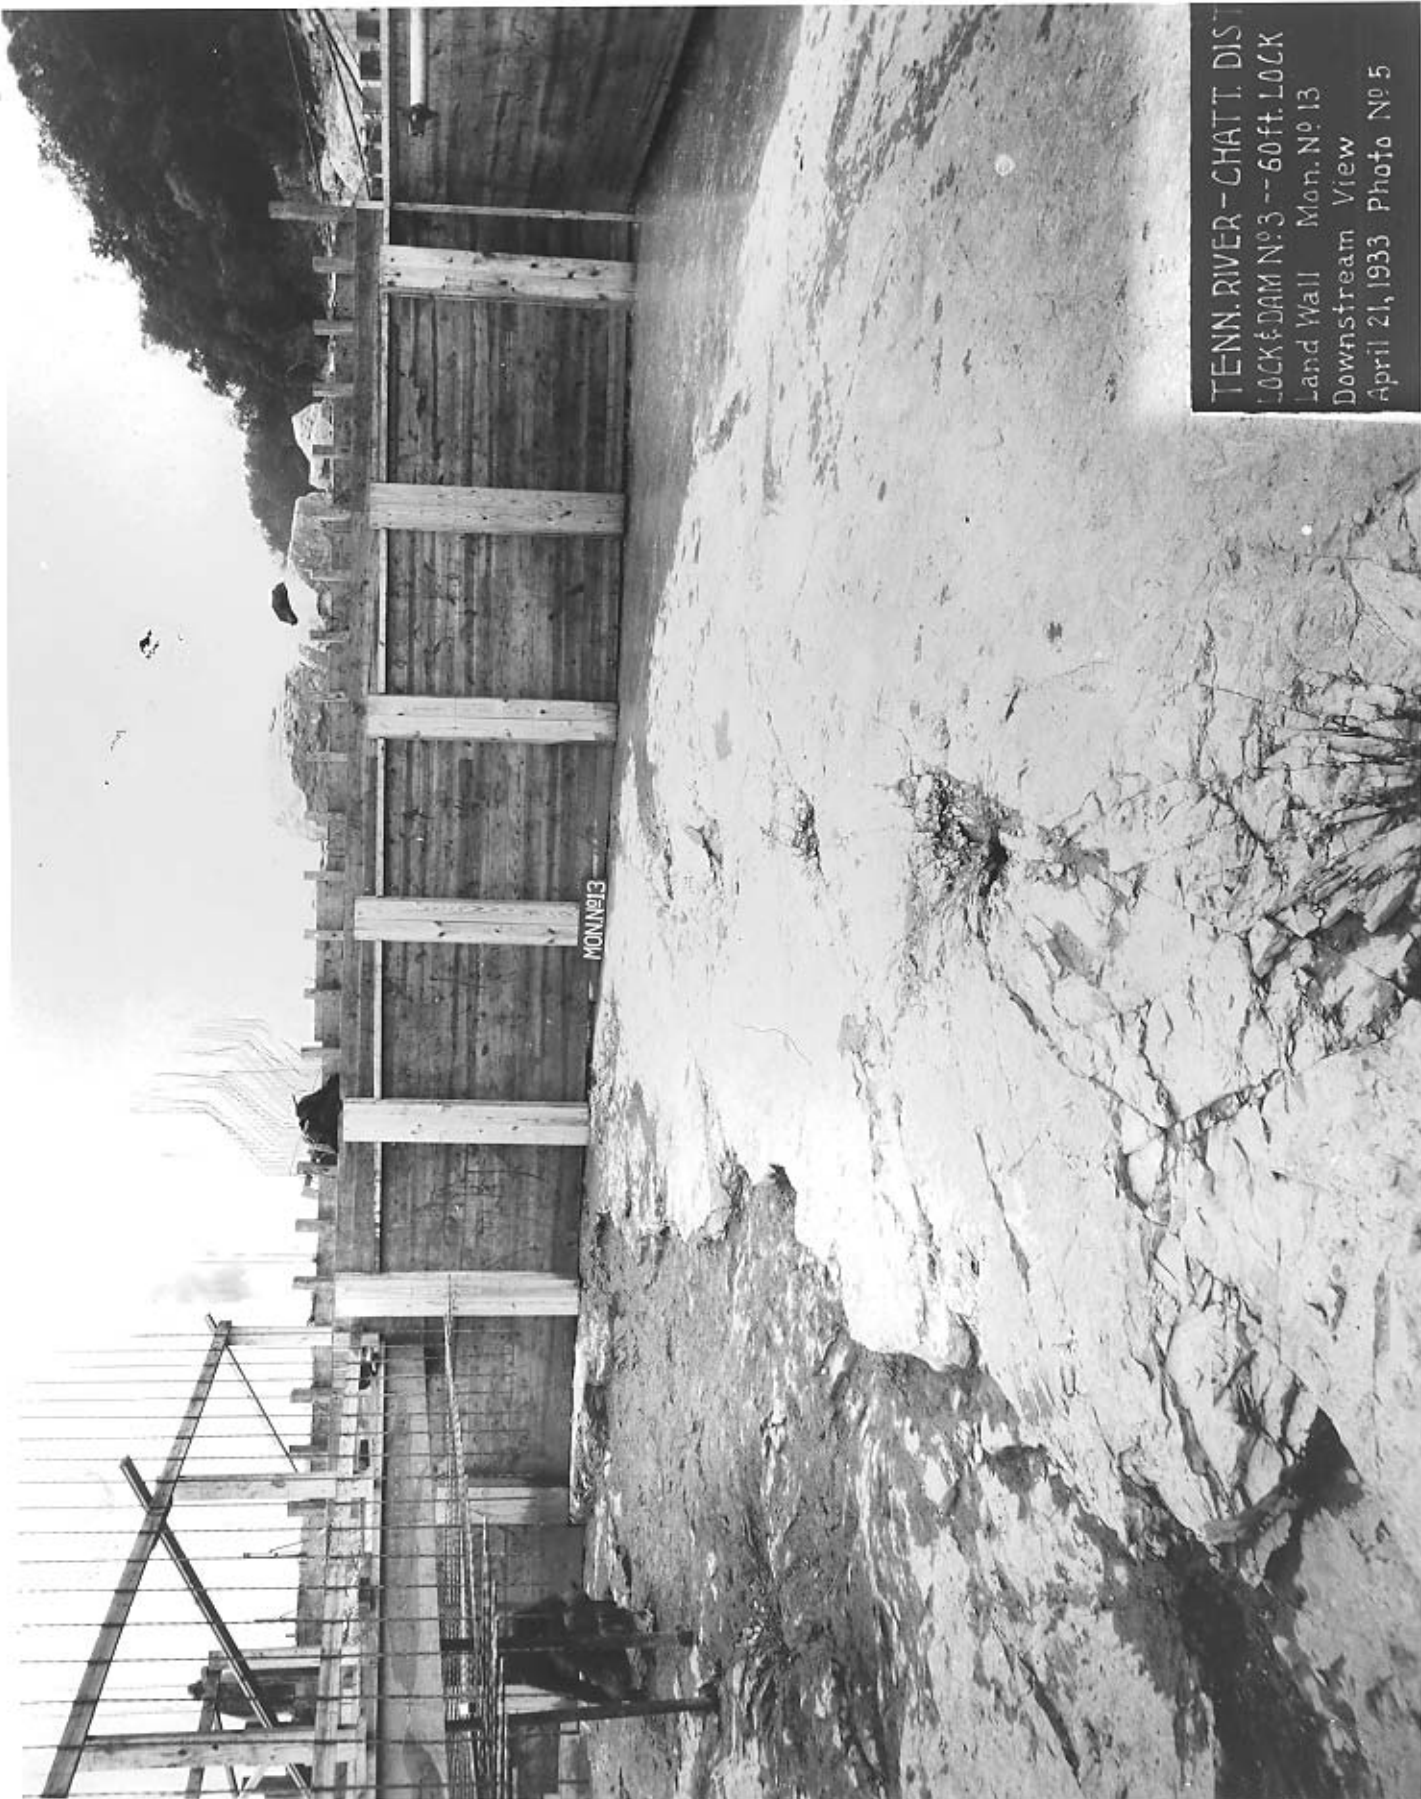
TENN. RIVER - CHATT. DIST.
LOCK & DAM N° 3 -- 60 ft. LOCK
Land Wall Mon. N° 13
Downstream View
April 21, 1933 Photo N° 5

The overburden for this section of wall consists of approximately 85 per cent muck and silt and 15 per cent loose slab rock and boulders, varying from 6 inches to 3 feet in depth. The average natural rock elevation was from elevation 493.7 \pm to elevation 496.2 \pm . The river face of the wall and a line 5 feet from the landside of the wall were channeled and the rock removed to elevation 483.8 \pm . The wall was later widened and an additional keyway added on the back side of the wall. In Monolith No. 12 the surface of the rock was a hard, close grained limestone with a few close horizontal seams. The bottom of the foundation was a harder, finer grained flintlike, blue limestone with small deposits of quartzite specked about its surface. The bottom of the keyway was similar to the bed. A 20-foot test hole revealed a dry hole and a satisfactory foundation. In Monoliths Nos. 13 and 14 the rock was similar to that in Monolith No. 12. In the foreground of Photograph No. 3, Monolith No. 13, is a large vertical seam. To the right of this is another. These seams are tight and appear to be well sealed. The rock, being very brittle, was shattered by blasting and shot holes are visible in Photograph No. 5. Test and grout holes shown on the attached sheet were grouted at a later date.

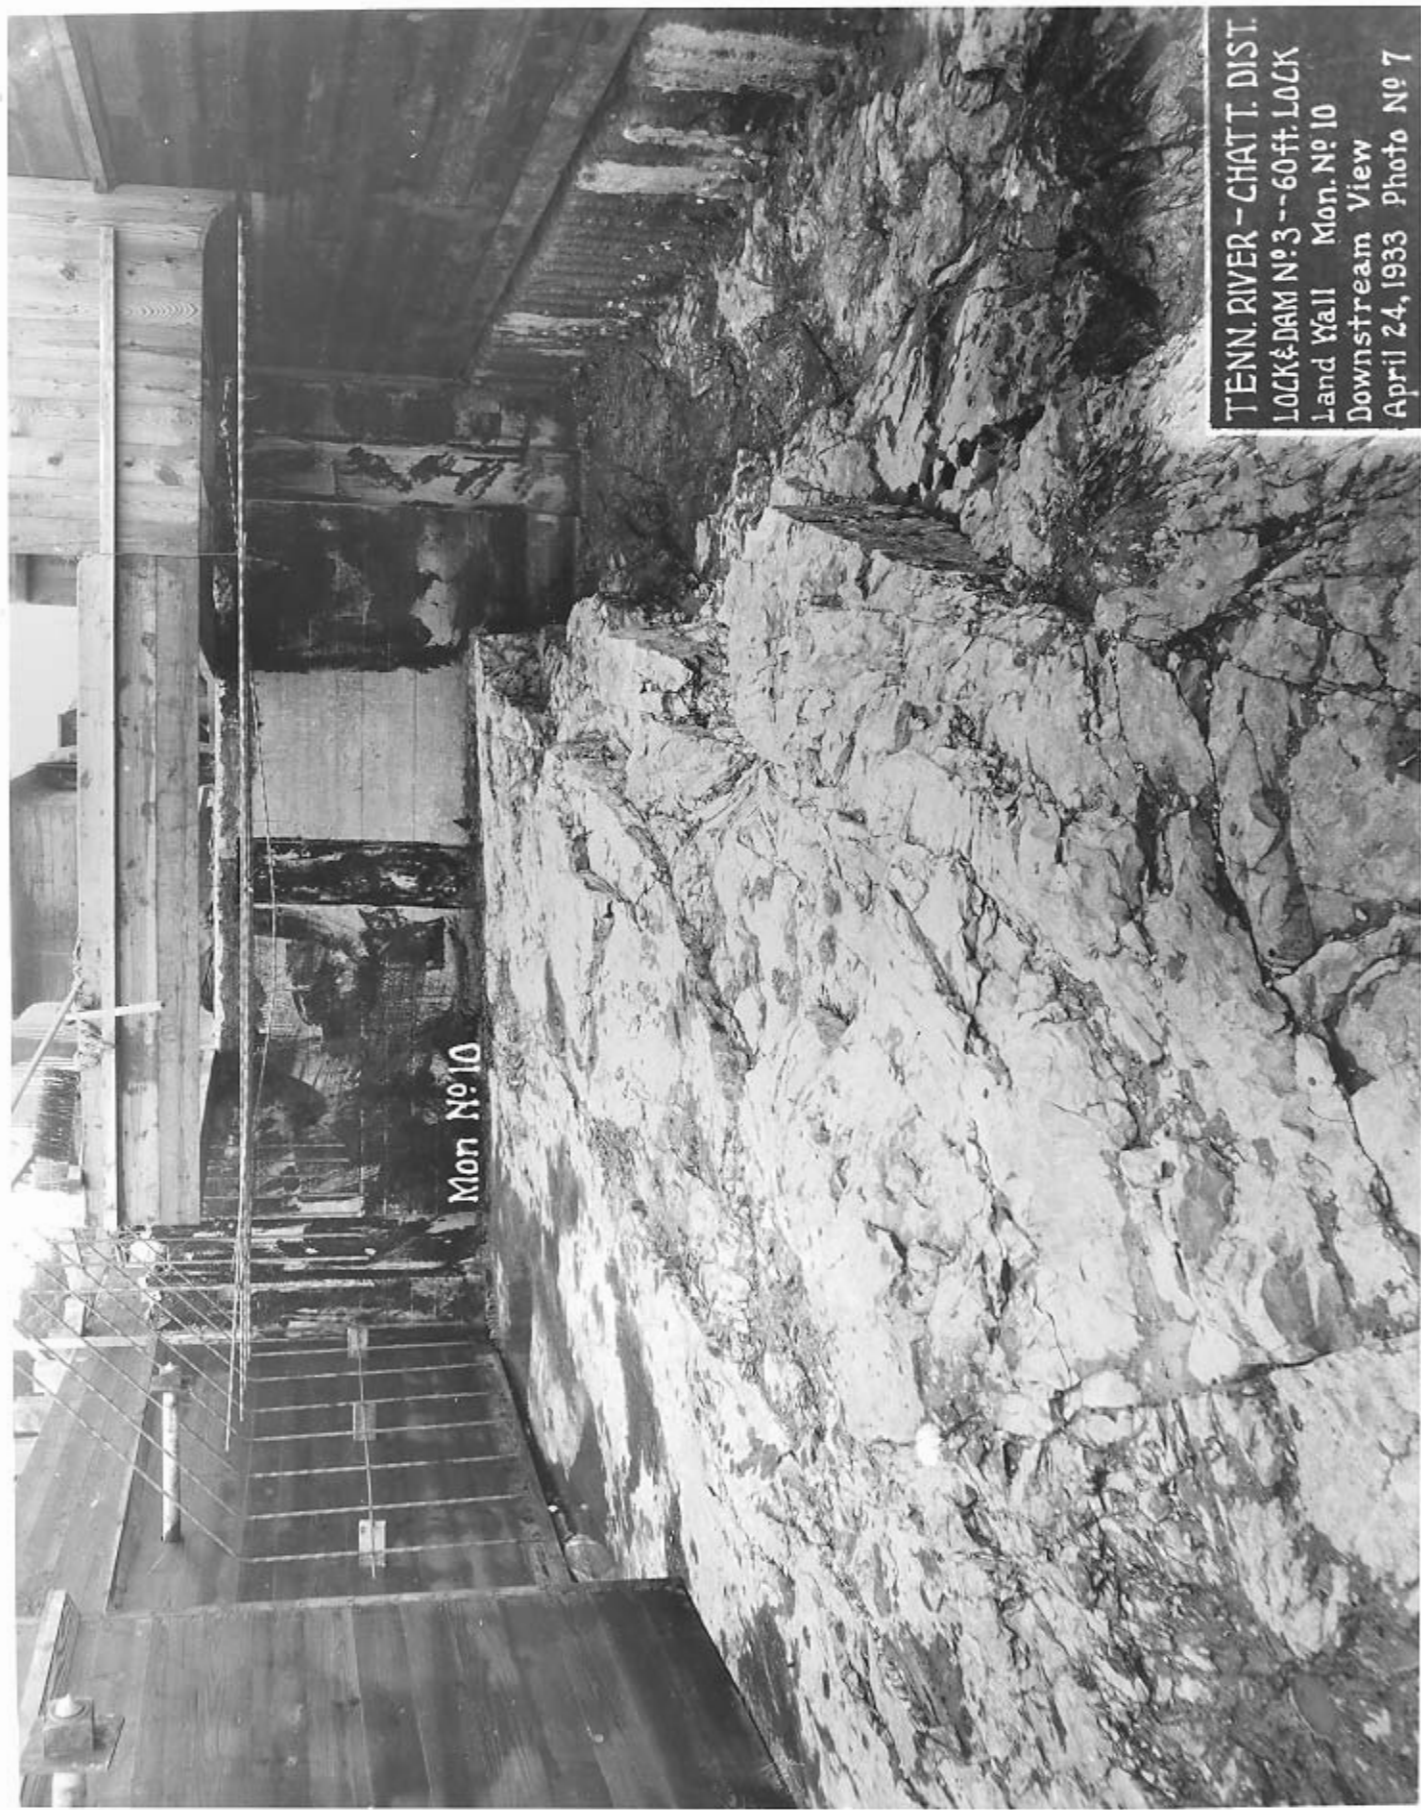
TENN. RIVER - CHATT. DIST.
LOCK & DAM N° 3 -- 60 ft. LOCK
Land Wall Mon. N° 10
Downstream View
April 24, 1933 Photo N° 7

The foundation proper consisted of a hard, fine grained, blue limestone underlaying a coarse grained, gray limestone on the surface. Small deposits of quartzite were found. In some instances where the limestone was hard and flintlike, the rock shattered badly from blasting. See Photograph No. 7. The rock lay in stratas from 6 inches to 4 feet thick, separated by close, tight seams. A 2-inch test hole, 20 feet deep, was drilled in Monoliths Nos. 1 to 11, inclusive, but no grouting was considered necessary for this section of wall. The attached general layout sheet shows the log of test holes and seams encountered. In Monoliths Nos. 1 and 2 a small amount of surface water ran under the forms above the lock face rock ledge. This seepage was pocketed in the upstream end of the keyway and removed with a pump until the concrete being placed reached an elevation above the rock ledge and sealed off this flow. No seepage water through open seams in the rock was encountered.

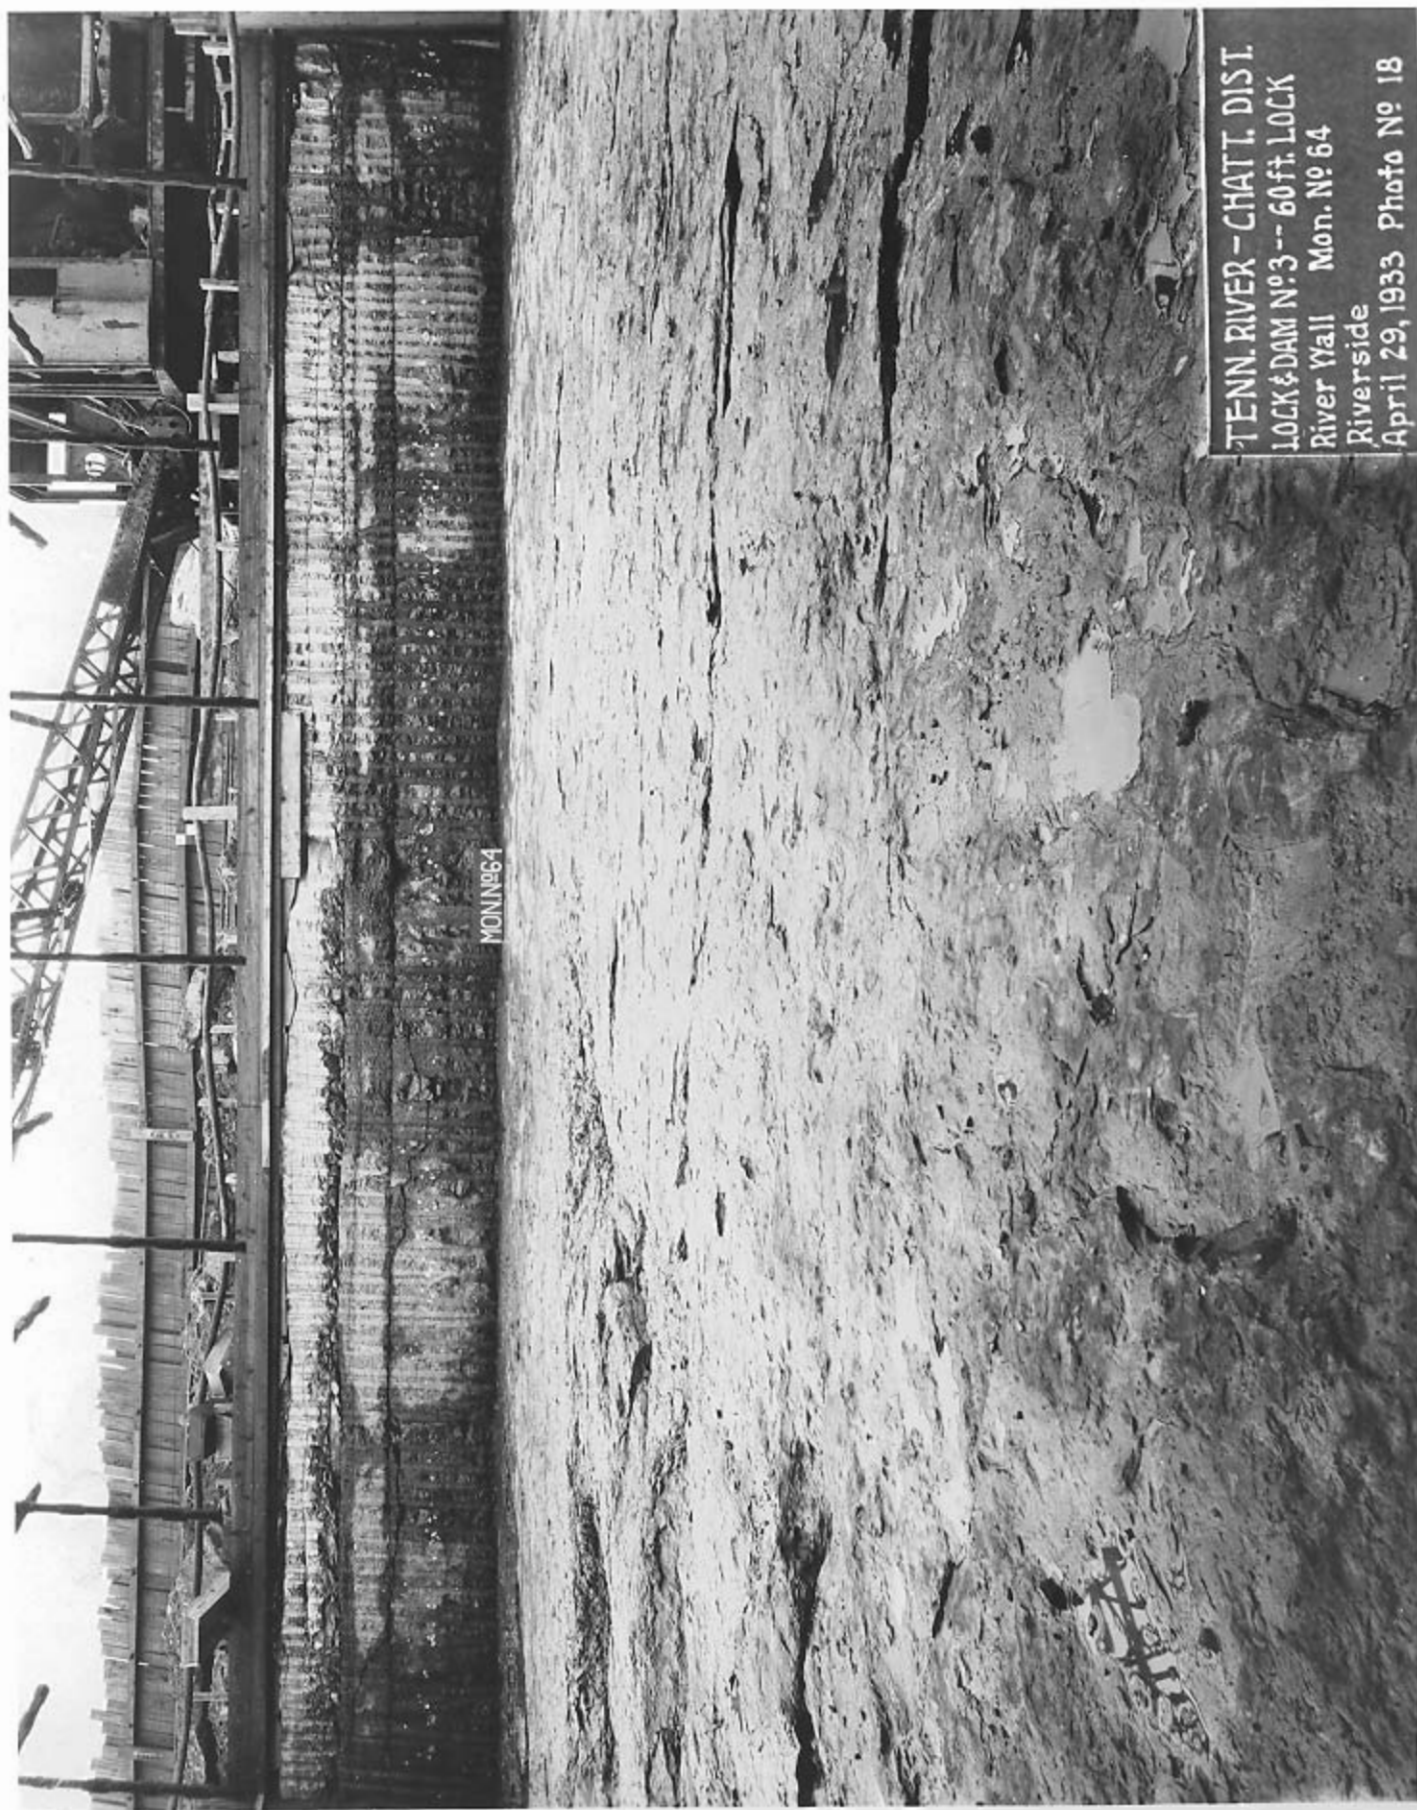
TENN. RIVER - CHATT. DIST.
LOCK & DAM N° 3 -- 60ft. LOCK
River Wall Mon. N° 64
Riverside
April 29, 1933 Photo N° 18

The foundation for Monoliths Nos. 62 to 65, inclusive, was a hard, blue grained limestone and laying in horizontal stratas. Vertical keyway faces were maintained and a very satisfactory foundation obtained. See Photograph No. 18.

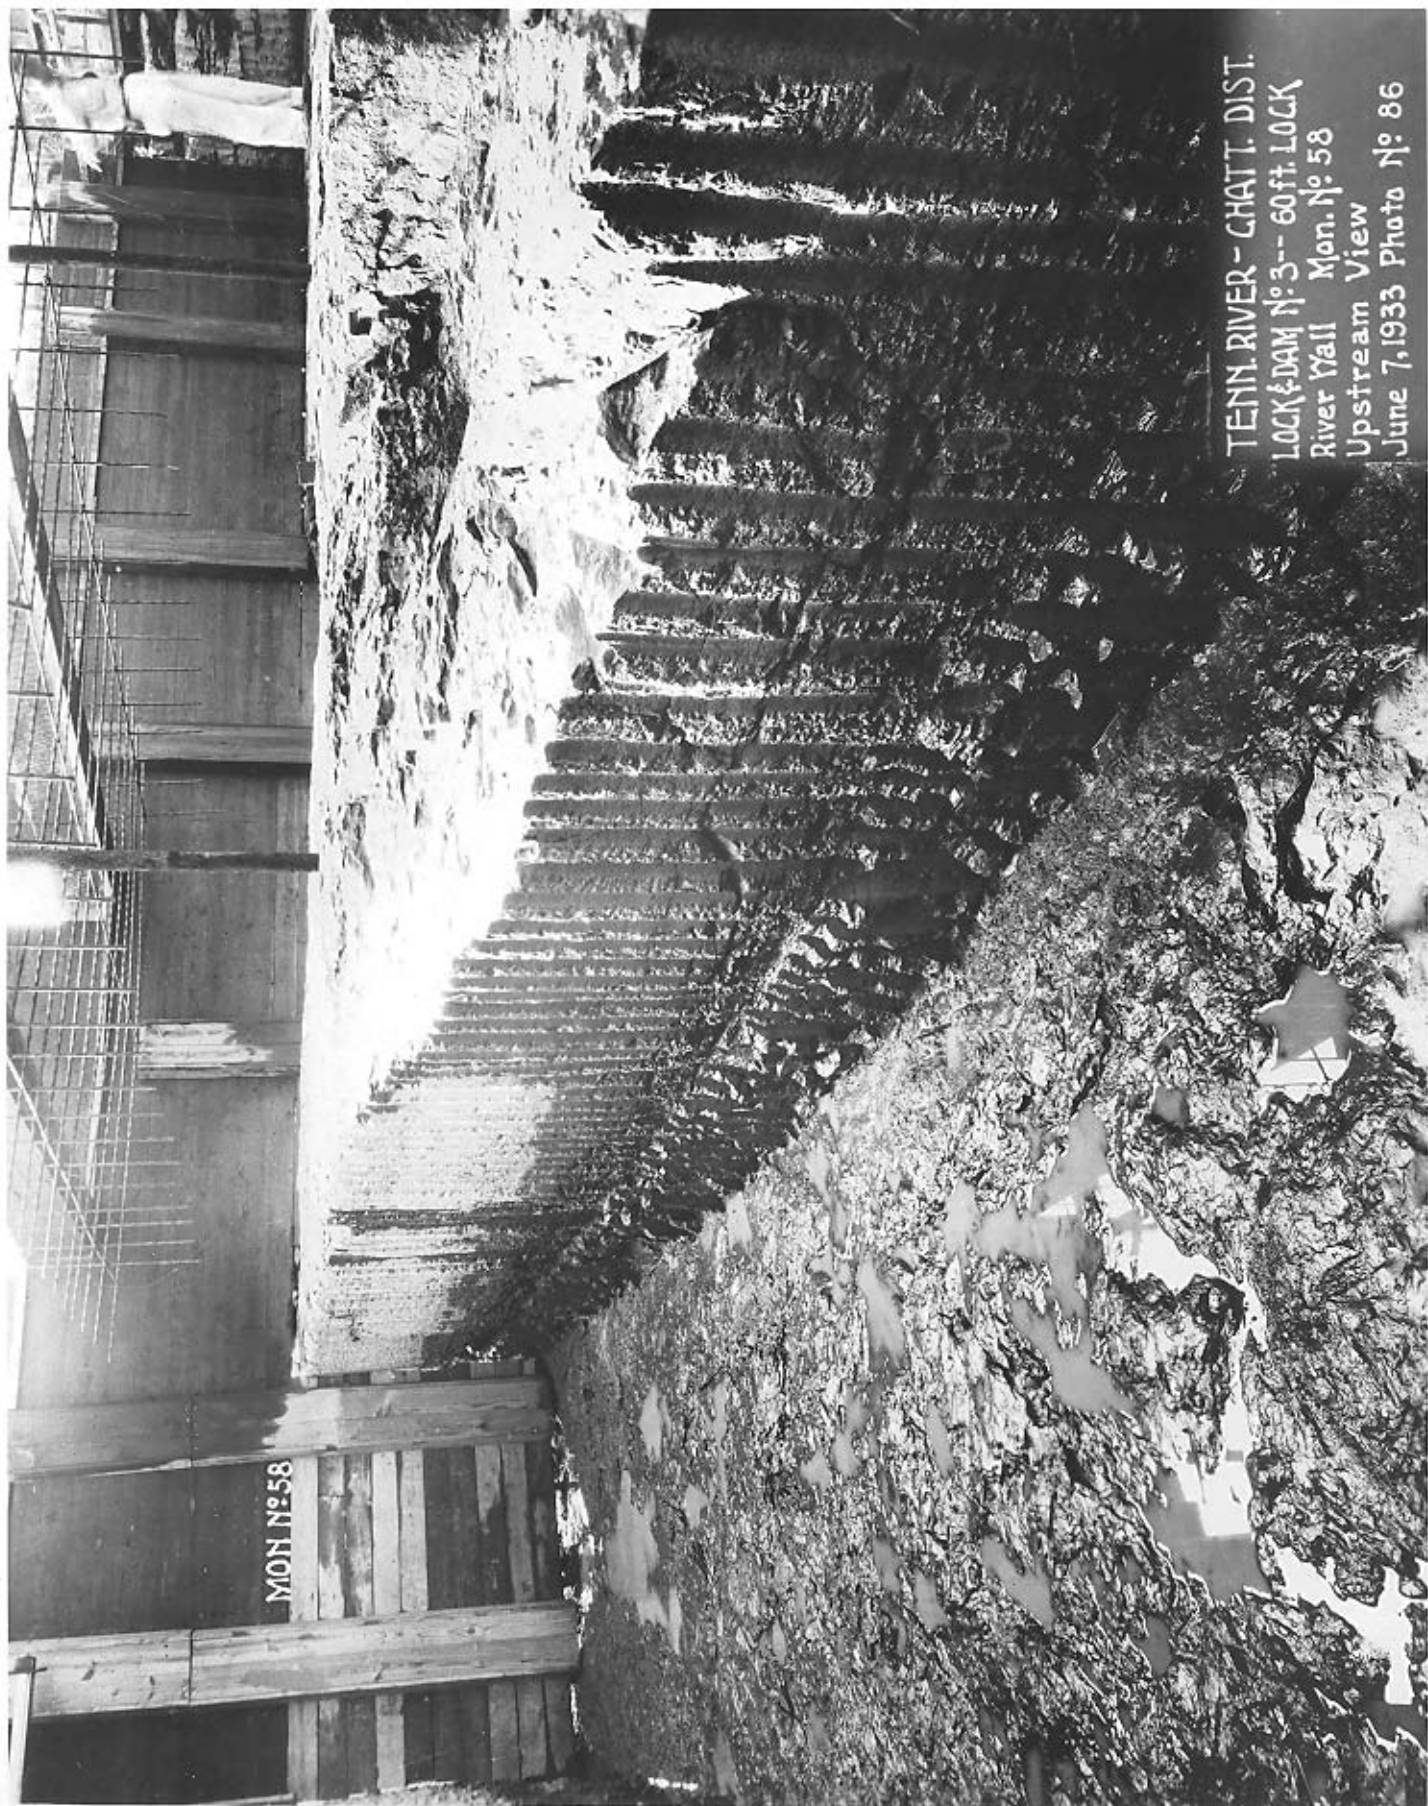
TENN. RIVER - CHATT. DIST.
LOCK & DAM N° 3 - 60 ft. LOCK
River Mill Mon. N° 58
Upstream View
June 7, 1933 Photo N° 86

In Monolith No. 57, the foundation was stepped back above the seam, and a better grade of rock was apparent. Note absence of seam in keyway picture No. 86, of Monolith No. 58, and step in foundation of Monolith No. 57 in Photograph No. 87. The foundation proper was a hard, blue grained limestone. The foundation material for Monoliths Nos. 59, 60, and 61 was a brittle, flintlike limestone, that was easily shattered by blasting.
